**DEVELOPMENT AND CRASH TESTING OF AN AESTHETIC,
SEE-THROUGH BRIDGE RAIL, TYPE 90**

DEPARTMENT OF TRANSPORTATION
DIVISION OF RESEARCH AND INNOVATION
OFFICE OF SAFETY INNOVATION AND COOPERATIVE RESEARCH

November, 2008

1. REPORT NO. FHWA/CA08-0766	2. GOVERNMENT ACCESSION NO.	3. RECIPIENT'S CATALOG NO.	
4. TITLE AND SUBTITLE DEVELOPMENT AND CRASH TESTING OF AN AESTHETIC, SEE-THROUGH BRIDGE RAIL, TYPE 90		5. REPORT DATE November 2008

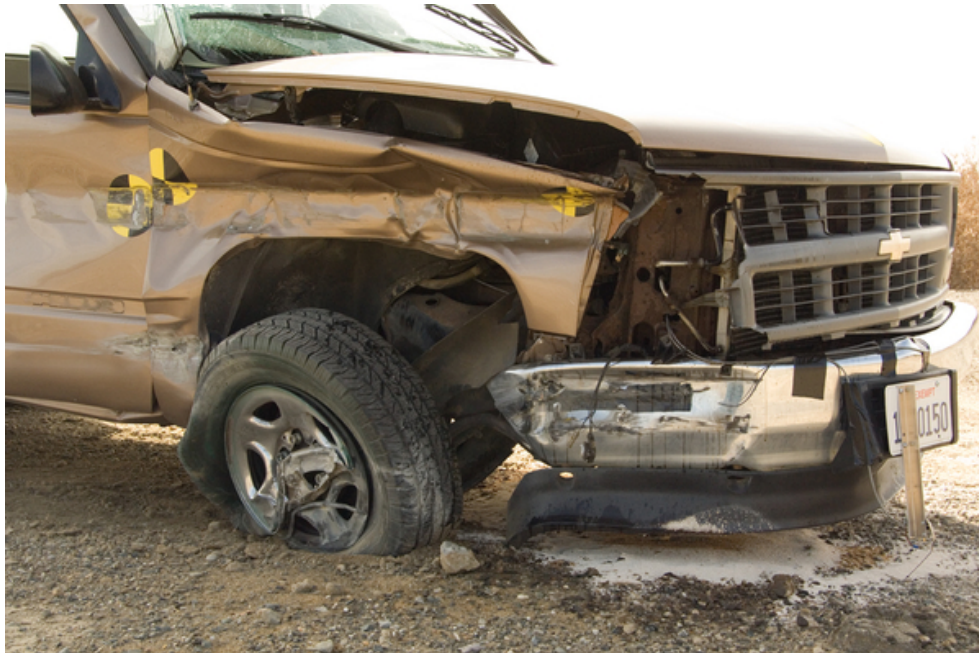
Figure 2-8 – Right front corner of test vehicle after Test 631

The right front corner of the vehicle was moderately damaged in the initial impact with the barrier. The right front fender, hood, bumper, headlamp area, grille, and suspension components were all affected. The passenger side doorframe was deformed outward but the door remained latched. The right front tire was also ruptured. The steel rail caused denting along the entire length of the passenger side as the vehicle continued to contact the barrier after the initial impact. The right front tire was pushed rearward and slightly into the passenger side foot well area. The maximum amount of passenger compartment deformation was 124 mm¹, which occurred in the floorboard². The entire windshield spider-cracked but did not separate or enter the occupant compartment. However, this cracking was not caused entirely by the test. The windshield was inadvertently damaged (see Figure 2-10) on the impact side shortly before the test was run and it was decided that the damage was not significant enough to warrant postponing the test. Post-crash photos show the initial crack to be the weak point and the source of future cracking.

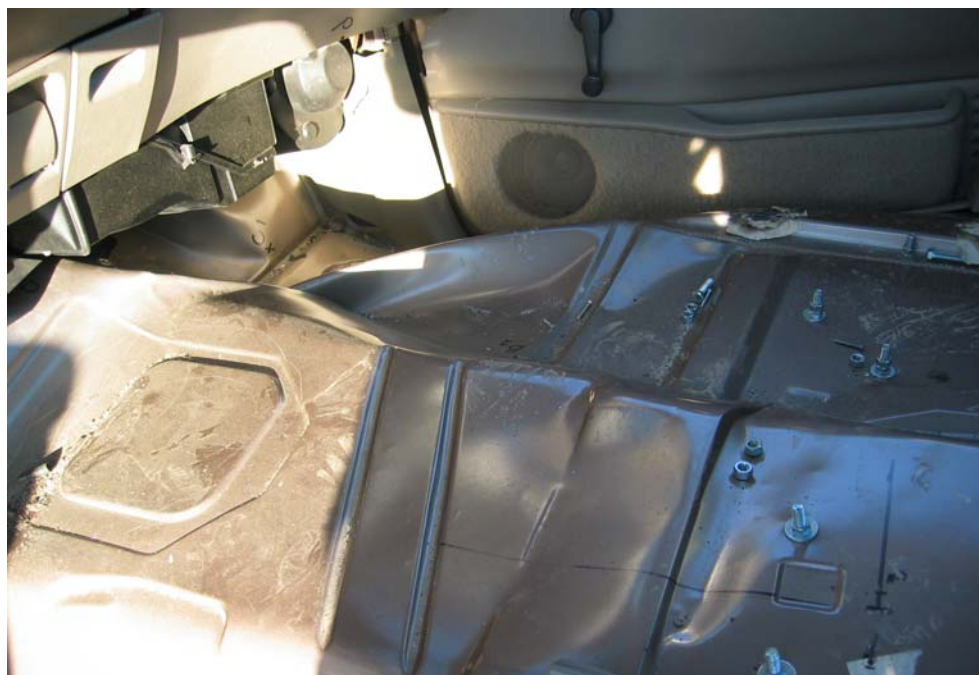
Figure 2-9 – Floorboard deformation of test vehicle after Test 631

1. The Type 90 can successfully contain and redirect a 2000-kg pickup truck impacting at 25° and 100 km/h. (There was moderate occupant compartment deformation, mainly in the cab floorboard area. This deformation was judged to be insufficient to cause serious injury to vehicle occupants).

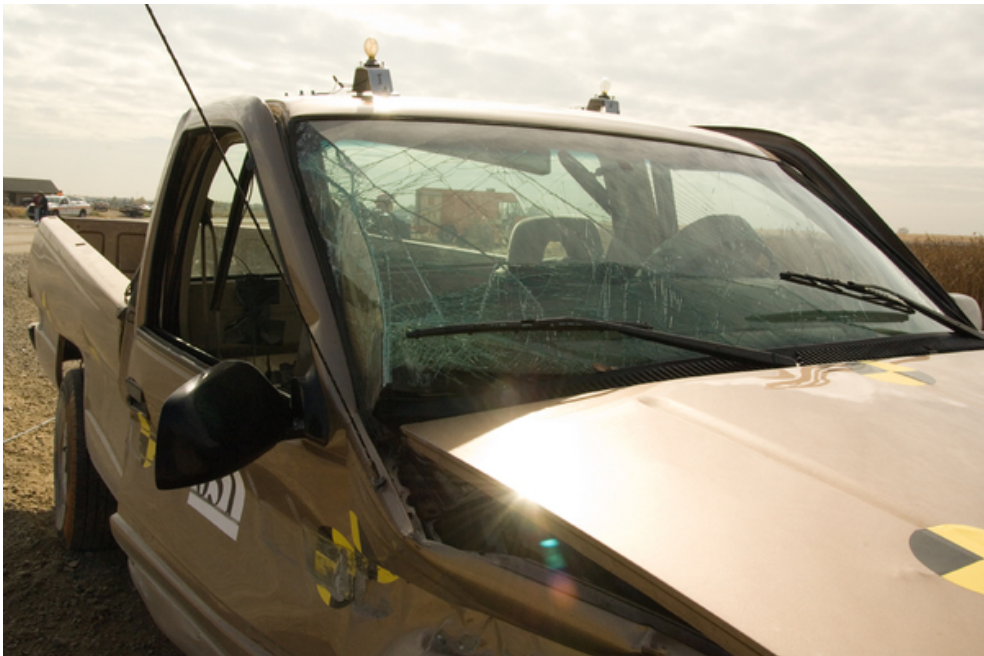
Figure 2-11 – Vehicle windshield after Test 631

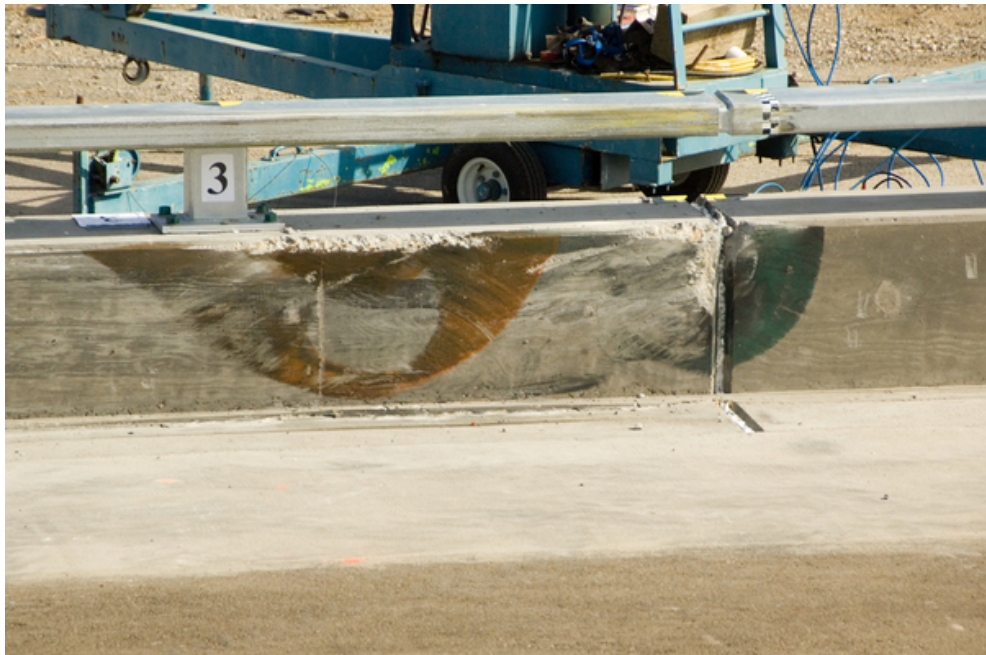
Figure 2-13 – Type 90 barrier face after Test 631

Barrier Damage: Maximum dynamic deflection in steel rail of 38 mm, superficial concrete spalling, and no permanent lateral deflection.

There was only minimal permanent damage to the barrier during Test 631. The steel rail scraped a small amount of paint off the vehicle along the length of contact. The vehicle caused some minor concrete spalling at the downstream vertical face of the expansion joint near the impact point and along the top of the curb for approximately 1.5 m. No rebar was exposed so there was no structural damage to warrant immediate repair. For aesthetic reasons and because the concrete cover over the rebar has been compromised, the damage should be repaired by maintenance crews.

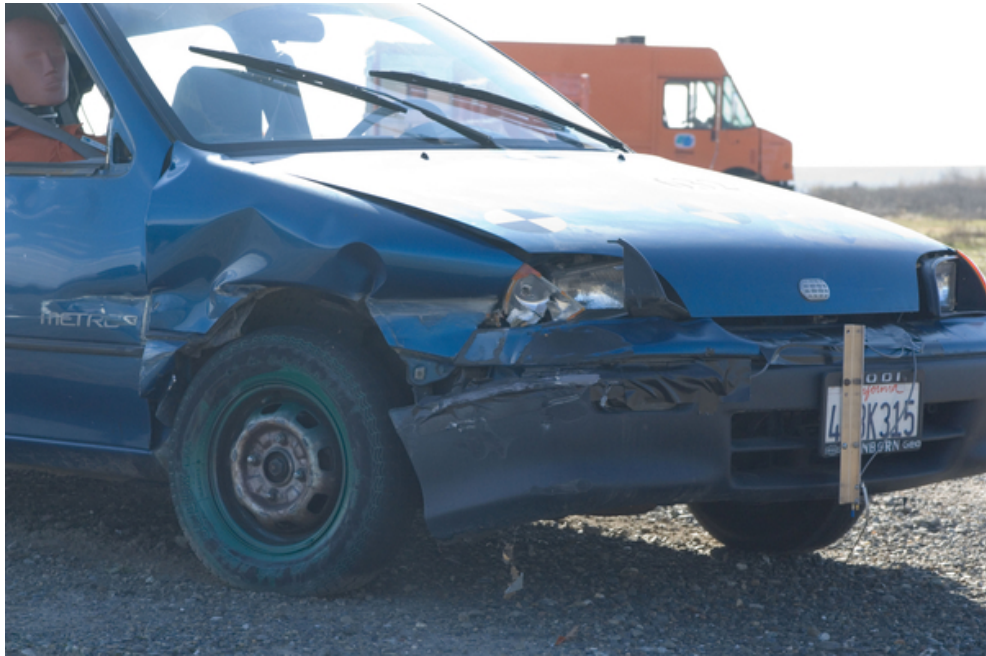
Figure 2-18 – Front right corner of test vehicle after Test 632

The right front corner of the vehicle was moderately damaged. The right front bumper and right fender were pushed rearward. The right front tire and wheel assembly were pushed rearward about 146 mm into wheel well, deforming it. The entire right side of the vehicle was moderately damaged. There was no significant passenger compartment or floorboard deformation. The passenger-side mirror was broken off.

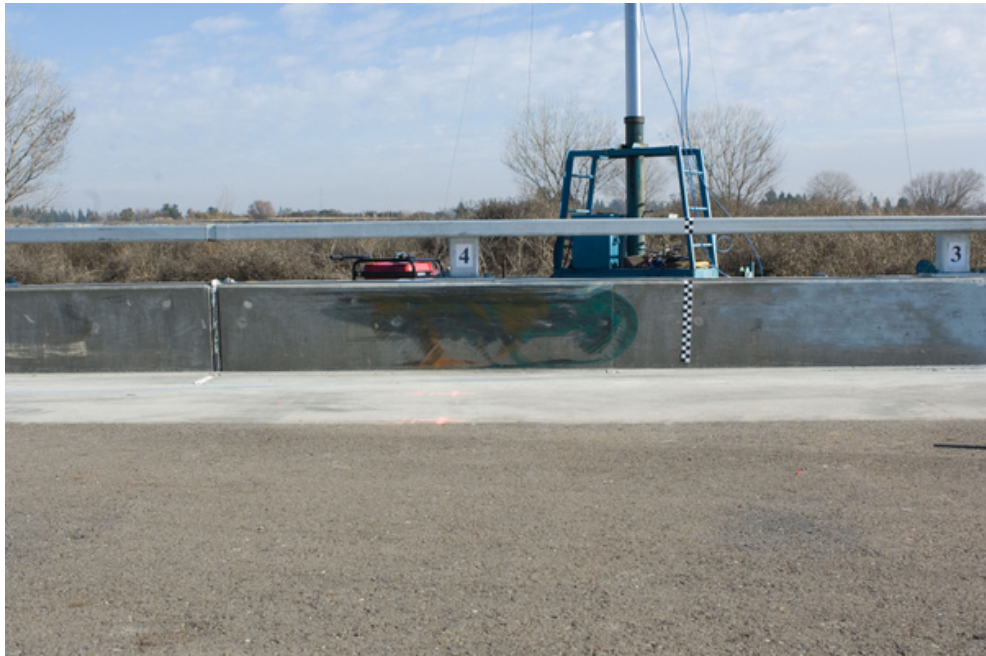
Figure 2-20 – Type 90 bridge rail face after Test 632

There was essentially no permanent damage to the barrier during Test 632. The steel rail scraped a small amount of paint off the vehicle along the length of contact. There was a negligible amount of concrete spalling on the concrete curb. There would be no need for repair by a maintenance crews.

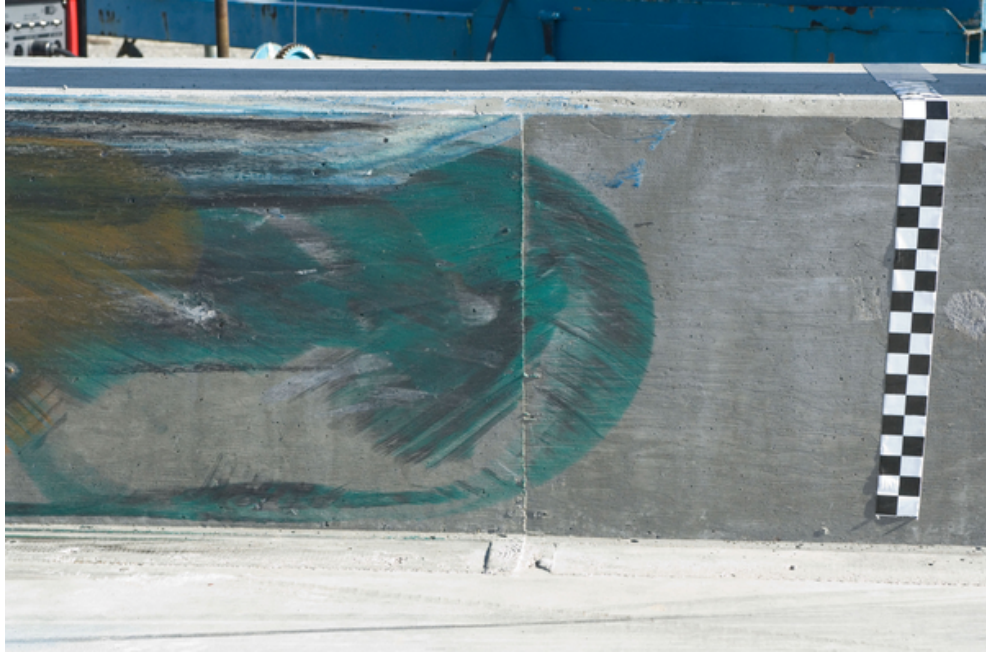
Figure 2-21 – Barrier face scraping after Test 632

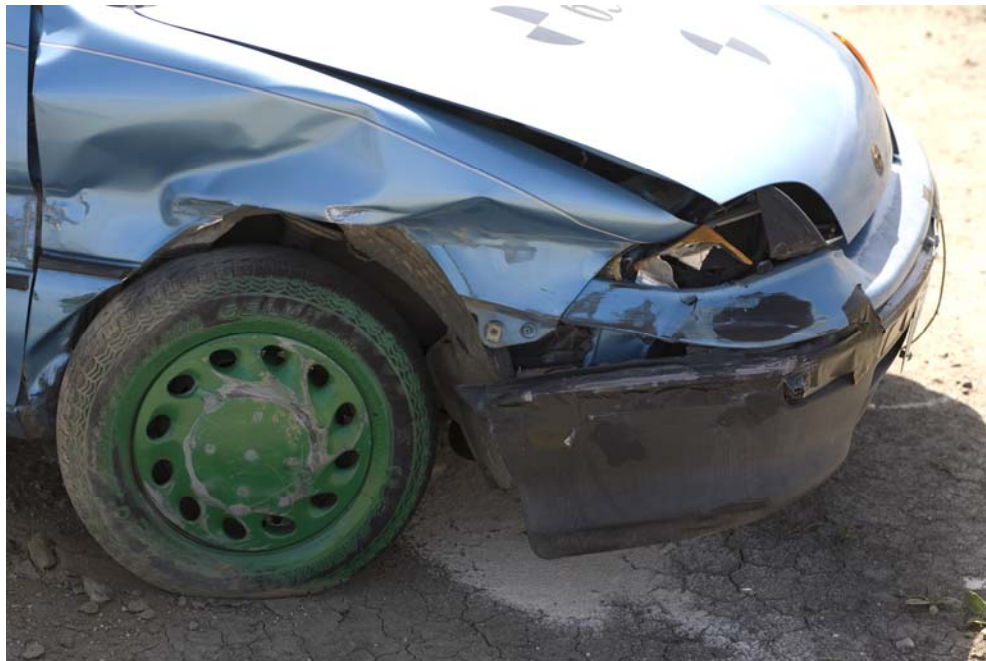
Figure 2-27 – Front right corner of test vehicle after Test 633

The right front corner of the vehicle was moderately damaged in the initial impact with the concrete curb. The right front bumper and right fender were pushed rearward. The right front tire and wheel assembly was pushed rearward about 130 mm into wheel well, deforming it. The entire right side of the vehicle was moderately damaged. There was no significant passenger compartment or floorboard deformation.

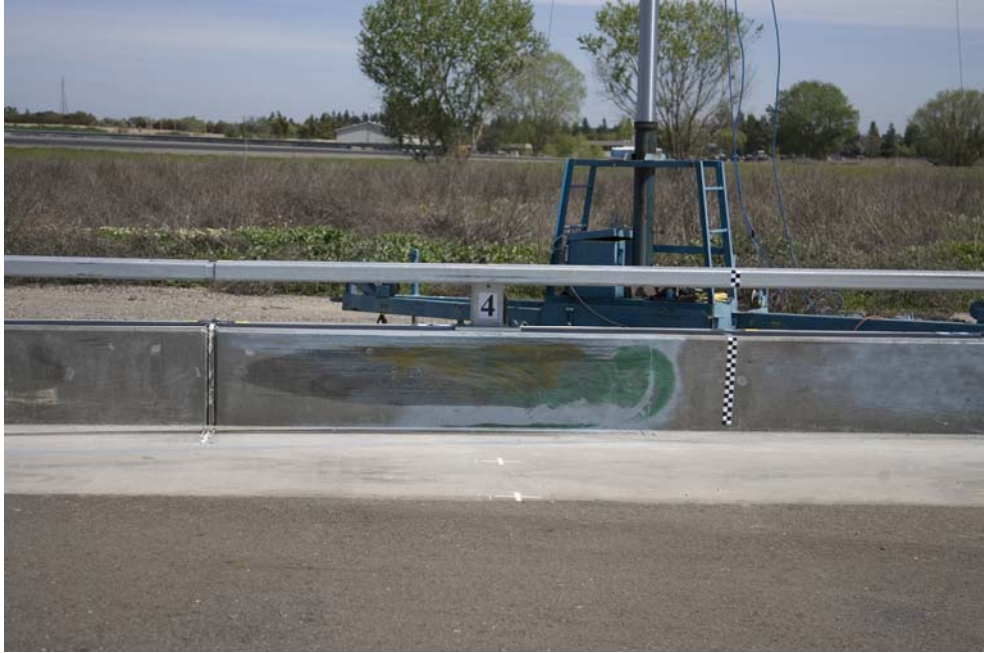
Figure 2-28 – Type 90 bridge rail face after Test 633

As in Test 632, there was essentially no permanent damage to the barrier during Test 633. The steel rail scraped a small amount of paint off the vehicle along the length of contact. There was a negligible amount of concrete spalling on the concrete curb. There would be no need for repair by a maintenance crews.

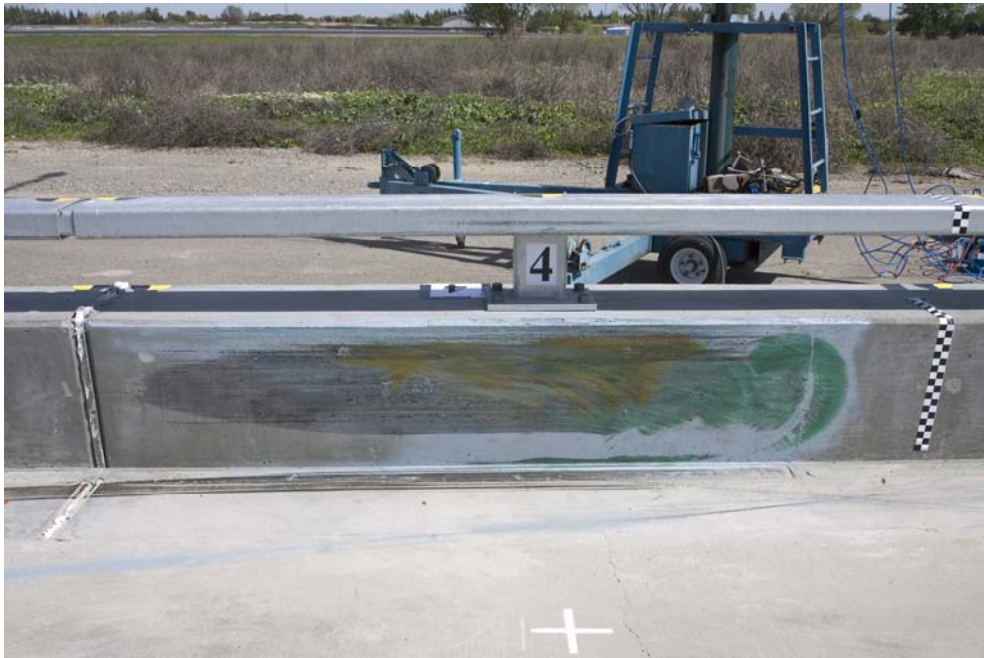
Figure 2-29 – Barrier face scraping after Test 633

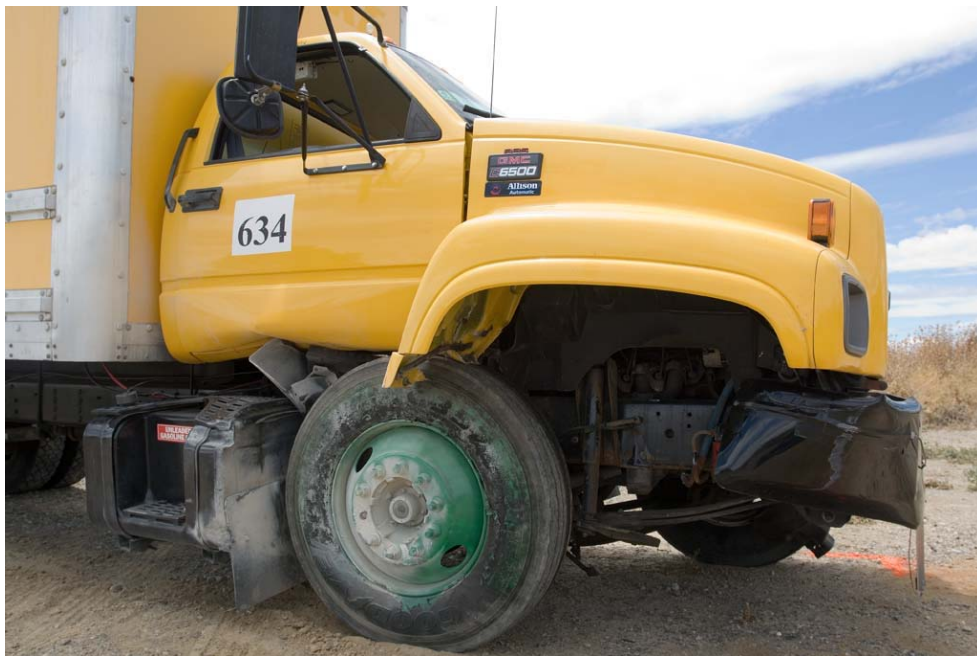
Figure 2-34 – Right side of test vehicle after Test 634

The impact of the right front tire with the barrier caused failure of several suspension components, including the right-side U-bolts which secure the axle to the leaf springs as well the end of the leaf spring on the right side. The axle shifted rearward 650 mm on the impact side and forward 160 mm on the driver side. When the front passenger side wheel was driven rearward, it crushed the battery box, the OEM fuel tank, the fender, and the door. Additionally, the front passenger side shock mounting bolt was sheared, a wheel stud on the front passenger tire sheared off, the passenger side of the front bumper was bent rearward, the rear passenger side wheel was damaged, and the bottom of the cargo bed was scraped at support locations from scraping the top of the steel rail. The passenger-side door remained latched even though the battery box was pushed upward into the bottom of the door, causing significant deformation. There was no significant passenger compartment or floorboard deformation. Additionally, all tires were still fully inflated after the test, despite the impact-side rims being bent and/or scraped during impact.

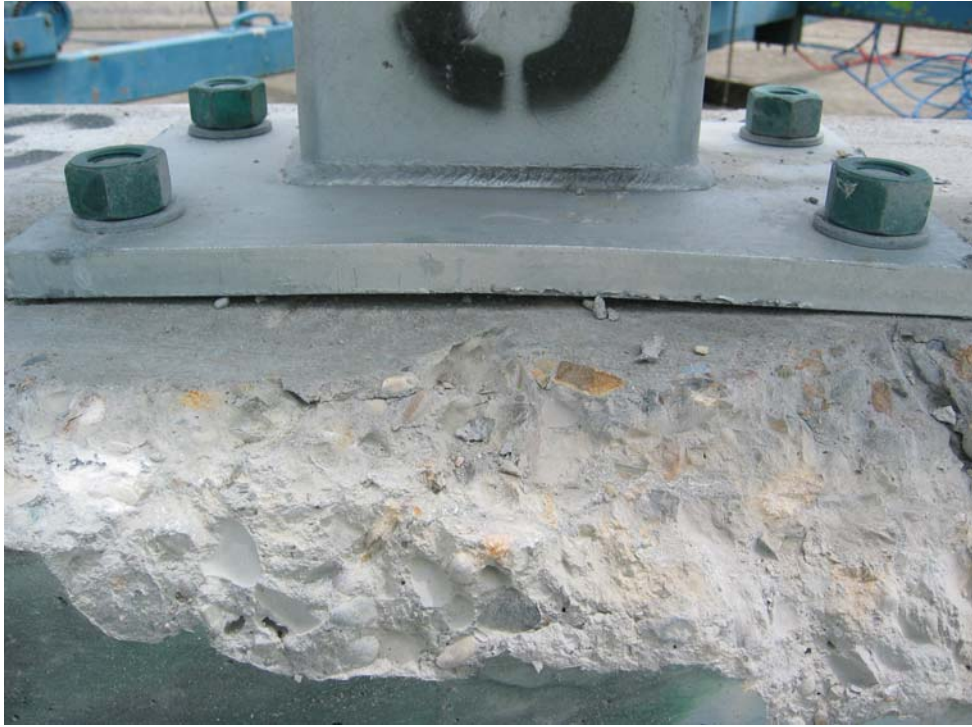
Figure 2-35 – Post 3 Close-up after Test 634

Unlike the previous tests, there was some permanent damage to the barrier. The vehicle lug nuts and rims caused gouging and spalling of the top of the concrete curb from just upstream of the initial impact point to where the rear tire lost contact with the rail, about 4.5 meter downstream of the impact point. At posts 3 and 4 the spalling extended to the front edge of the post base plate. As in Test 631, the gouging and spalling were superficial and not structural as evidenced by the lack of exposed rebar¹. More significantly, there was minor weld cracking at Post 3 (the post nearest the impact location) where the post was attached to the base plate. The welds were cracked approximately 6 mm on each side of all four corners, with a 0.05-mm gap at the crack locations. The center of the base plate was also bent upwards on the traffic and upstream sides, with the maximum deformation of 5 mm occurring on the traffic side. Additionally, the steel rail had a permanent lateral deflection of less than 15 mm. Because the weld cracking was minor, it is unlikely that damage to the steel rail would pose a safety concern to other vehicles before maintenance crews could repair the damage.

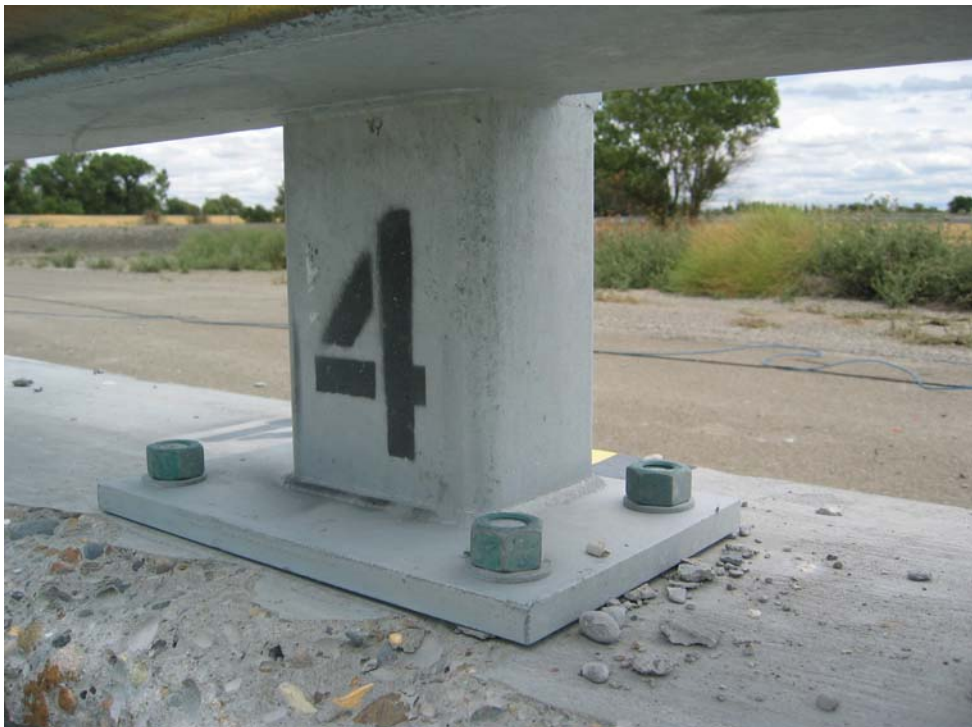
Figure 2-36 – Post 4 Close-up after Test 634

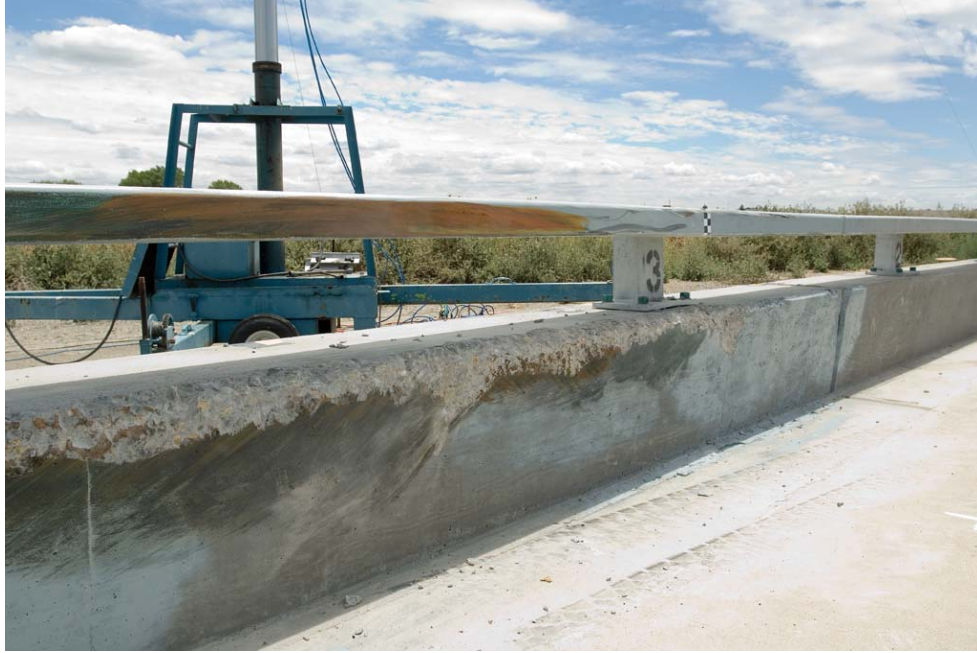
Figure 2-37 – Type 90 barrier face after Test 634

Barrier Damage: Maximum dynamic deflection in steel rail of <50 mm and <15 mm of permanent lateral deflection, moderate concrete spalling from vehicle lug nuts scraping, and <15 mm of permanent lateral deflection.

¹ The damage to the concrete, although not aesthetically pleasing, would not likely have an adverse affect on the crashworthiness of the barrier.
