Subject: INFORMATION: In-service Performance Evaluation and Continuous  
Monitoring of Roadside Safety Features

## SCI GM ATTENUATOR IN-SERVICE EVALUATION REPORT

## SCI\_GM ATTENUATOR IMPACT HISTORY

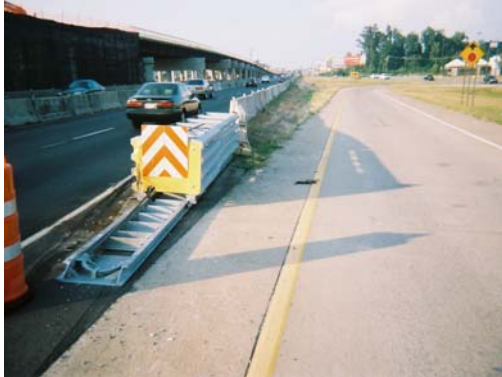
8-7-04 - 1st incident - Serial# 163  
Frontal Impact - Collapse 8 feet  
No Injuries  
Part Required – shear bolts  
Repair cost part and labor - \$201.50  
Vehicle – not known  
Posted speed – 55

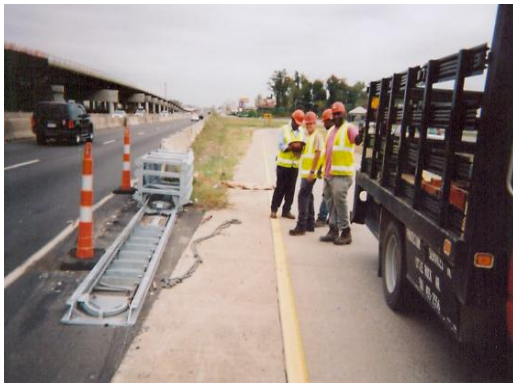
11-2-04 - 3rd Incident – Serial# 163  
Frontal Impact - Collapse 14 feet  
No Injuries  
Part Required – shear bolts  
Repair cost part and labor - \$151.50  
Vehicle – Tractor/trailer  
Posted speed – 55

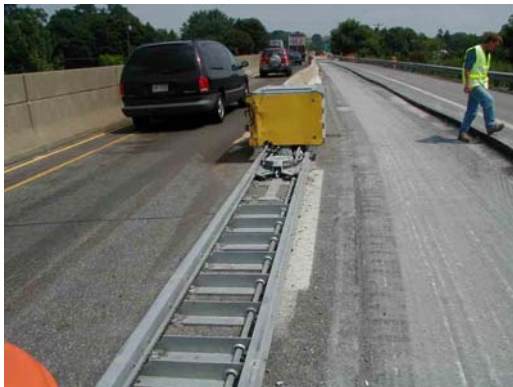
8-16-04 - 1st Incident Serial# 17  
Frontal Impact – Collapse - Full  
No Injuries  
Part Required – shear bolts  
Repair cost part and labor - \$201.50  
Vehicle – Tractor/trailer  
Posted speed – 55

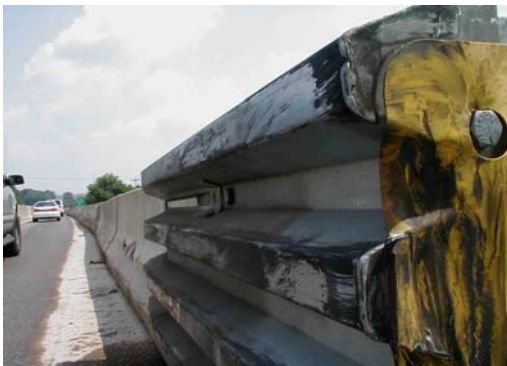
Close up of above incident  
When attenuator collapsed, the front wheel of the Tractor/trailer was taken off and the fuel tank was severely damaged. The Tractor/trailer followed down the barrier before coming to a stop. With significant side pressure on the sled, there was no damage to the attenuator except for small dent in top corner which doesn't affect function.

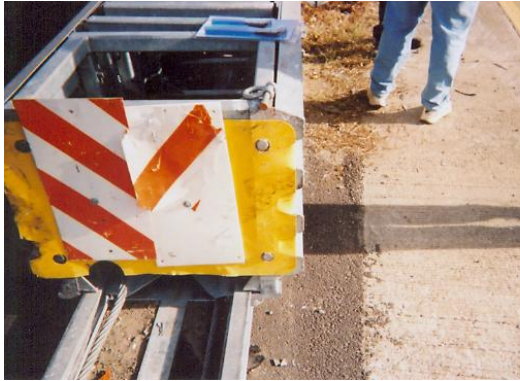
11-10-04 - 4th Incident - Serial#163  
Frontal Impact – Collapse - Full  
No Injuries  
Part Required – shear bolts, side keepers, and side panel  
Repair cost part and labor - \$332  
Vehicle – Tractor/trailer  
Posted speed – 55

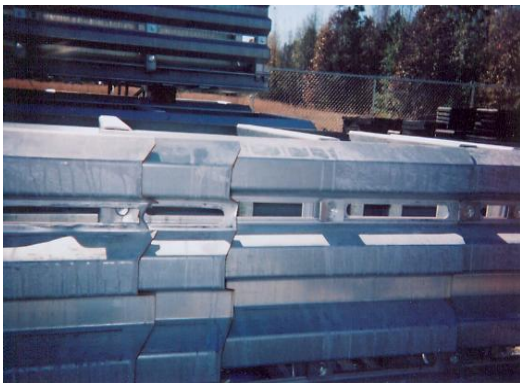
Side panels from above picture  
This incident was this attenuators 4<sup>th</sup> impact all by very large vehicles and required extra parts. The Tractor/trailer was full and running around 80,000 lbs.

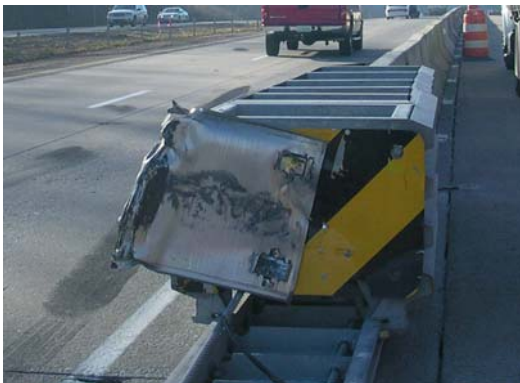
2-7-05 - 1st Incident – Serial #9  
Frontal Impact – Collapse – 8.5 feet  
No Injuries  
Part Required – shear bolts  
Repair cost part and labor - \$201.50  
Vehicle – Tractor/trailer  
Posted speed – 70

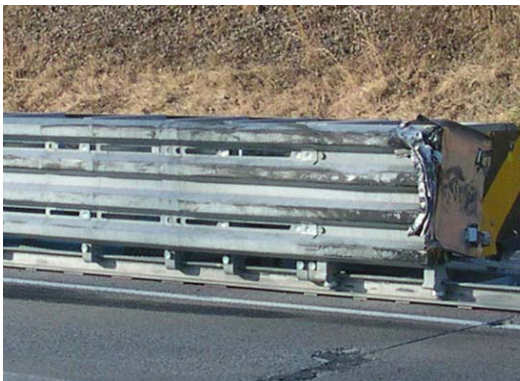
Side view of above incident  
You can see a piece of the tool box left on the attenuator on the top picture and the tire marks down the side on this picture. The corner was caught and the collapse started. We are coming to the conclusion that truck drivers are able to steer off of our unit. The unit was still structurally sound and ready for further collapse.

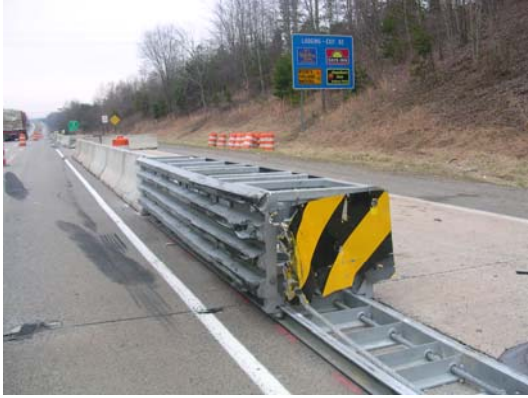
2-8-05 - 2nd Incident – Serial #9  
Frontal Impact – Collapse – 6 feet  
No Injuries  
Part Required – shear bolts and sled panel  
Repair cost part and labor - \$426.50  
Vehicle – Tractor/trailer  
Posted speed – 70

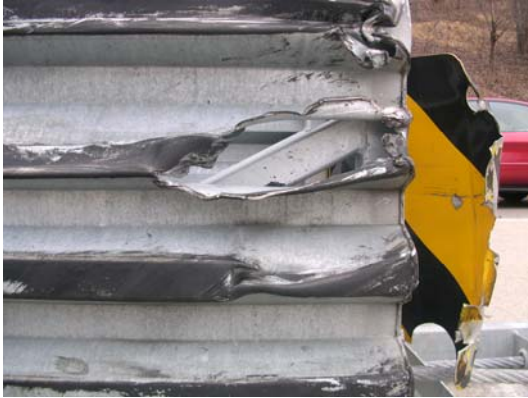
Close up of incident above  
This happened one day after the previous incident. It was a glancing blow with something very sharp catching the panels. Even with significant side pressure the sled was not racked and it only required minimal parts.

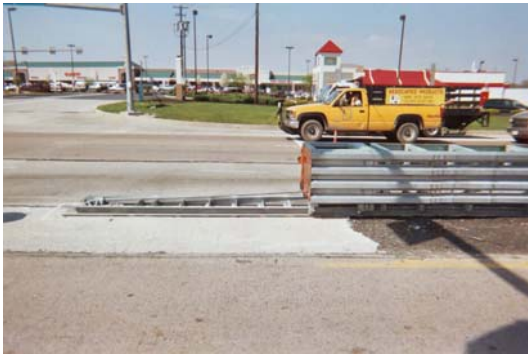
4-20-05 - 6th Incident – Serial #44  
Frontal Impact – Collapse – 7 feet  
No Injuries  
Part Required – shear bolts  
Repair cost part and labor - \$101.50  
Vehicle – Chevy S10 Blazer  
Posted speed – 45

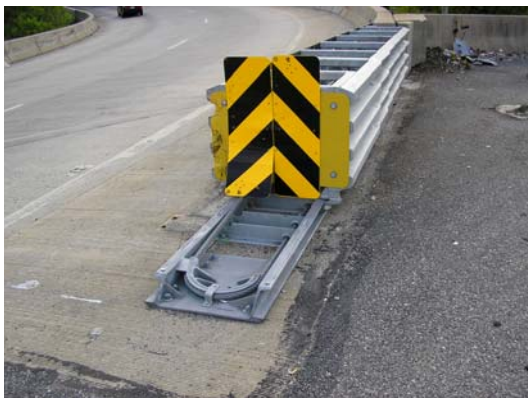
5-3-05 - 1st Incident - Serial #96  
Frontal Impact – Collapse – 4 feet  
No Injuries  
Part Required – shear bolts  
Repair cost part and labor - \$151.50  
Vehicle – not known  
Posted speed – 55

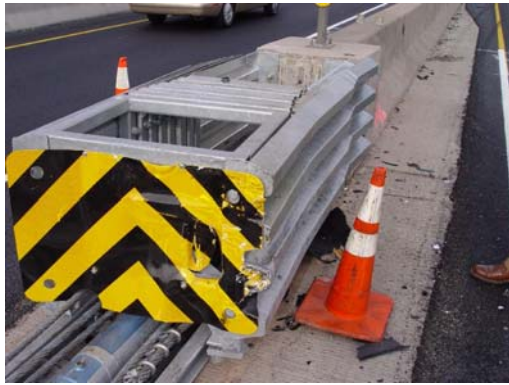
**There was only one reported injury** in all of the impacts. The resulting injury was a check and release from the hospital with facial lacerations. This impact was at a very high speed. We have impacted a single attenuator multiple times at our test location at 74 mph+ and have never experienced fatigue with our ½” stop plate. This picture of the forces sustained by the SCI\_GM shows how the cylinder bent our stop plate back ½”. All of the components held with no failure. This was one of two units that we opted to replace as we have never been able to tow a vehicle at this speed to analyze results. We have not yet received the cylinder back from the

5-16-05 - 1st incident – Serial #158  
Frontal Impact – Collapse – full  
Injuries – facial lacerations  
Part Required – replace unit and transitions  
Repair cost part and labor - \$21,333.72 included air freight and expedited fabrication  
Vehicle – Chevy 1500 + added weight from 5<sup>th</sup> wheel attachment  
Posted speed – 55

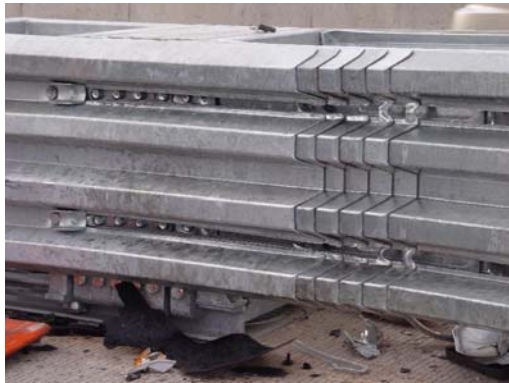
Incident above was impacted at very high speed. The  $\frac{3}{4}$  ton pickup was making a quick change from an HOV lane into regular traffic. The vehicle hit the attenuator just left of center in front of the steering wheel.

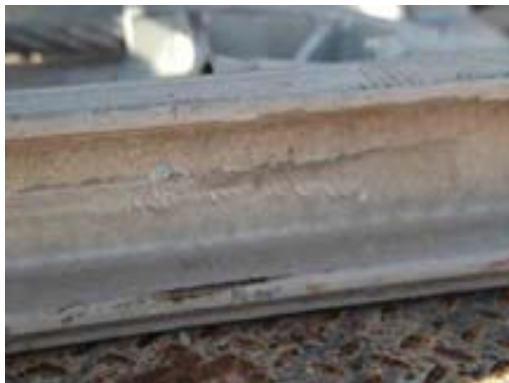
The SCI\_GM has machined rollers on its' front sled. These rollers dug into the channel  $\frac{3}{16}$ " deep from the side force caused by the lane change.

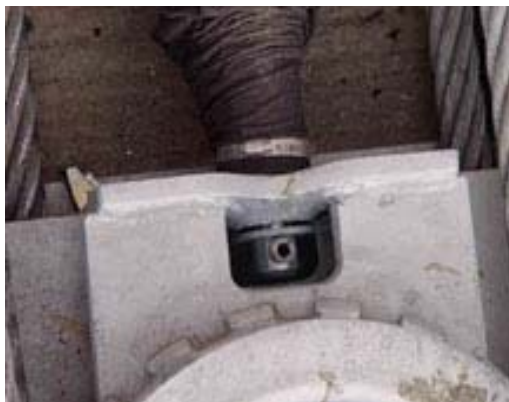
The cylinder rod pushed the  $\frac{1}{2}$ " plate back  $\frac{1}{2}$ " but did not fail. Our units have been impacted numerous times at 75 mph and this plate has never fatigued but with an impact that was 2.3 times above NCHRP350 criteria, it still held.

End result: The driver walked away from the incident as a check and release for facial lacerations.

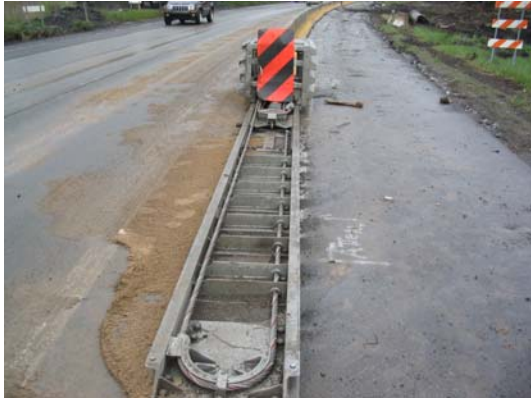
5-25-05 - 1st Incident – Serial #104  
Frontal Impact – Collapse – full  
No Injuries  
Part Required – shear bolts and front panel  
Repair cost part and labor - \$191.5  
Vehicle – Tractor/trailer  
Posted speed – 40

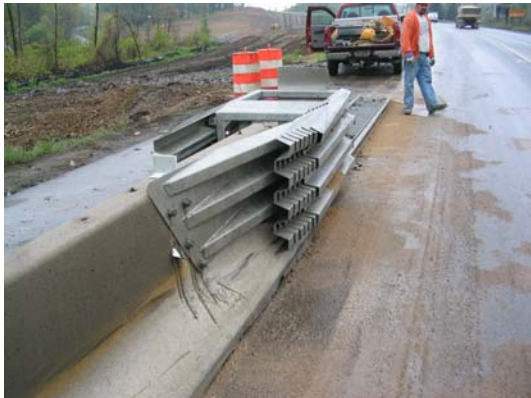
Incident above  
Shows how the panels nest without being stressed.

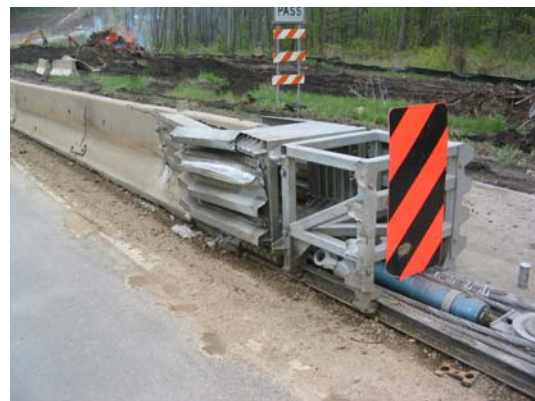
5-25-05 - 2nd Incident – Serial #104  
Hit 2<sup>nd</sup> time same day after reset  
Frontal Impact – Collapse – full  
No Injuries  
Part Required – replace unit  
Repair cost part and labor - \$13,500.00  
Vehicle – Tractor/trailer  
Posted speed – 40

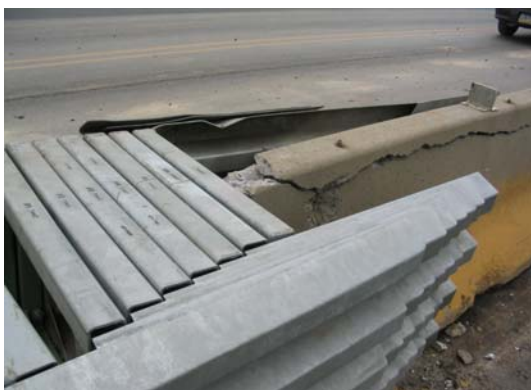
This was an angled impact. A significant object on the Tractor/trailer caught enough of the attenuator to collapse it fully then break the concrete barrier. The speed was probably not excessive so the cylinder did not provide full stopping force but the energy of the Tractor/trailer bottomed out the unit and cracked the barrier wall.

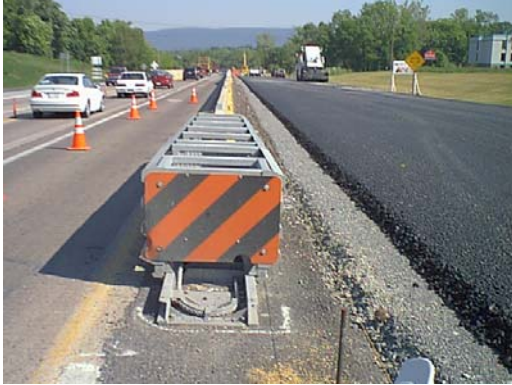
5-31-05 - 1st Incident – Serial #152  
Frontal Impact – Collapse – two feet  
No Injuries  
Part Required – shear bolts  
Repair cost part and labor - \$101.50  
Vehicle – not known  
Posted speed – 45  
Nuisance impact but attenuator could take another impact

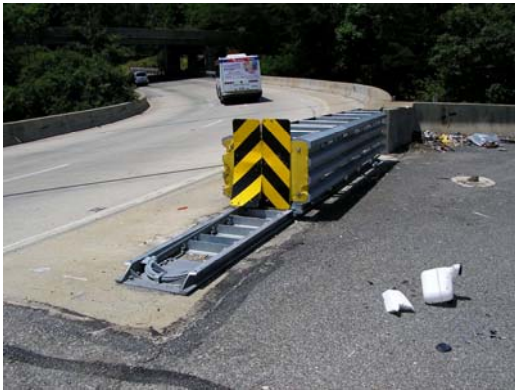
7-7-05 - 2nd Incident – Serial #96  
Frontal Impact – Collapse – 5.5 feet  
No Injuries  
Part Required – shear bolts  
Repair cost part and labor - \$151.50  
Vehicle – not known  
Posted speed – 55

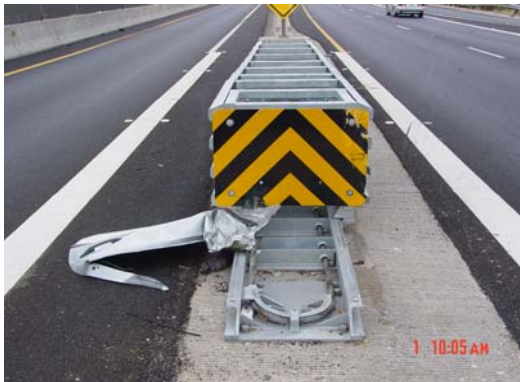
8-1-05 - 2nd Incident – Serial #166  
Frontal Impact – Collapse – 4 feet  
No Injuries  
Part Required – shear bolts and front panel  
Repair cost part and labor - \$115.00  
Vehicle – not known  
Posted speed – 55
