**VEHICLE CRASH TESTS OF THE
AESTHETIC, SEE-THROUGH CONCRETE
BRIDGE RAIL WITH SIDEWALK, TYPE 80SW**

STATE OF CALIFORNIA
DEPARTMENT OF TRANSPORTATION
ENGINEERING SERVICE CENTER,
OFFICE OF MATERIALS ENGINEERING AND TESTING SERVICES

1. REPORT NO.	2. GOVERNMENT ACCESSION NO.	3. RECIPIENT'S CATALOG NO.	
4. TITLE AND SUBTITLE VEHICLE CRASH TESTS OF THE AESTHETIC, SEE-THROUGH CONCRETE BRIDGE RAIL WITH SIDEWALK, TYPE 80 SW		5. REPORT DATE August 1998, revised 8/99

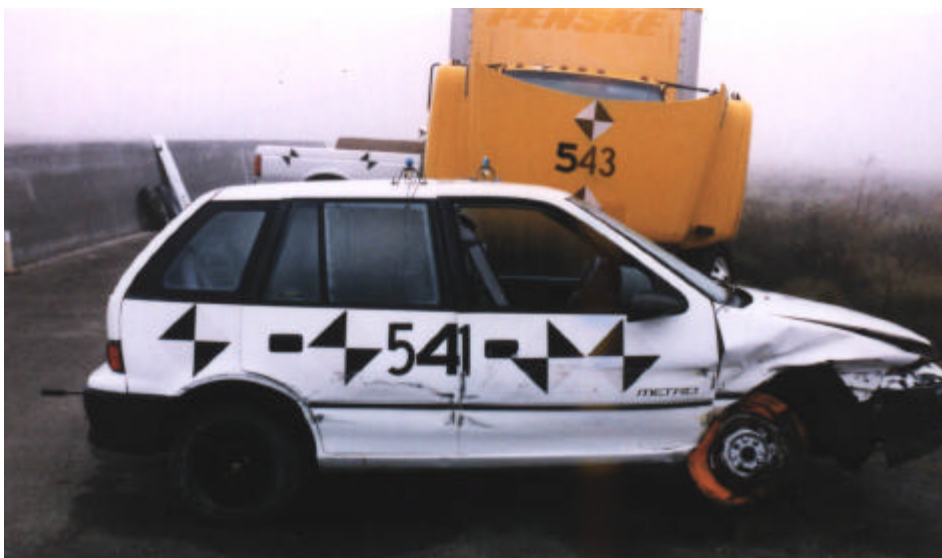
Figure 2-21 -
Close up of
Passenger Side
Front Damage,
Vehicle 541

The right front section of the vehicle sustained crushing of the bumper and minor unibody frame deformation, damage to the suspension and a flat tire. Initial right front wheel damage occurred on impact with the sidewalk 0.38 m from the beginning of the bridge rail installation. The sidewalk contact caused deformation of the wheel and tire deflation. Other tires experienced minor deformation on impact with the sidewalk but remained inflated. After contacting the bridge rail the right front wheel was pushed back, forcing the wheel well area to deform (Figure 2-21).

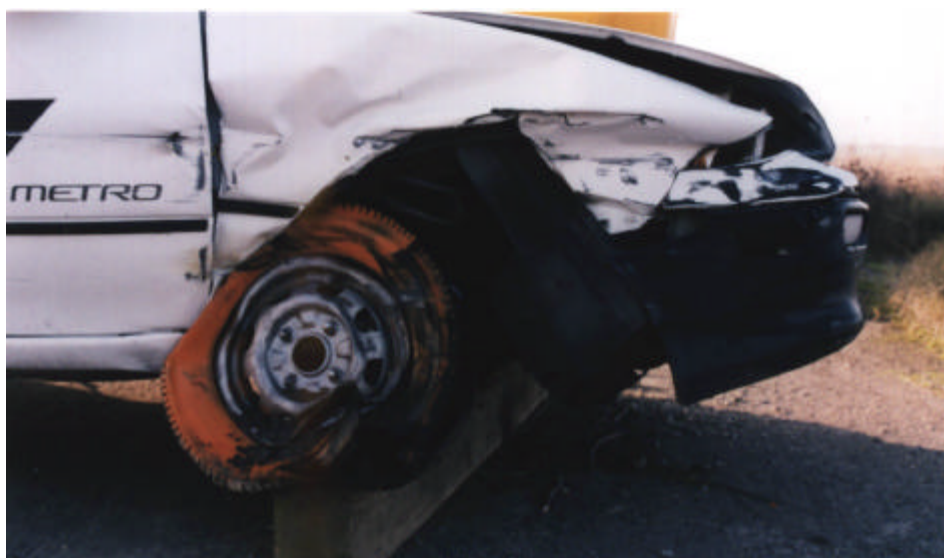
Figure 2-22 -
Post Impact
Front View,
Vehicle 541

As the vehicle turned parallel to the bridge rail, the sheet metal on both the right doors came into contact with the bridge rail face and caused minor scraping. The right rear tire rubbed along the bridge rail, but was not damaged beyond moderate scuffing. The vehicle continued along the sidewalk with the left wheels dropping off the curb 19 m from the beginning of the bridge rail. The shock absorber and right drive shaft of the right front wheel were bent but remained attached. The interior of the vehicle experienced minor deformation, less than 130 mm in the front passenger right foot floorboard area with negligible deformation elsewhere. The right front passenger door was jammed but the other three doors and hatchback functioned properly. The windshield was cracked on the passenger side. The hood and headlights were not damaged.

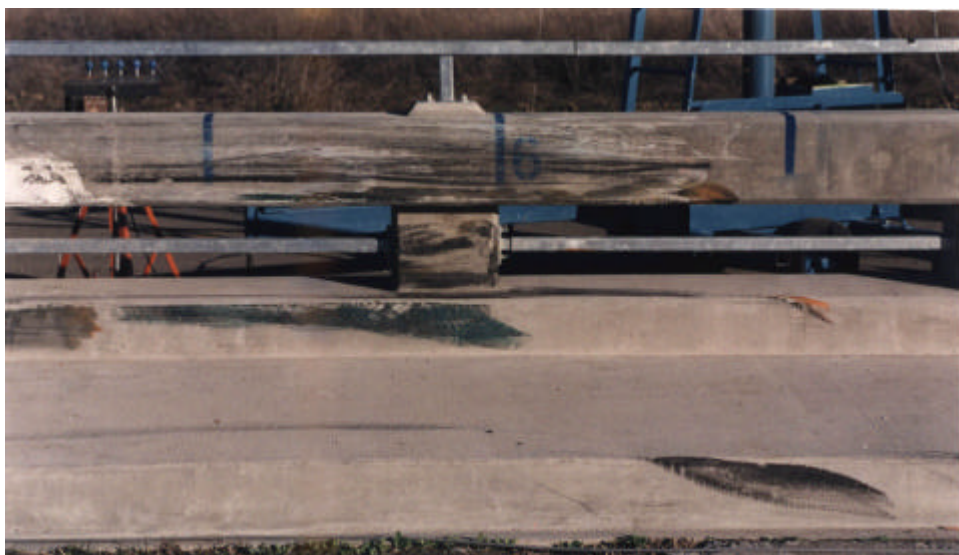
Figure 2-25 -
Close up of Post
Impact Bridge
Rail Scuff Marks

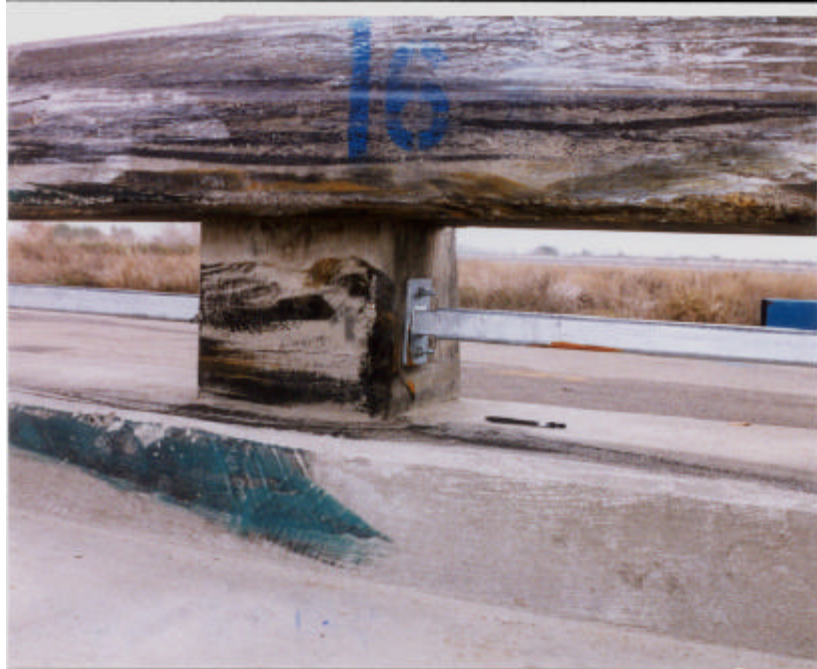
Figure 2-26 -
Wheel Rotation
Marks Around
Bridge Rail Post

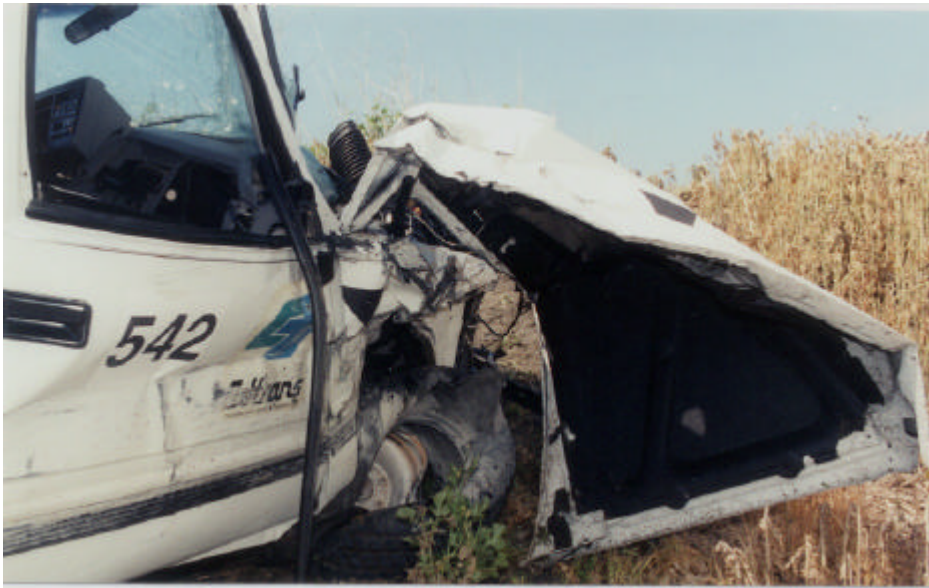
Figure 2-36 -
Close-up of
Impacting
Corner Of
Tested
Vehicle 542

The extra speed of the vehicle, 10.2 km/h over target, undoubtedly contributed to higher deformation of the impacting right corner of the vehicle than would have otherwise occurred. Figure 2-36 shows the right front wheel pushed back into the wheel well, caused by impact with the rail curb and beam face. All of the wheels stayed connected to the vehicle throughout the test. The front right shock absorber, stabilizer bar and upper and lower control arms were bent but still attached. The rear and left front suspension components were intact and appeared undamaged. There was minor deformation of the right front frame.

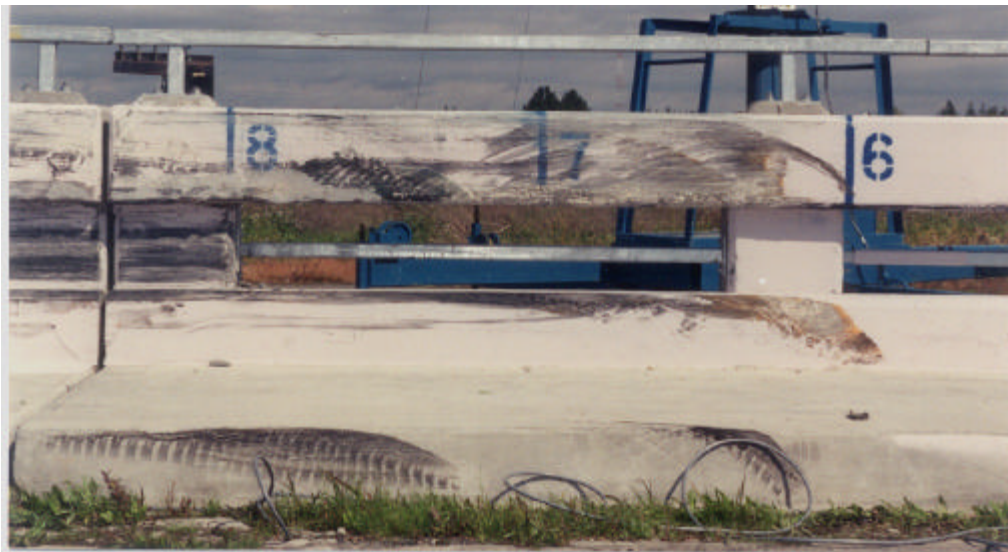
Figure 2-41 -
Impact Area
and Expansion
Joint

The barrier sustained minor spalls from the point of impact to roughly 4 m downstream. Other barrier damage was cosmetic only, consisting of scrapes and tire marks. Both of the right side tires left marks along the face of the barrier for the 6.5 m of contact. Small amounts of concrete spalled from the face of the barrier where the vehicle's sheet metal and wheel made contact with the beam face and beam lower edge. The pedestrian handrail remained intact. The barrier remained fully functional after the impact with only minor, mainly cosmetic, repairs needed for complete restoration.

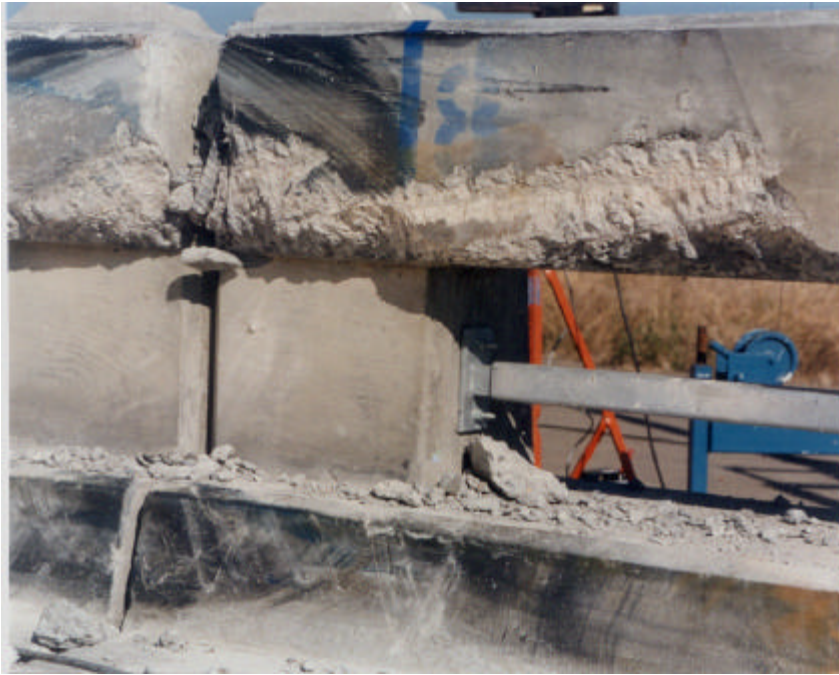
It appeared that the right front lug nuts scraped along the beam face, causing most of the concrete spalling seen in Figure 2-55. The right wheel well hit the handrail 0.028 s after initial contact with the bridge rail. Beginning 0.177 s after contact with the bridge rail, both the left front and left rear tires rose approximately 1 m off the ground and remained off the ground for 0.480 s and 0.757 s, respectively. The vehicle continued to make contact with the barrier for approximately 4.5 m. A peak roll of the vehicle box section to the right and then left was 17.5° at 0.521 s and 14.5° at 1.099 s, respectively, from the impact with the rail. These peaks were taken before the vehicle exited the end of the test article installation. Higher values may have occurred later after the brakes were applied. The vehicle continued to a point of rest on an earth berm about 43 m from the point of impact. The vehicle remained upright throughout and after the collision.

Figure 2-55 -
Close-up of
Impact Area for
Test 543

The barrier was scraped along the face and edges over a 3 m length. There was also spalling on the underside of the beam caused by the downward force of the rotating right front wheel lug nuts. The tire marks along the barrier were only a little longer than the scraping along the face. A concrete spall at the expansion joint was 80 mm to 100 mm deep and extended to the back face of the rail, shown in Figure 2-55 and Figure 2-56. The spall exposed the end of a piece of rebar but no structural damage was evident. The bridge rail withstood the impact from vehicle 543 well with only spall repairs necessary before subsequent tests.

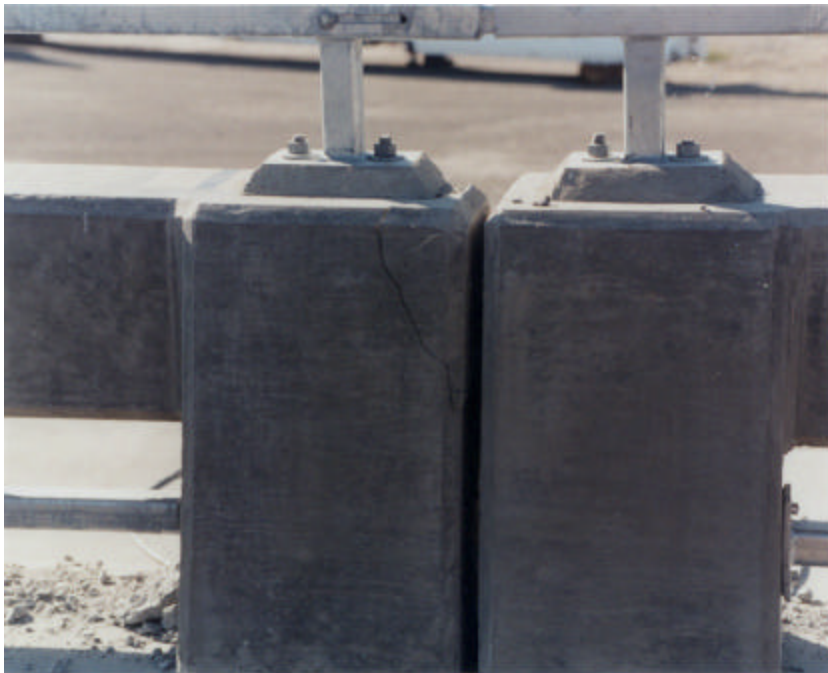
Figure 2-56 -
Backside of
Expansion Joint
Area after
Test 543

The barrier was scraped along the face and edges over a 3 m length. There was also spalling on the underside of the beam and at the expansion joint with no structural damage.

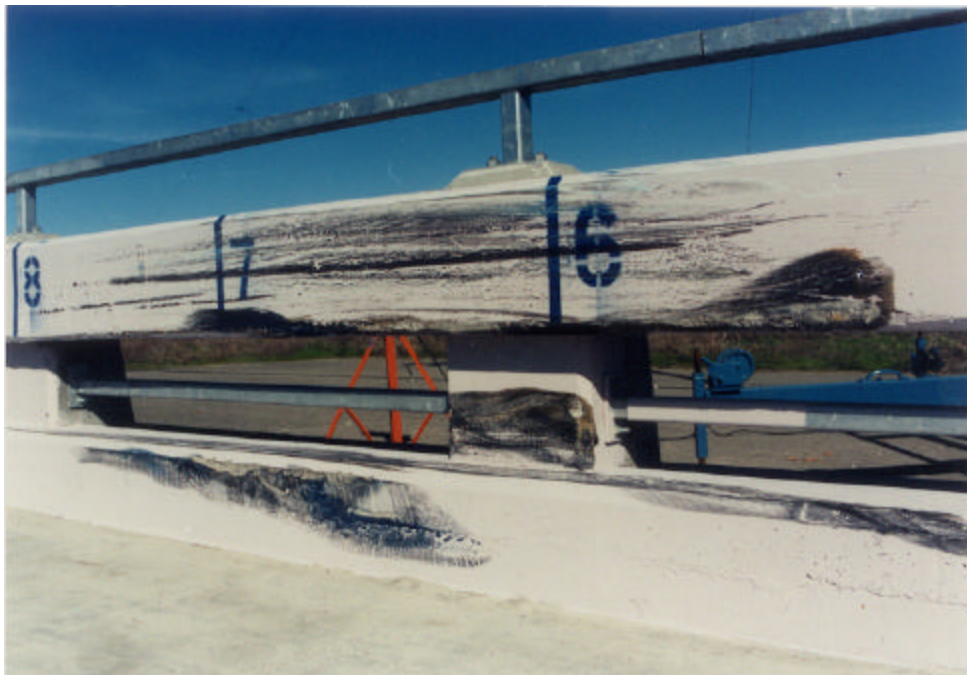
Figure 2-68 - Close-up View of Bridge Rail at Impact Point for Test 548

Damage consisted of only moderate scraping and tire scuffing over a length of four meters
