**FULL-SCALE 18,000 LB. VEHICLE CRASH TEST
ON THE
KANSAS 32 INCH CORRAL RAIL**

Project RES1 (0099) P450
TRANSPORTATION RESEARCH REPORT TRP-03-26-91

Midwest Roadside Safety Facility
Civil Engineering Department
W348 Nebraska Hall
University of Nebraska-Lincoln
Lincoln, Nebraska 68588-0531

July 1991

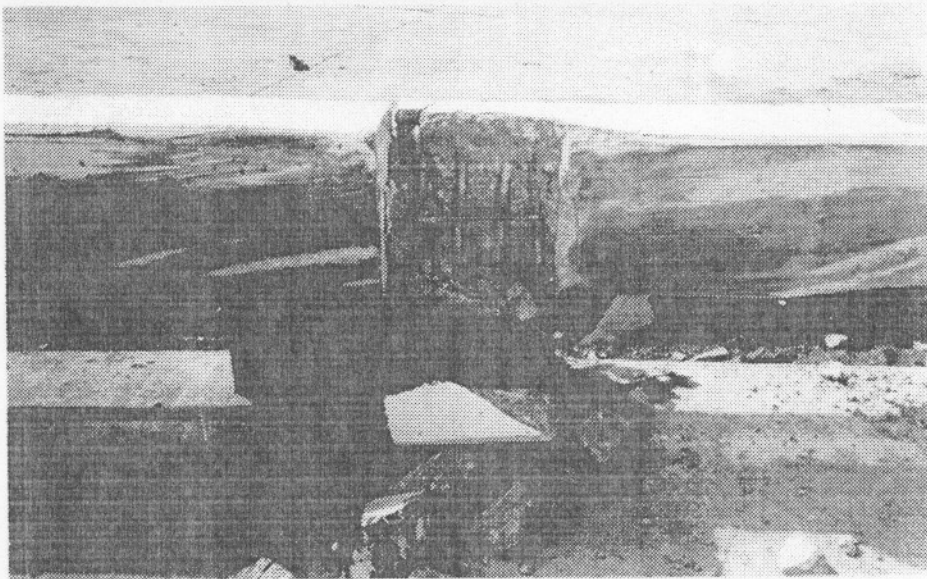
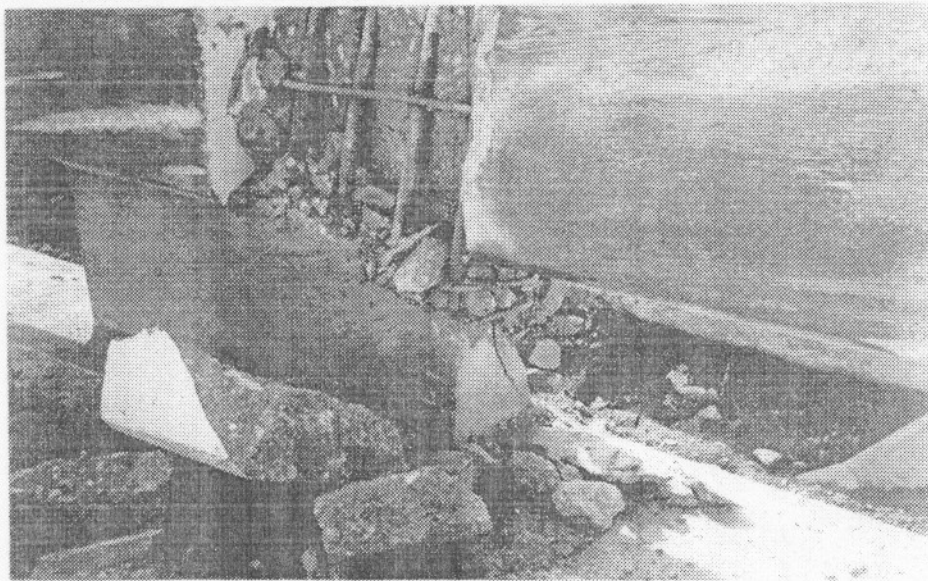
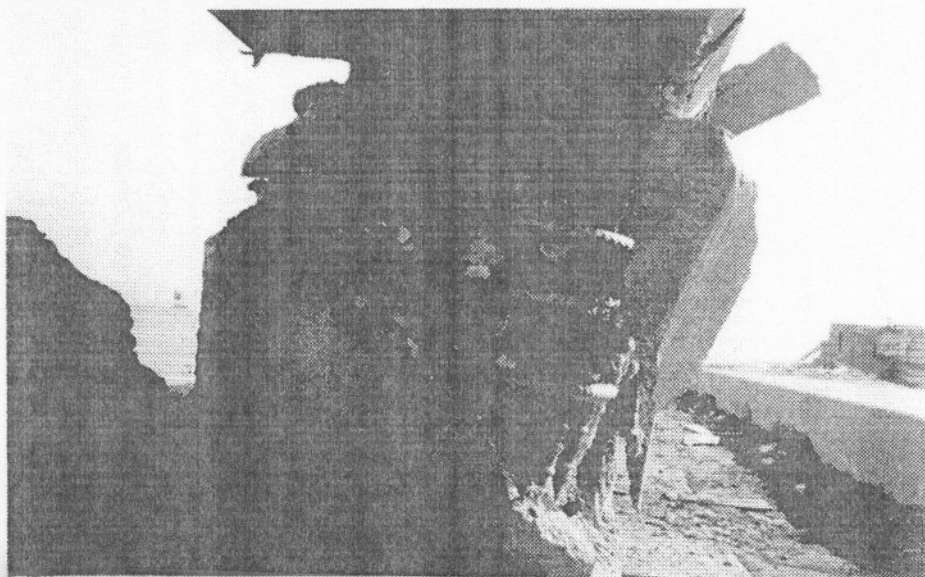
Figure 24. Rail and Post damage at Post No. 5

the traffic face of the rail at post No. 5 is shown in Figure 24. The total amount of concrete that was removed from this failure was 18.5 in. wide, 19 in. high (entire rail height), and 5 in. deep. The same failure viewed from the backside of the rail is shown in Figure 25. This failure occurred before the gap in the rail at midpoint of Post No. 5. A vertical crack in the deck also occurred near the location of the post on the upstream end. Deck cracking also occurred at post No. 4. These deck cracks continued underneath the deck to the support.

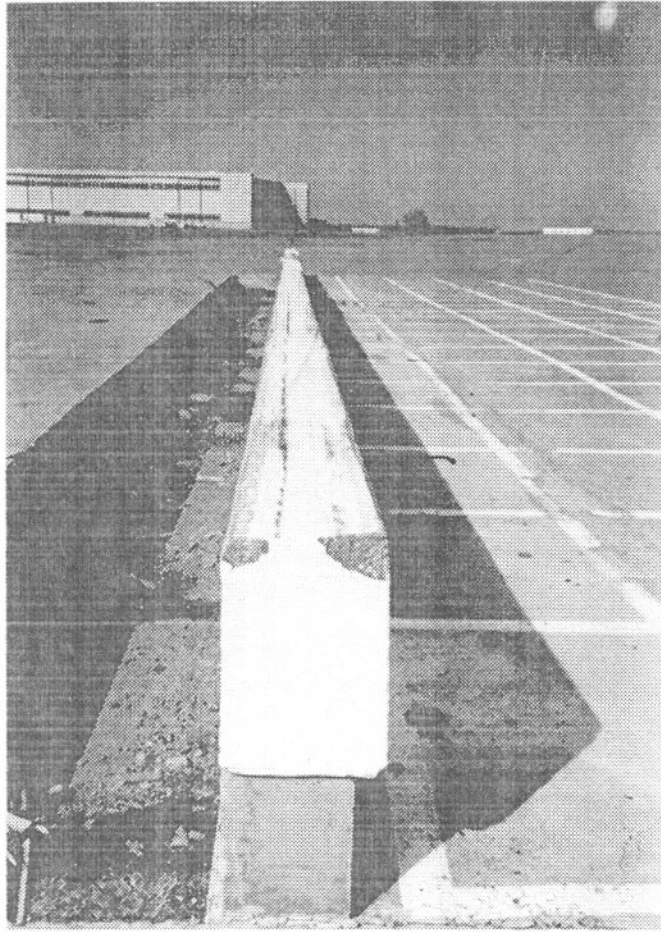
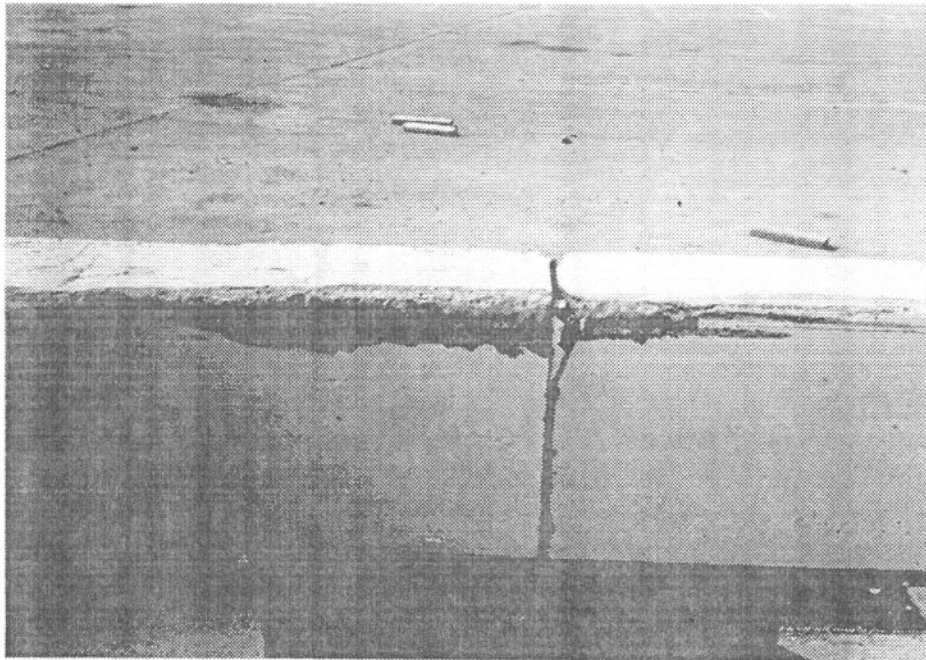
Figure 26. Damage from vehicle riding along the rail

The third major damage area resulted from the vehicle riding along the rail (Figure 26). Spalling and concrete chipping occurred continuously until the end of the rail. This damage occurred to the traffic face, the top and the back face of the rail.

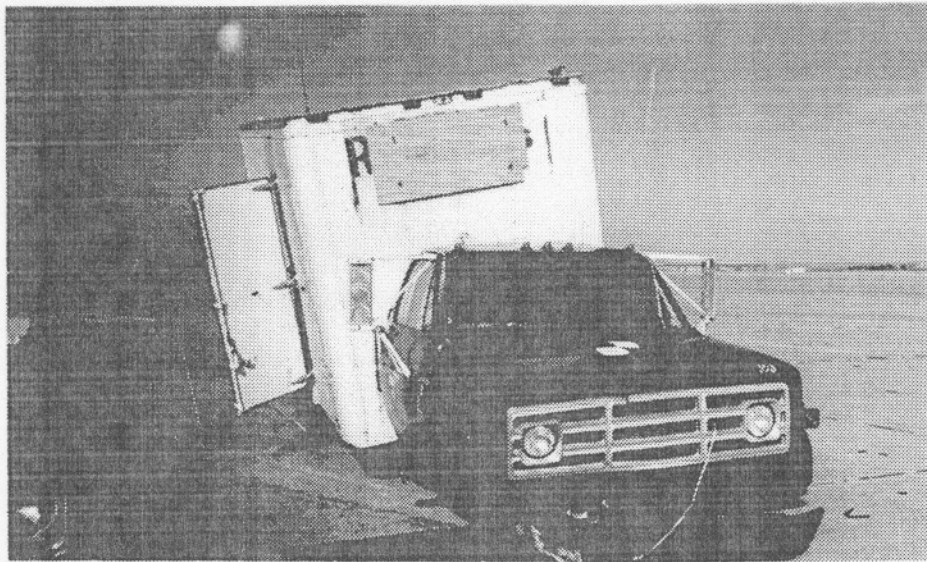
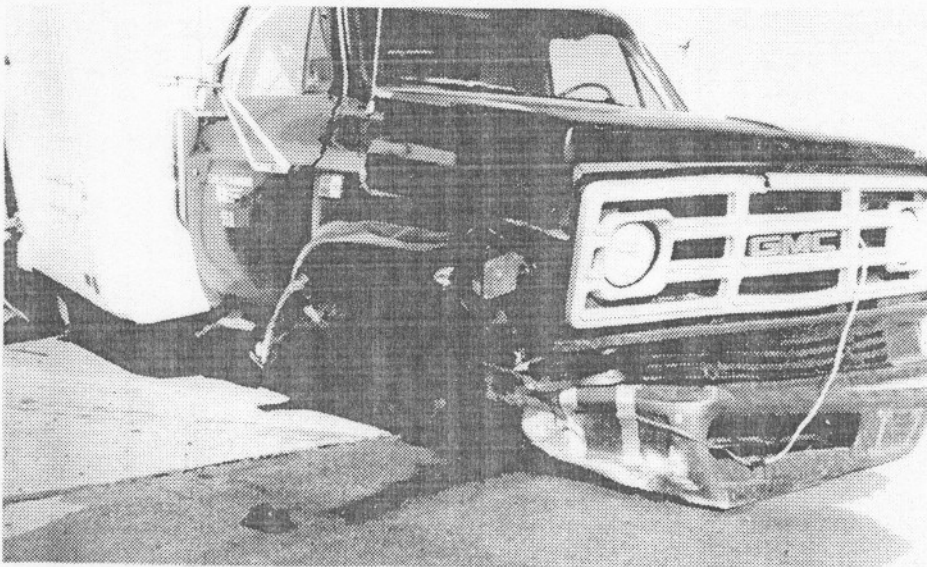
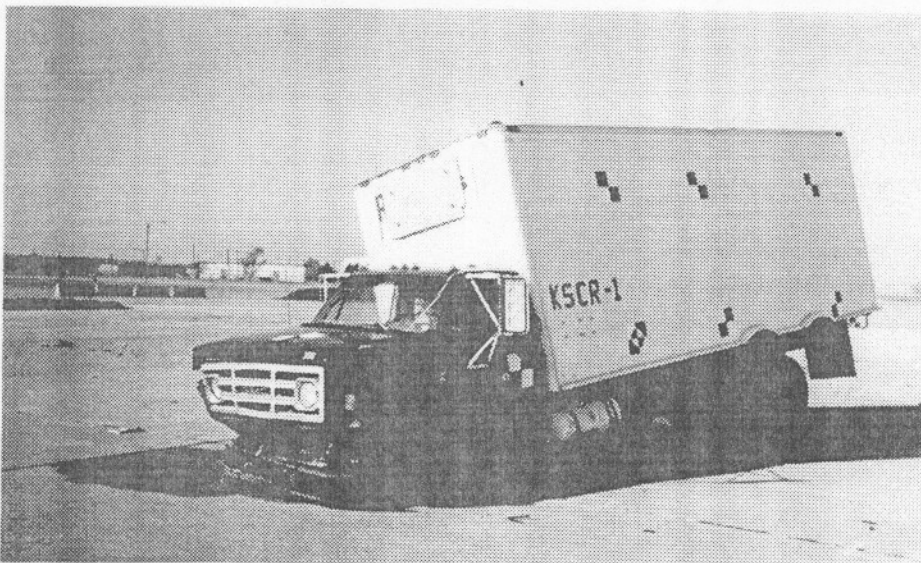
Figure 27. Vehicle Damage

The vehicle damage is shown in Figure 27. The damage included crushing of the passenger side bumper and grill. The front wheels and axle were totally removed from their original position and ended up lodged underneath the truck which may have contributed to the damage was minimal. The TAD (5) and VDI (6) damage classifications are shown in Figure 18.
