Vehicle Crash Tests of The Type 80 Bridge Rail

March 1999

An aesthetic, see-through concrete bridge rail, Type 80, was built and tested in accordance with NCHRP Report 350. The Type 80 bridge rail is an 810 mm-tall, reinforced concrete barrier. The rail has 280 mm-high by 1620 mm-long gaps, 230 mm above the bridge deck surface. The barrier tested was 23 m-long and was constructed at the Caltrans Dynamic Test Facility in West Sacramento, California.

**VEHICLE CRASH TESTS OF THE  
TYPE 80 BRIDGE RAIL**

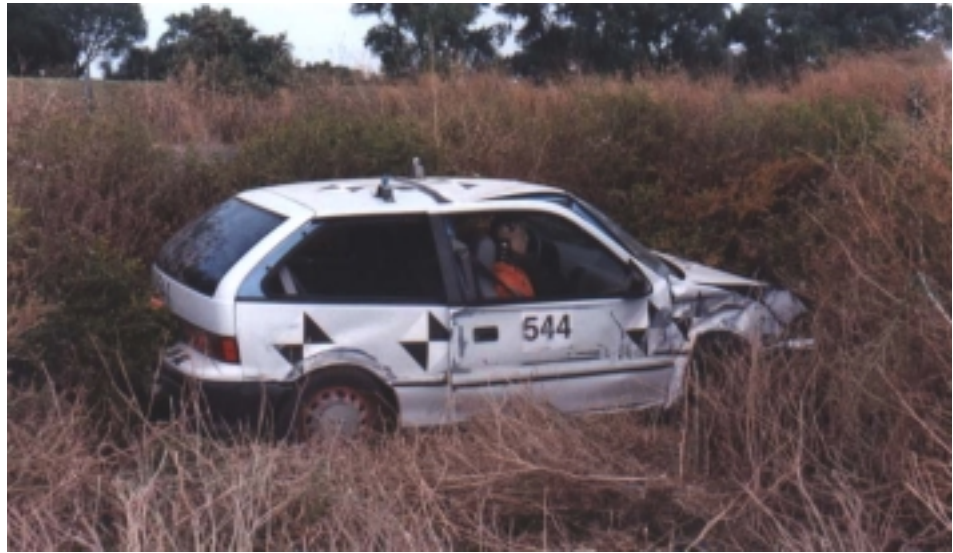
Figure 2-16 Post  
Impact Side View of  
Vehicle 544

The right front section of the vehicle sustained crushing of the bumper and frame, damage to the suspension and a flat tire, Figure 2-16 through Figure 2-18. The right side of the vehicle from the front bumper to the rear bumper was scraped during contact with the beam section of the rail. The hood was also crushed on the right side but remained attached at the latch and hinges.

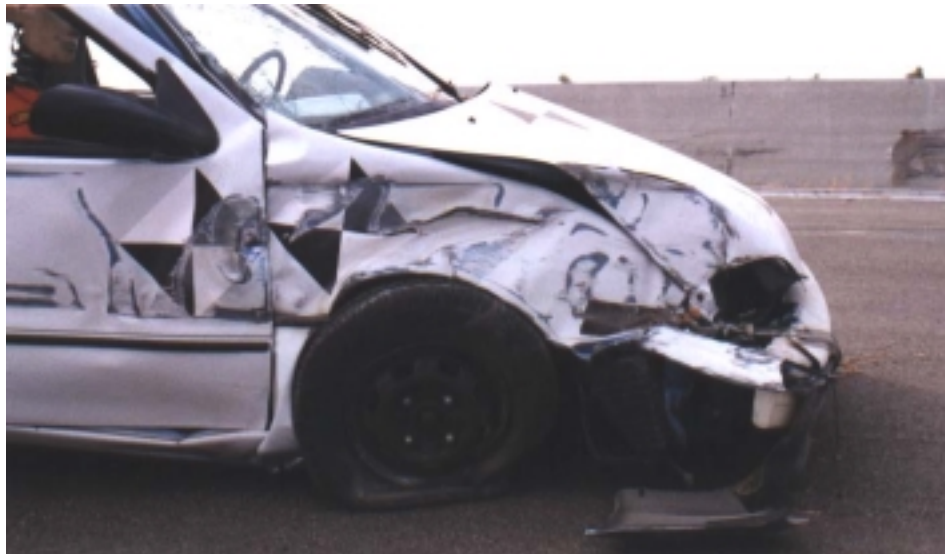
Figure 2-17 Close up  
of Passenger Side  
Front Damage,  
Vehicle 544

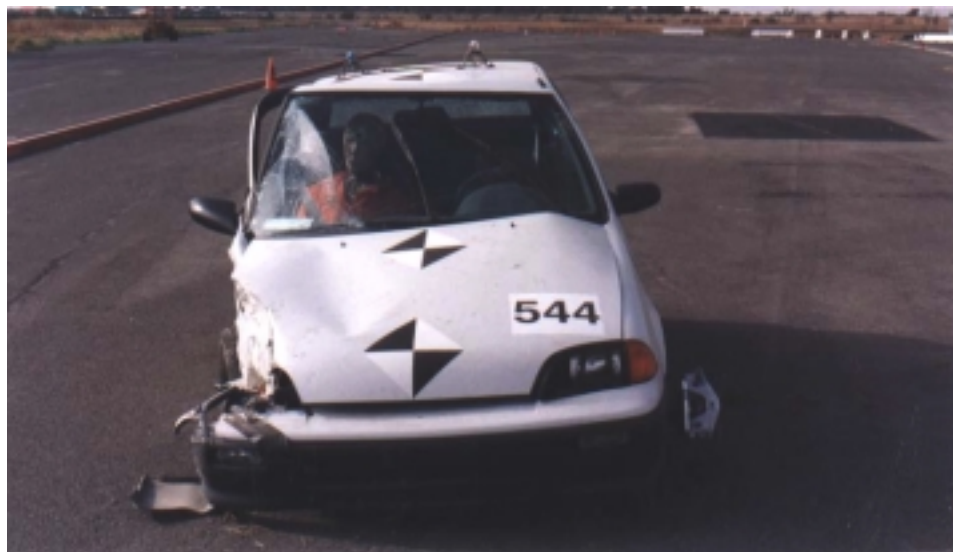
Figure 2-18 Post  
Impact Front View,  
Vehicle 544

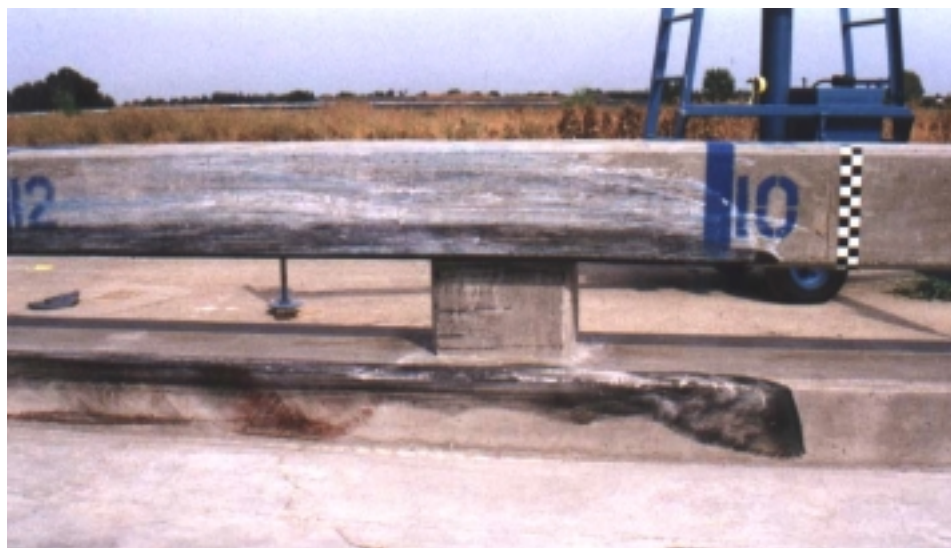
Figure 2-20 Post  
Impact Bridge Rail  
Scuff Marks Test 544

Barrier damage was cosmetic only, consisting of scrapes and tire marks. Both of the right side tires left marks on the curb and beam section of the bridge rail. Small amounts of concrete spalled from the face of the barrier where the vehicle’s sheet metal and wheels made contact.

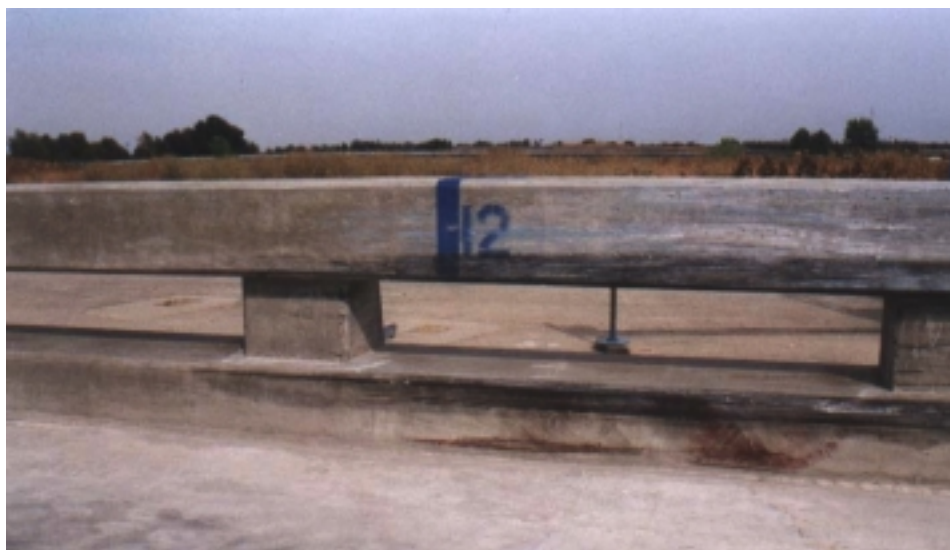
Figure 2-21 Post  
Impact Bridge Rail  
Scuff Marks Test  
544

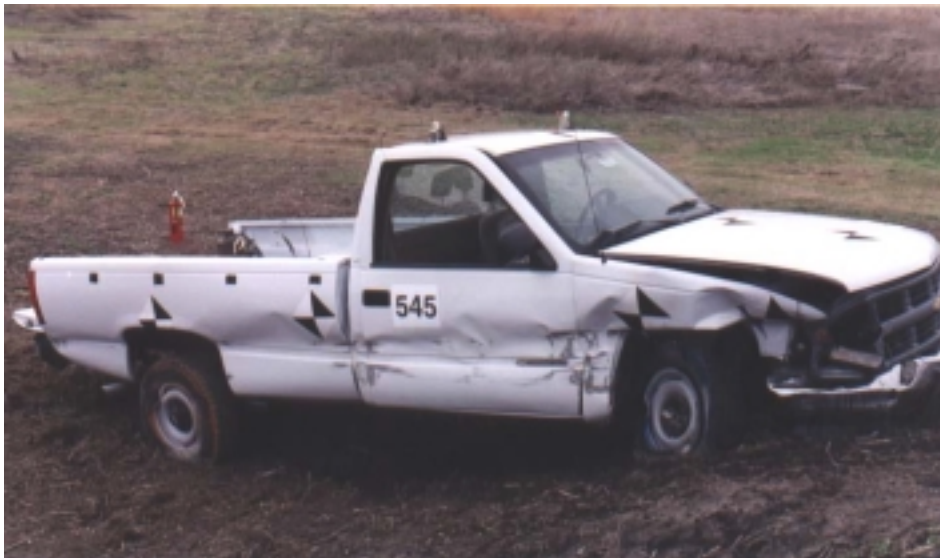
Figure 2-27 Post  
Impact Side of Test  
Vehicle 545

The vehicle received damage from the right front corner to the right rear corner, Figure 2-27. The right front and right rear wheel rims were deformed and the tires deflated. The left side wheels and tires were undamaged. The spare tire was forced from its undercarriage storage location and ended up about 15 m from the vehicle resting position.

The initial impact occurred on the right front quarter panel, resulting in substantial buckling and scraping, Figure 2-27. The right side of the bumper was pushed back about 260 mm. As the vehicle continued along the rail the entire right side was deformed where it contacted the bridge rail beam face. As a result, the right door did not operate due to moderate buckling and scraping. The truck bed was also scraped and buckled along the right side and the entire bed shifted to the right 40 mm. The tailgate did not function but the hood and left door were left in good condition and were operable. The roof of the truck did not have any signs of buckling. The windshield was cracked but remained mounted. The left and rear windows were not cracked.

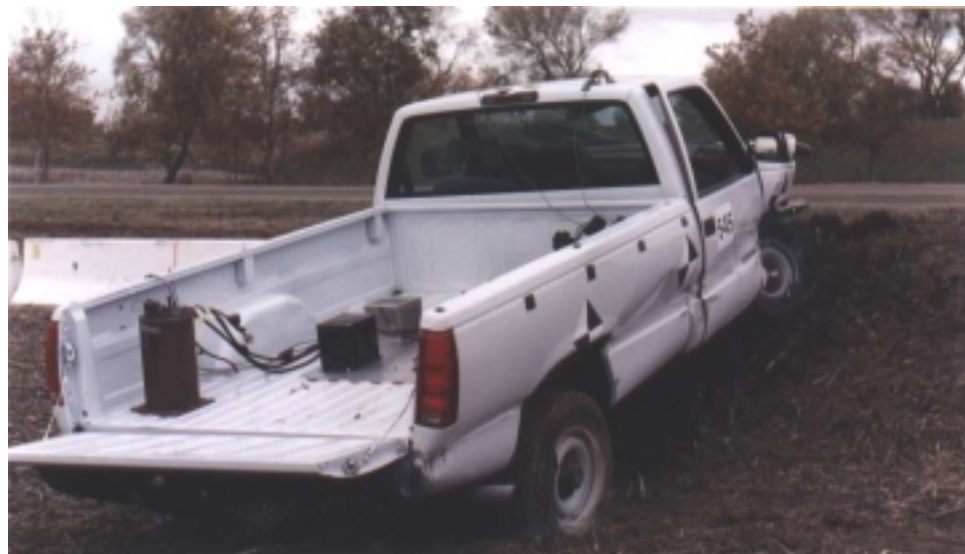
Figure 2-28 Rear  
Post Impact View of  
Vehicle 545

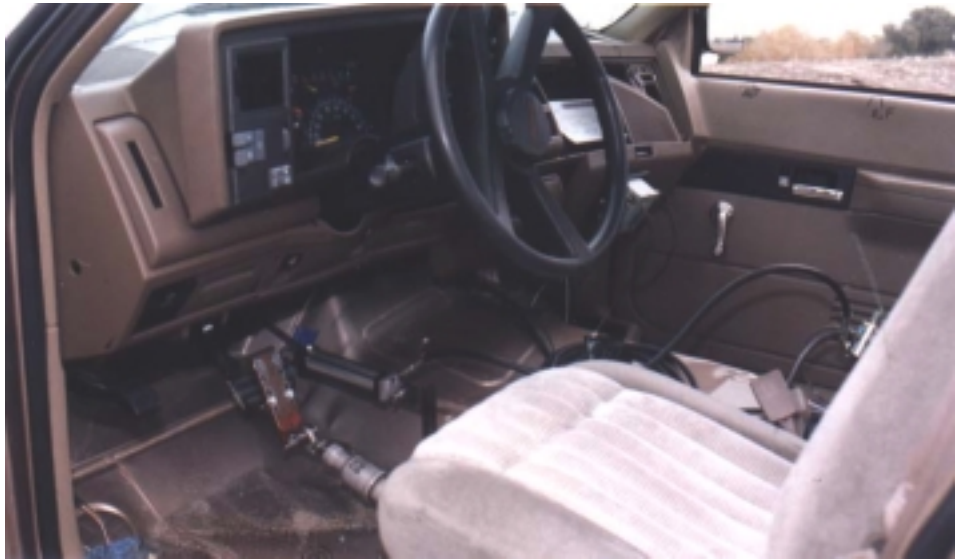
Figure 2-29 Post  
Impact Interior View  
of Vehicle 545

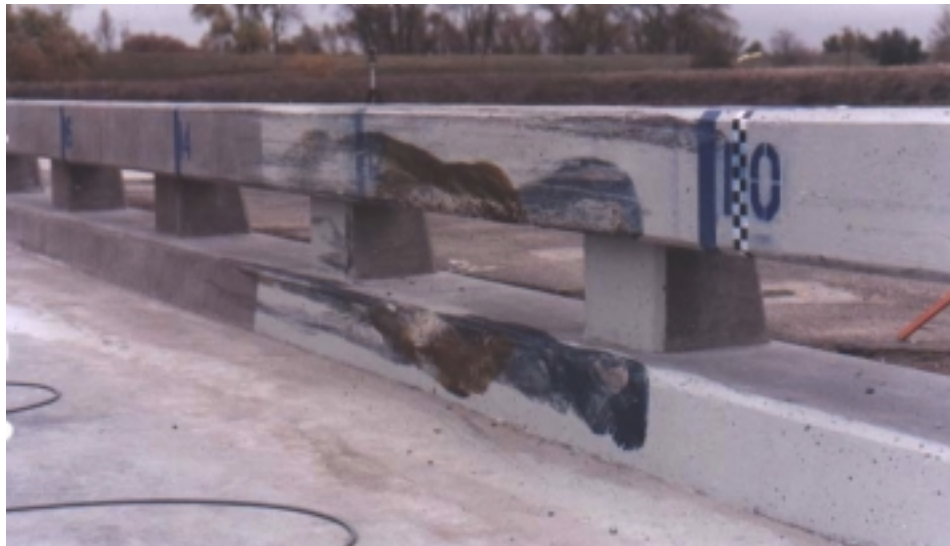
Figure 2-30  
Test 545 Impact  
Area

The barrier received minor scraping and spalling, mainly at the lower edge of the beam section. Other barrier damage was cosmetic only, consisting of scrapes and tire marks. Both of the right side tires left marks along the face of the barrier.

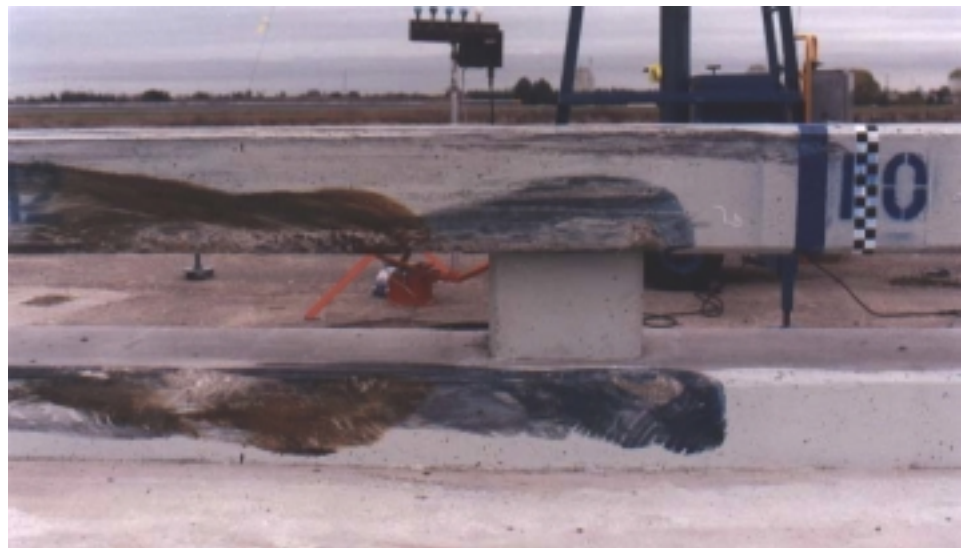
Figure 2-31 Test  
545 Impact Area

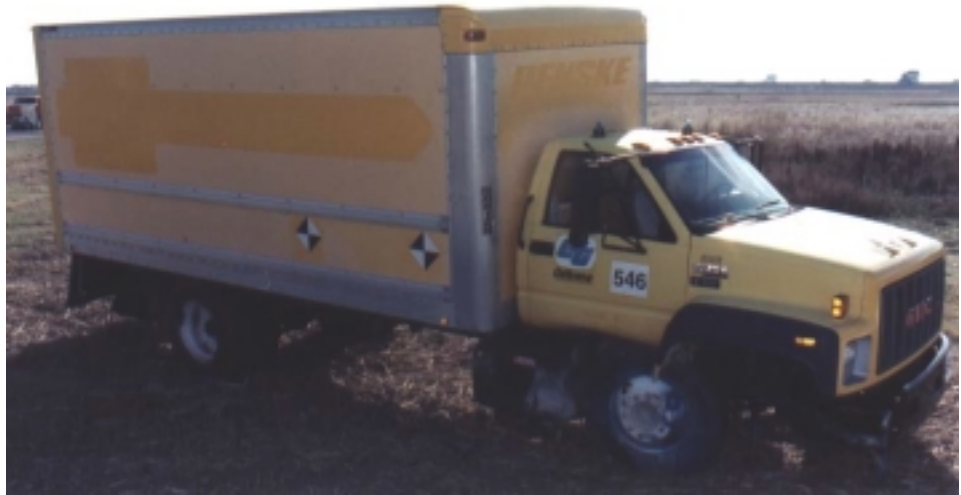
Figure 2-36 Post  
Test Impact Side of  
546 Test Vehicle

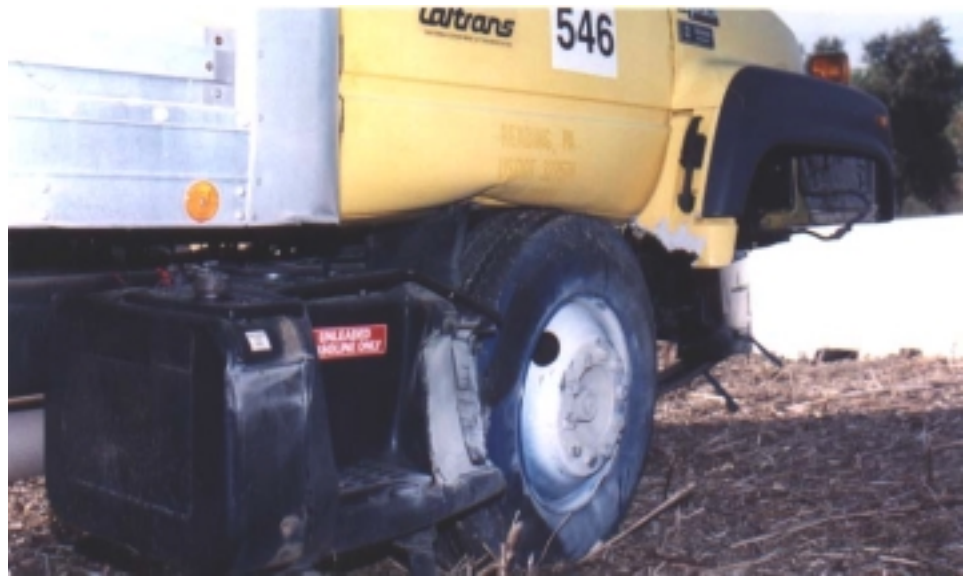
Figure 2-39  
Close-up of Right  
Front Wheel Area

The majority of damage occurred to the right front corner of the truck. The impacting tire was pushed back into the rear of the wheel well which severed the u-bolt connecting the leaf springs to the front axle. The steering rod and front axle on the right side were bent rearward. The battery box, located directly under the passenger door was completely crushed. The fuel tank was pushed rearward and moderately deformed while in contact with the beam face, Figure 2-39.

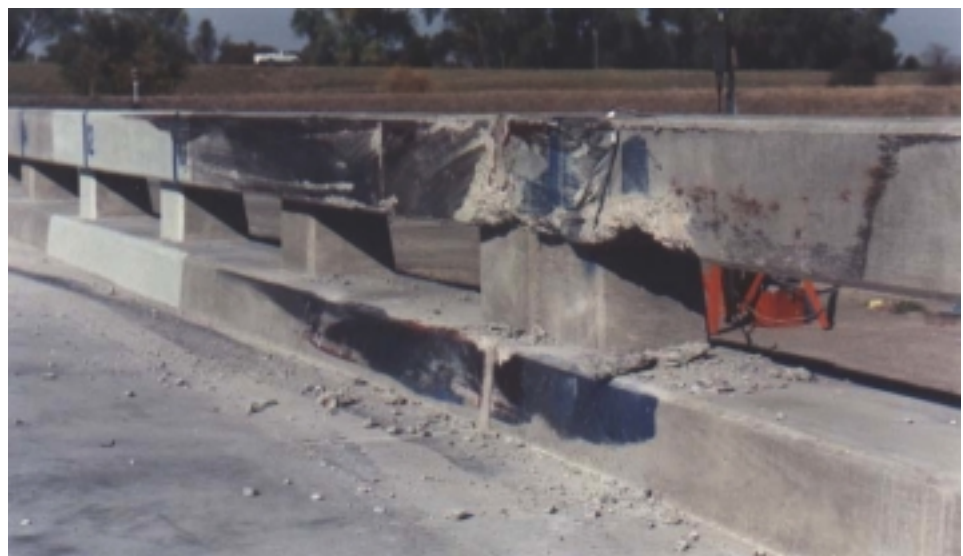
Figure 2-41  
Impact Area

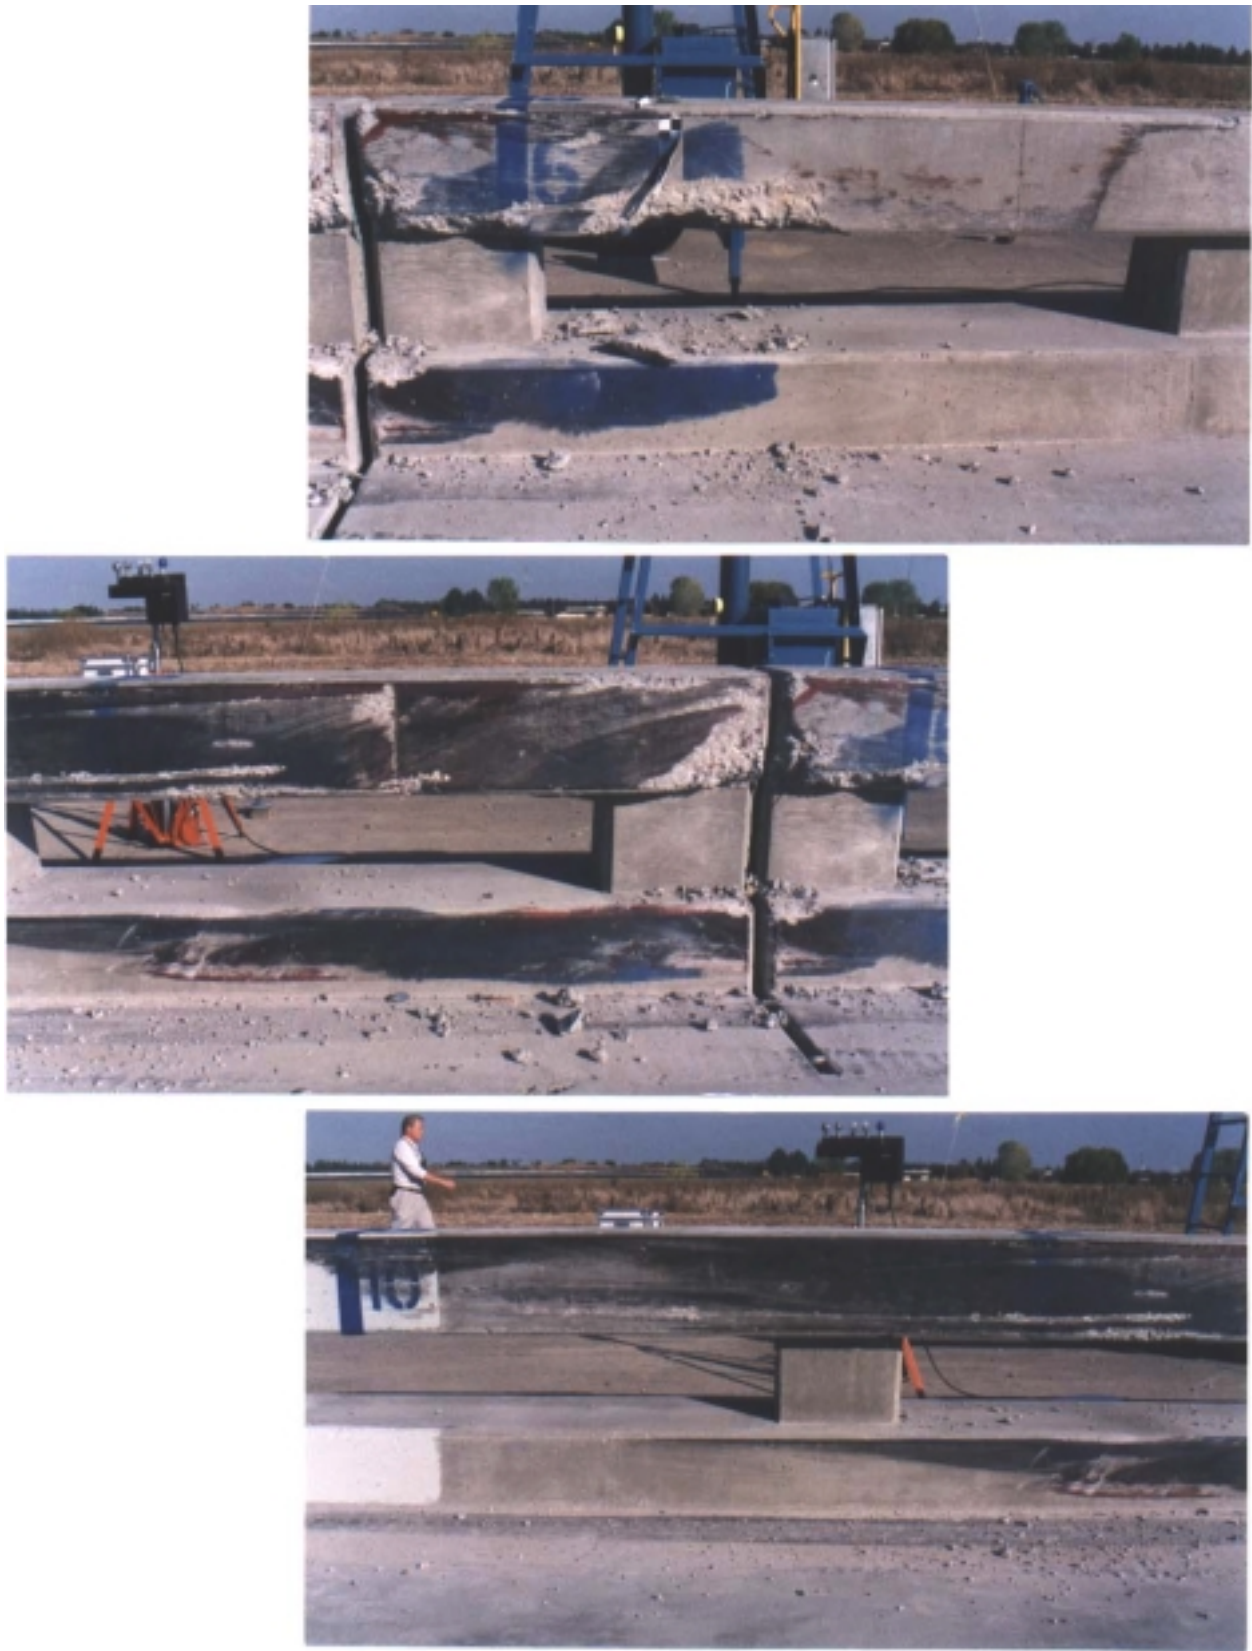
Figure 2-42 Close up of Impact Area

The bridge rail was scraped along the curb and beam section face leaving exposed patches of aggregate and concrete spalls. Most of the spalling occurred 0.75 m upstream of the expansion joint and at the expansion joint, Figure 2-42. The spalls were minor in nature and could be easily repaired. Additional marks were left on the bridge rail from the trucks tires. The right front and rear tires were painted blue and red, respectively.
