Evaluation and Design of ODOT's Type 5 Guardrail with Tubular Backup

Draft Final Report

State Job Number *PS-04-10*

November 3, 2005

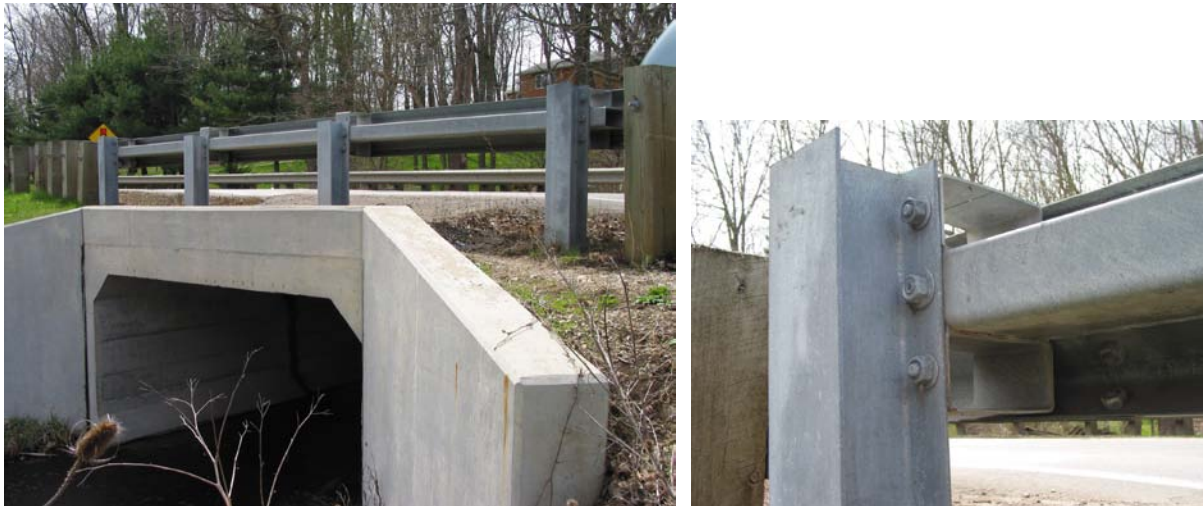
Figure 1: Typical installation of the ODOT GR-2.2 guardrail

The Ohio Department of Transportation (ODOT) uses a somewhat generic guardrail system installed on many culverts throughout the state. The system used for this purpose employs the standard ODOT Type 5 W-beam guardrail with a Tubular Backup (ODOT GR-2.2). The guardrail system typically consists of two 13.5 ft (4.130 m) lengths of 12-gauge w-beam rails backed up with TS 8x4x3/16 inch (203x101x4.76 mm) structural tubing and supported by W6x25 steel section posts spaced 6.25 ft (1.9 m) on center. Mounting conditions for the guardrail posts vary from site to site depending on the depth of soil cover over the culvert (refer to Appendix 1 for detailed drawings). Figure 1 shows an installation of the system along a roadway in Ohio.

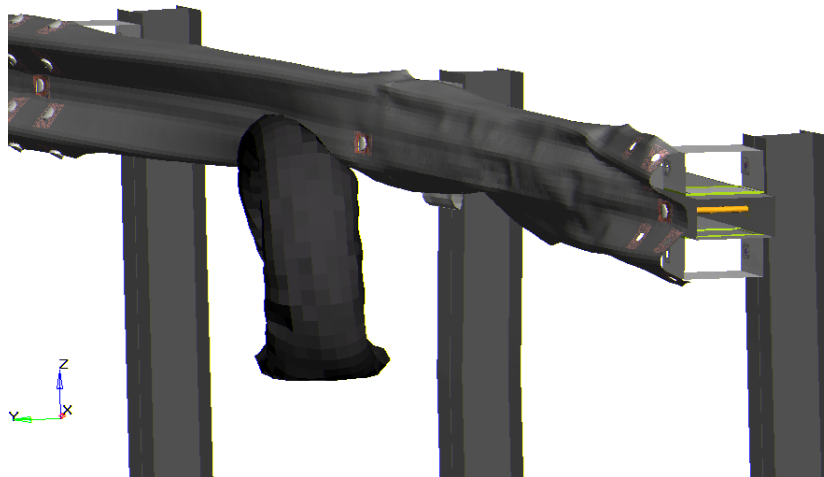
Figure 13: View from the F.E. analysis illustrating the interaction of the tire with the guardrail

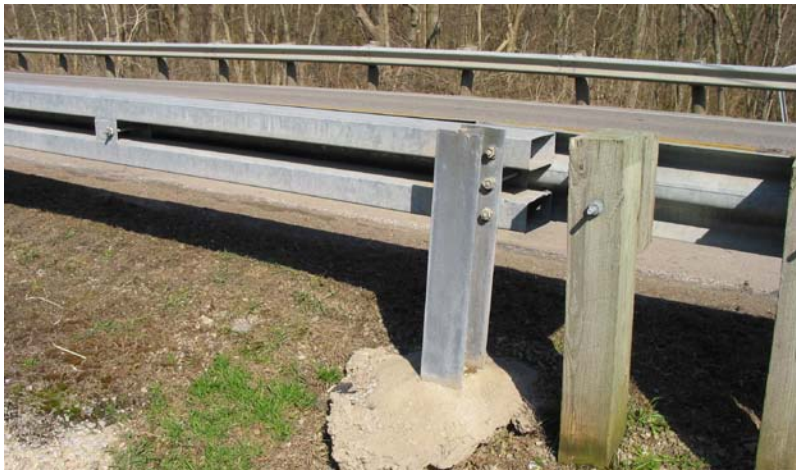
Figure 14: Long-span guardrail across a culvert on HW 315 in Delaware, County.

As opposed to having only one tube behind the w-beam for support, two thinner tubes could be used at the top and bottom of the w-beam, similar to the “long span” design shown in Figure 14. With such a design the guardrail would effectively have a taller face and make it less likely for the tire to push underneath.

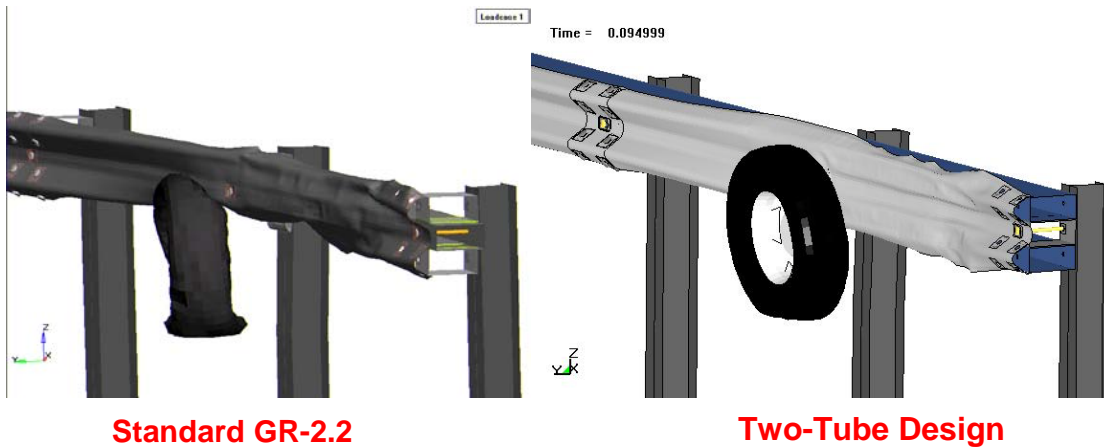
Figure 18: Comparison barrier deformation of the standard GR-2.2 design and the modified two-tube backup design.

guardrail deformation of the two-tube system compared to the standard GR-2.2 system. In the two-tube system, the effective height of the barrier face was maintained, preventing the tire of the vehicle from getting under the rail. The vehicle did experience moderate roll angle during redirection, however, vehicle stability was maintained in the simulation.

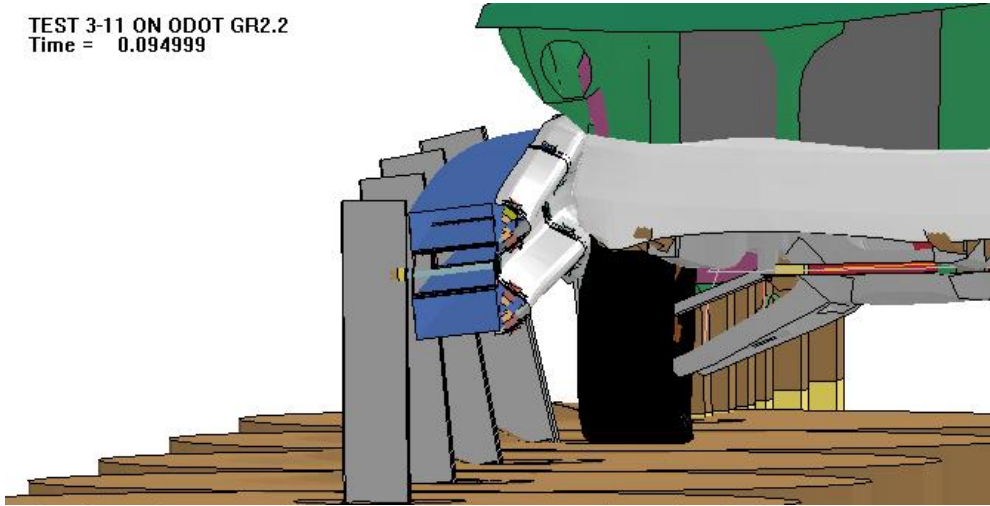
Figure 20: View from the F.E. analysis at maximum deflection of guardrail for the two-tube system with posts in soil

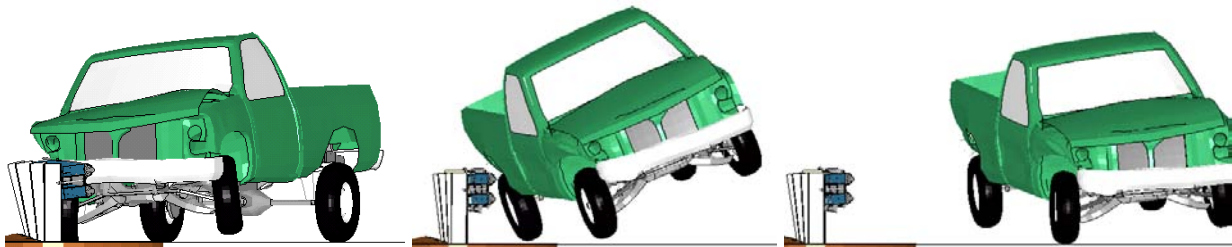
Figure 21: Sequential views of the simulated Test 3-11 impact event on the modified GR-2.2 with two-tube backup (posts in soil)

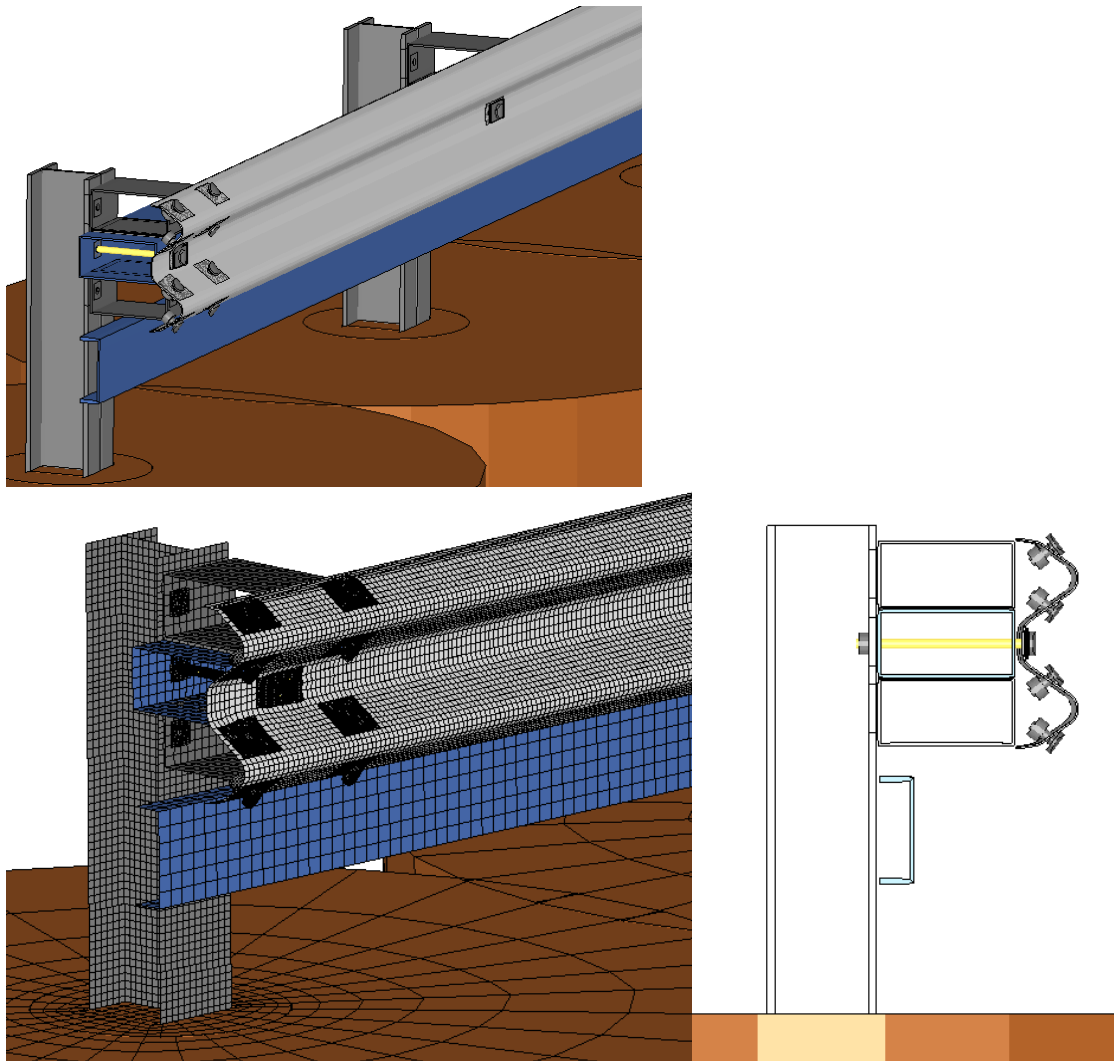
Figure 23: FE model of the modified ODOT GR-2.2 guardrail with rub-rail retrofit

Another design solution for improving the performance of the ODOT GR-2.2 guardrail was the simple modification of adding a rub-rail below the blockouts, which would serve to prevent the tires from snagging on the posts. The rub-rail will not, however, prevent the wheel from pushing underneath the w-beam and possibly impacting the spacer blocks. The rub-rail was placed 50.8 mm (2 inches) below the blockouts in the finite element model, as shown in Figure 23, and consisted of a single, continuous structural element 7.91 m long that spans across the entire length of the GR-2.2 guardrail. The rub-rail was modeled as a C6x8.2 steel section, which is a commonly used structural member for rub-rails in other roadside hardware. The C6x8.2 rub-rail element is designated as part number RLR01 in the *Standardized Guide to Highway Barrier Hardware*.

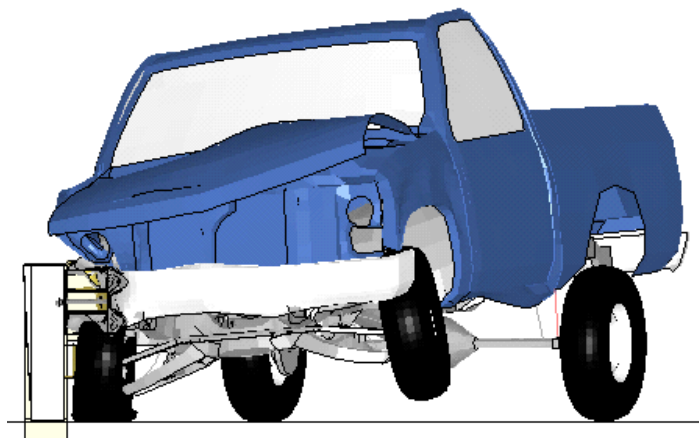
Figure 24: Wheel of vehicle successfully redirected by rub-rail

During impact the tire of the vehicle pushed under the w-beam rail and was successfully redirected by the rub-rail, as shown in Figure 24, with little or no risk of direct impact with a post. The vehicle experienced minimal roll angle during redirection and remained very stable throughout the simulated impact event.

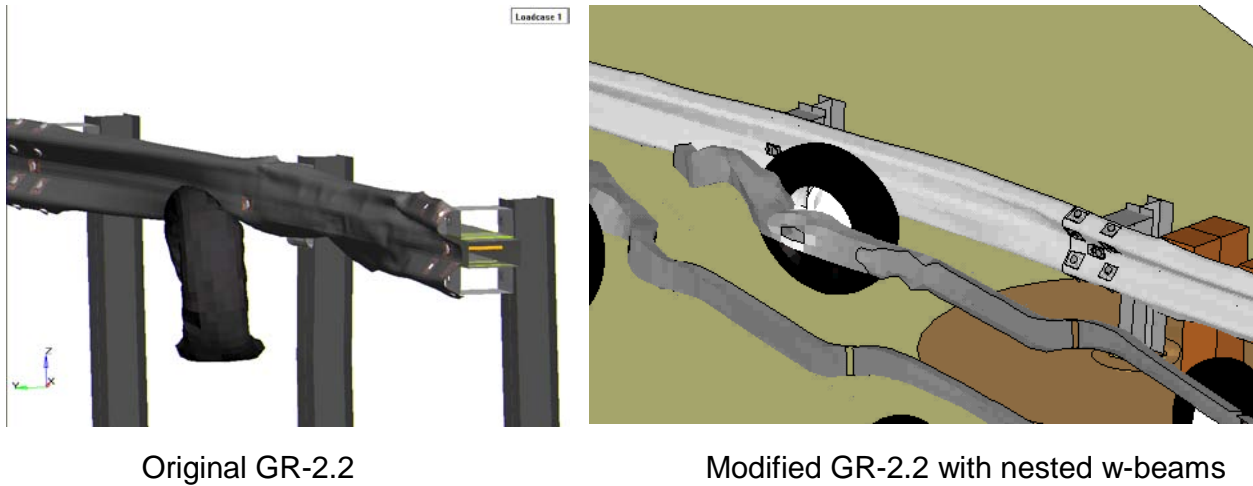
Figure 30: Comparison of the modified GR-2.2 with nested w-beam rails and the original GR-2.2 system, illustrating the reduced potential for snagging

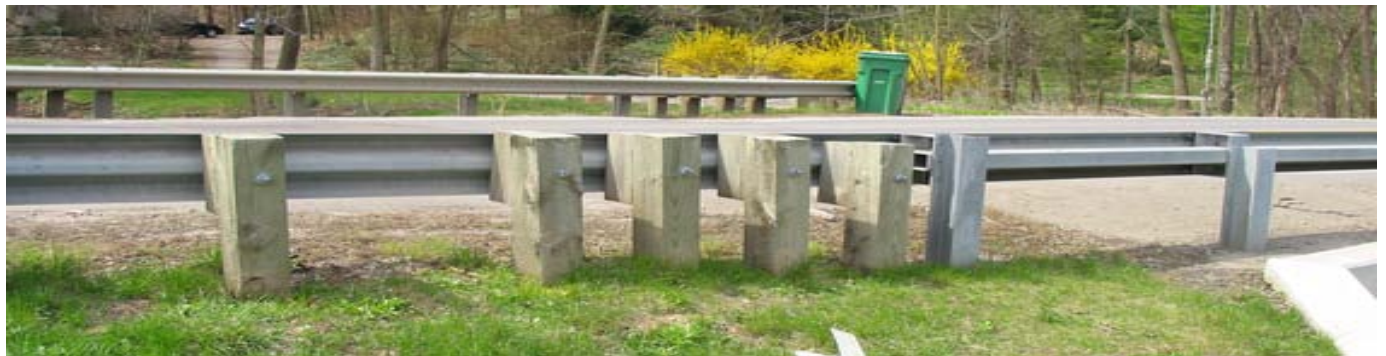
Figure 33: Photo of the ODOT GR-2.2 guardrail and ODOT GR-3.4 transition at a site along HW 315 north of Columbus, Ohio.

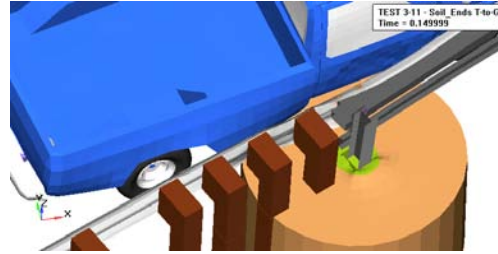
Time = 0.150 seconds

The wheel of the vehicle smoothly passed across the connection of the GR-2.2 and the GR-3.4 with no apparent likelihood of wheel snag. A summary of Occupant risk measures were computed and are provided below in Table 14 and the acceleration-time histories are shown in Figure 40.

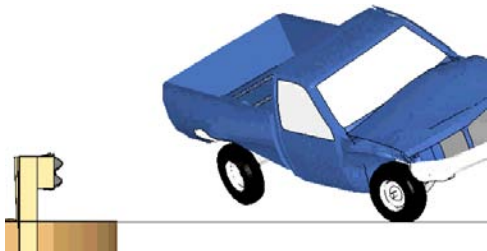
Time = 0.800 seconds

Figure 50: Sequential views of the NCHRP Report 350 Test 3-11 analysis of the modified GR-2.2 with nested w-beam rails and standard GR-3.4 transition for impact.

Figure 50 shows sequential views of the results of Modification B from a downstream view point and an overhead view perspective. The wheel of the pickup truck again was prevented from pushing underneath the rail and the system met all safety requirements of NCHRP Report 350 Test Level 3. A summary of Occupant risk measures were computed and are provided below in Table 19 and the acceleration-time histories are shown in Figure 51.
