Development of Two Test Level 2 Bridge Railings and Transitions for Use on Transverse Glue-Laminated Deck Bridges

Ronald K. Faller, Barry T. Rosson, Michael A. Ritter,
Eric A. Keller, and Sheila R. Duwadi

The Midwest Roadside Safety Facility, in cooperation with the United States Department of Agriculture Forest Service Forest Products Laboratory and FHWA, designed two bridge railing and approach guardrail transition systems for use on transverse glue-laminated timber deck bridges. The bridge railing and transition systems were developed and crash tested for use on medium-service roadways and evaluated according to the Test Level 2 safety performance criteria provided in NCHRP Report 350. The first railing system was constructed by using steel hardware, whereas the second railing system was built by using glulam timber components. Four full-scale crash tests were performed, and the bridge railing and transition systems were determined to be acceptable according to the current safety standards in NCHRP Report 350.

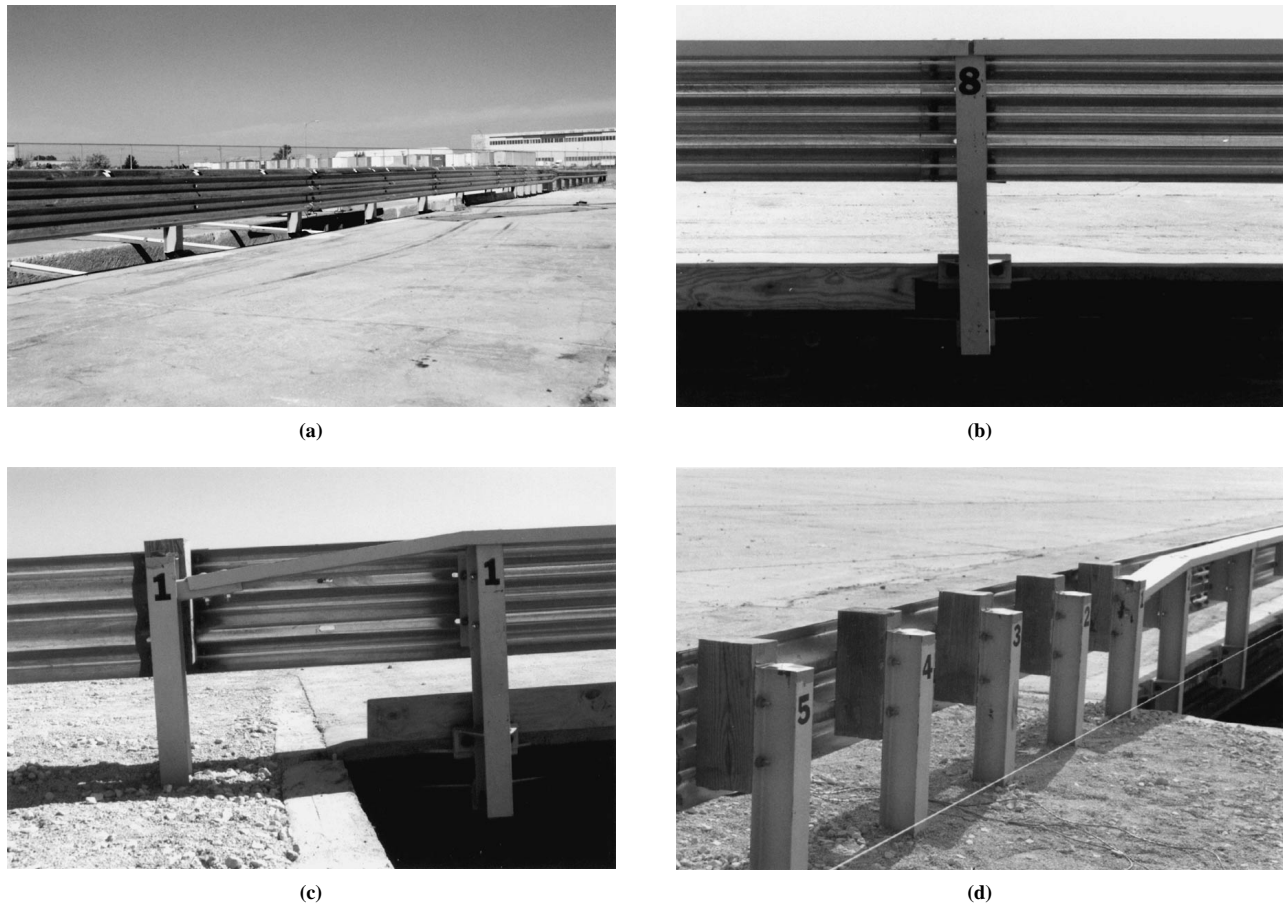
FIGURE 1 Steel thrie beam with channel bridge railing and thrie beam with channel transition, System 1.

The first bridge railing, referred to as System 1, was a steel system constructed with a thrie beam rail, an upper structural channel rail, and wide-flange posts and blockouts. Photographs of the steel bridge railing system and the attached thrie beam approach guardrail transition are provided in Figure 1. The second bridge railing, referred to as System 2, was a wood system constructed by using a rectangular rail, posts, and blockouts, all of which were manufactured from glulam timber. Photographs of the wood bridge railing system and the attached W-beam approach guardrail transition are provided in Figure 2.

The first bridge railing system was designed as an all-steel system. This system was constructed with a thrie beam rail, an upper structural channel rail, wide-flange bridge posts and rail blockouts, and deck mounting plates. Specific details of this system are provided in Figure 4. For the steel system, a 10-gauge thrie beam rail was blocked away from wide-flange posts with wide-flange spacers. A structural channel rail was then attached to the top of the posts. The lower end of each post was bolted to two steel plates that were connected to the top and bottom surfaces of the bridge deck with vertical bolts.

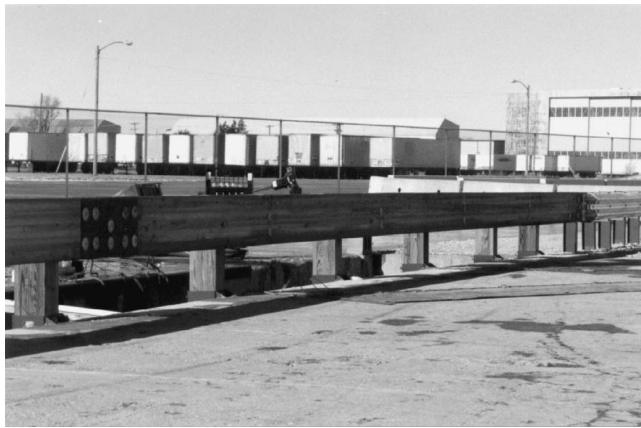
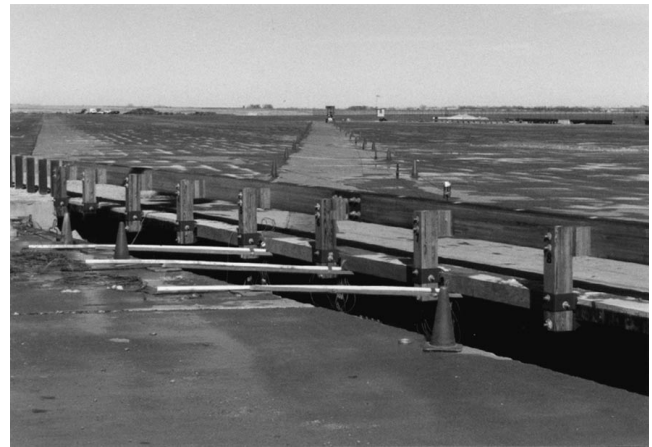
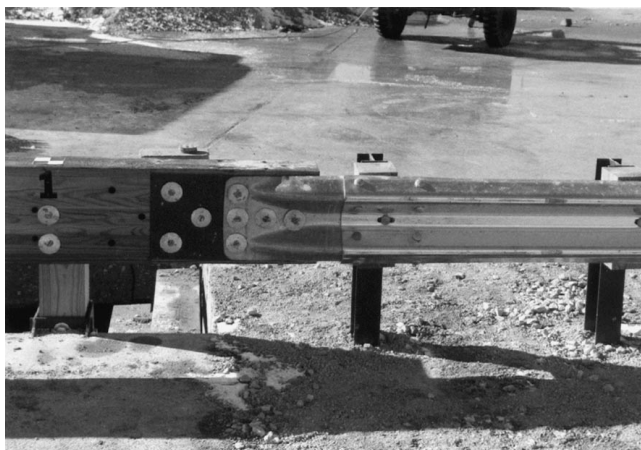
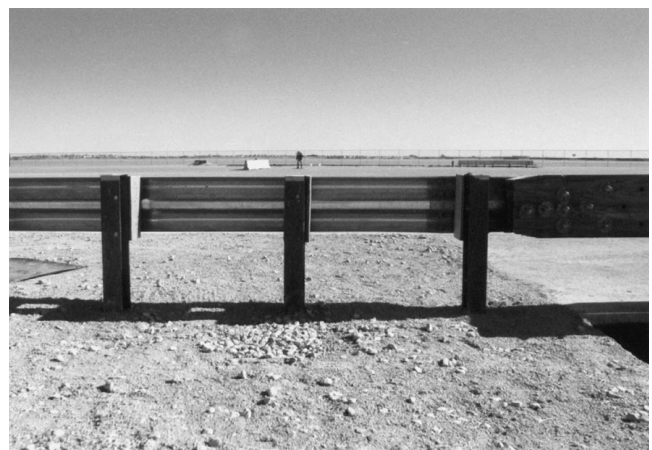
FIGURE 2 Glulam bridge railing and W-beam transition, System 2.

The second bridge railing system was designed to be an all-wood system, except for the structural steel connections. This system was constructed by using a rectangular rail, rectangular bridge posts, rail

A TL-2 approach guardrail transition system was designed for attachment to each end of the bridge railing system. The system was constructed by using two nested steel W-beam rails, guardrail posts, and rail blockouts. Details of the approach guardrail transition used with System 2 are provided in Figure 9.

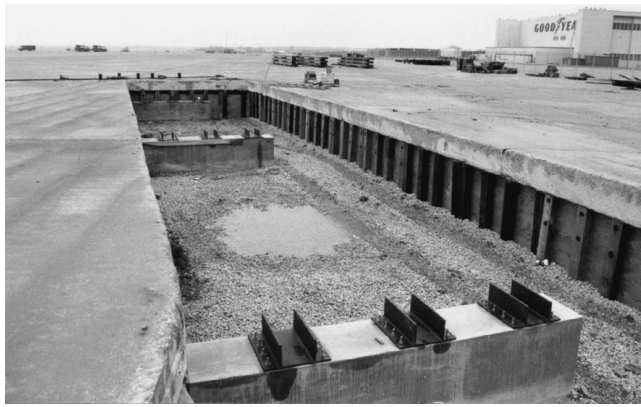
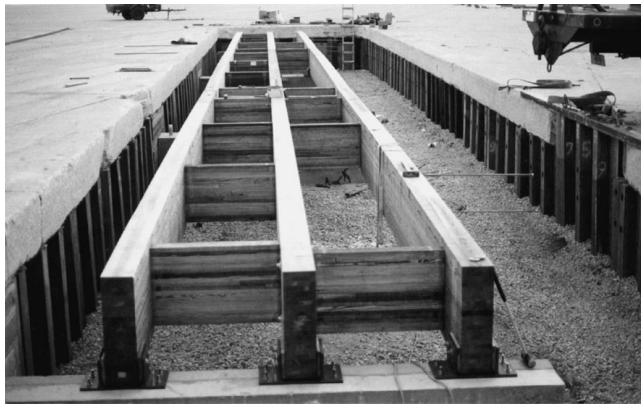
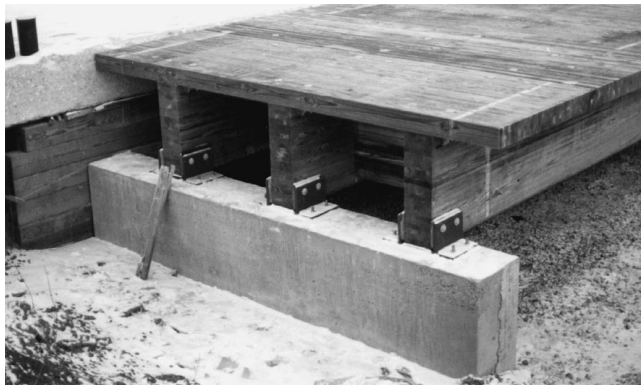
FIGURE 3 Simulated test bridge.

Testing of the bridge railing and approach guardrail transition systems was conducted at MwRSF's outdoor test site in Lincoln, Nebraska. To perform all the barrier testing, a full-size test bridge was constructed, as shown in Figure 3. The test bridge measured approximately 3.96 m wide and 36.58 m long and consisted of three simply supported spans measuring approximately 12.19 m each.

The transverse deck system was constructed of glulam timber panels 130 mm thick by 1.22 m wide. The glulam timber for the deck was Combination 47 southern yellow pine, as specified in the AASHTO *LRFD Bridge Design Specifications*. The timber was treated according to the American Wood Preservers' Association (AWPA) Standard C14 (23). Thirty glulam timber panels were placed side by side to achieve the 36.58-m length, and they were attached to the longitudinal glulam beams with standard aluminum deck brackets.

The test bridge was positioned on concrete supports that were placed in a 2.13-m-deep excavated test pit. The concrete supports were placed so that the top of the test bridge was 51 mm below the concrete surface to allow for placement of the bridge deck wearing surface. A detailed discussion of the test bridge is beyond the scope of this paper and is presented in detail by Fowler (17).

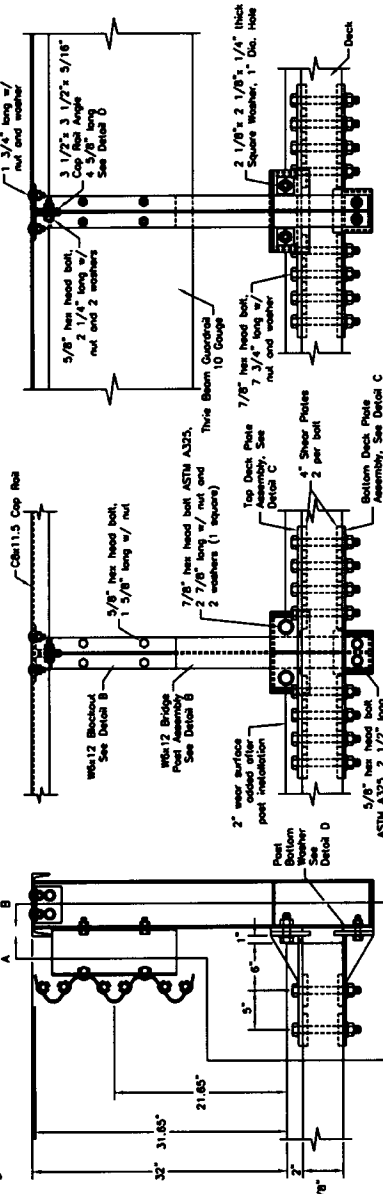
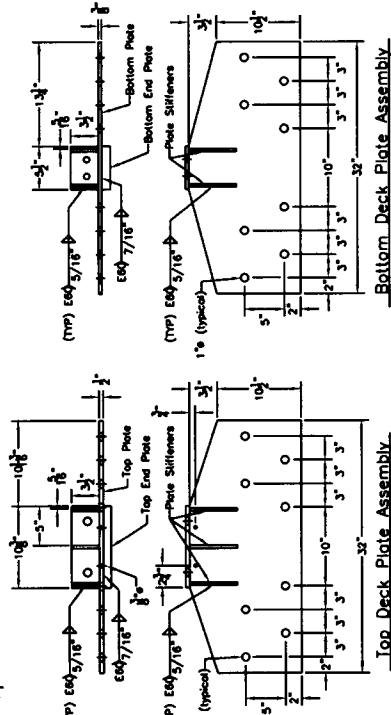
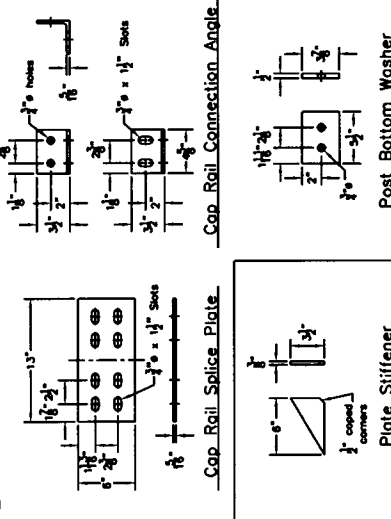
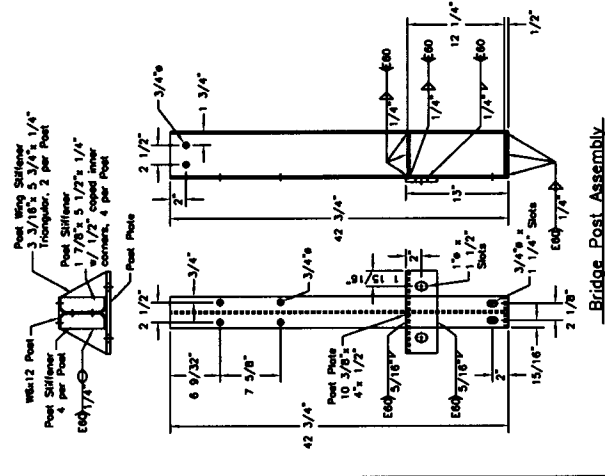
FIGURE 4 Steel bridge railing design details, System 1 (1 in. = 25.4 mm).

several design modifications were deemed necessary. As a result, the upper structural tube rail on the TL-4 system was replaced with a channel rail section. This modification not only provided reduced weight but improved constructability. Other design modifications included a reduction in the size of the deck mounting plates and a decrease in the number of vertical bolts used to attach the mounting plates to the timber deck panels. A 2438-mm post spacing, also used with the TL-4 railings for transverse decks, was selected instead of the usual 1905-mm post spacing. The increased post spacing was selected to optimize the design and to significantly improve the constructability of the railing system, which was based on 1219-mm-

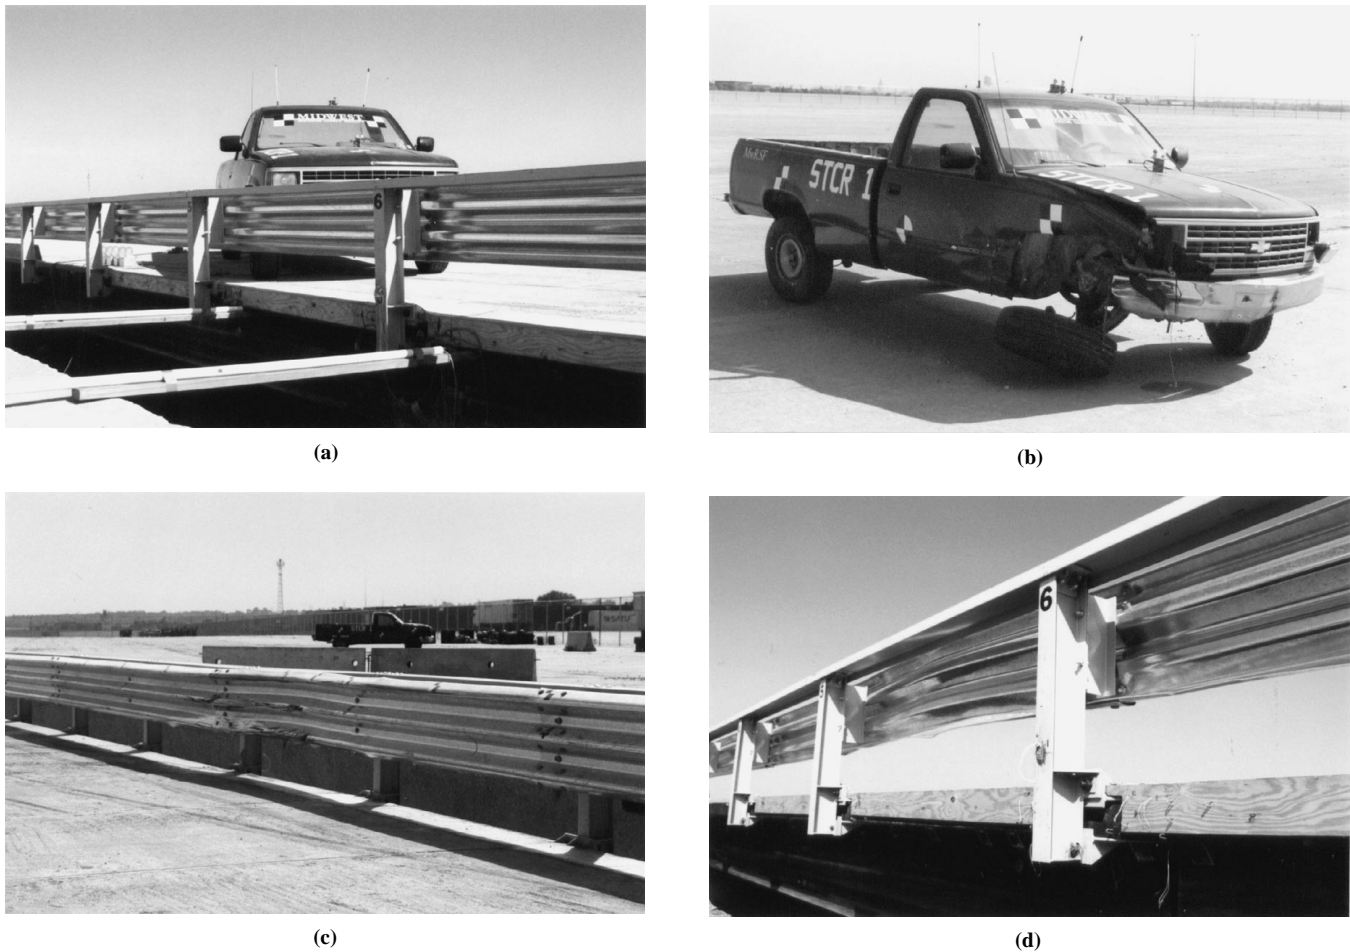
FIGURE 6 Test STCR-1: (a) impact location, (b) vehicle damage, and (c, d) bridge railing damage.

The first crash test, STCR-1, was successfully performed with a 1990 Chevrolet 2500 pickup truck with a test inertial mass of 1966 kg and at the impact conditions of 66.6 km/h and 25.6 degrees. During the impact event, the truck became parallel to the railing at 0.229 s and a speed of 46.1 km/h. At 0.519 s after impact, the vehicle exited the railing system at a speed of 45.2 km/h and an angle of 14.7 degrees. The maximum lateral permanent set and dynamic rail deflections were observed to be 102 and 157 mm, respectively. The location of the vehicle impact with the bridge railing, vehicle damage, and barrier damage are shown in Figure 6.

Following an analysis of the test results, it was determined that the steel bridge railing system met the TL-2 safety performance criteria provided in NCHRP Report 350. No significant damage to the test bridge was evident from the vehicle impact test. For the bridge railing system, damage consisted primarily of permanent deformation of the thrie beam rail, channel rail, wide-flange posts, and rail spacers. Although visual permanent set deformations of the steel components were found in the vicinity of the impact, all the steel members remained intact and serviceable after the test. Thus, replacement of bridge railing components would be based more on aesthetics than on structural integrity.

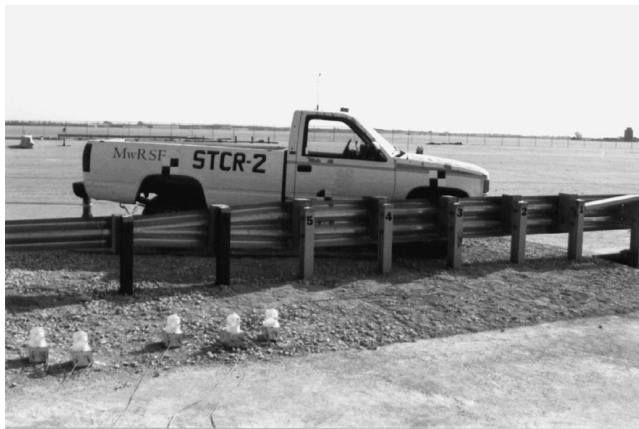
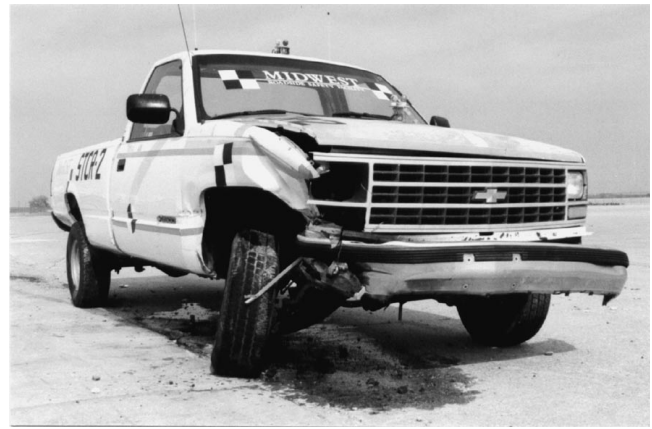
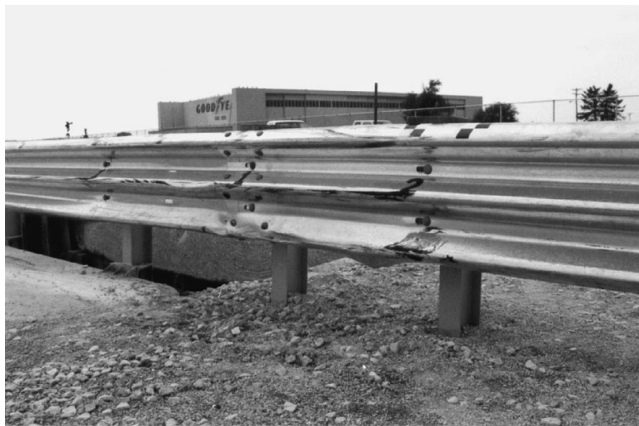
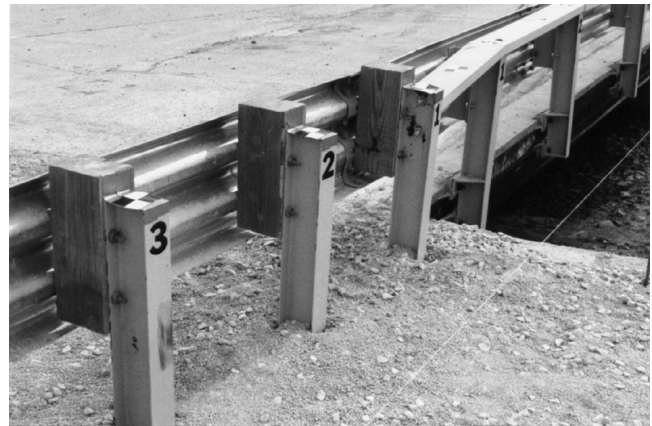
FIGURE 7 Test STCR-2: (a) impact location, (b) vehicle damage, and (c, d) bridge railing damage.

transition system at a speed of 45.5 km/h and an angle of 17.6 degrees. The maximum lateral permanent set and dynamic rail deflections were observed to be 117 and 202 mm, respectively. The location of the vehicle impact with the approach guardrail transition, vehicle damage, and barrier damage are shown in Figure 7.

Following an analysis of the test results, it was determined that the approach guardrail transition for use with the steel bridge railing system met the TL-2 safety performance criteria provided in NCHRP Report 350. No significant damage to the upstream end of the test bridge was evident from the vehicle impact test. For the approach guardrail transition system, damage consisted primarily of deformed thrie beam rail and bridge posts as well as displaced guardrail posts. Although visual permanent set deformations of the thrie beam rail were found in the vicinity of the impact, the rail remained intact and serviceable after the test. Thus, replacement of the guardrail would be based more on aesthetics than on structural integrity.

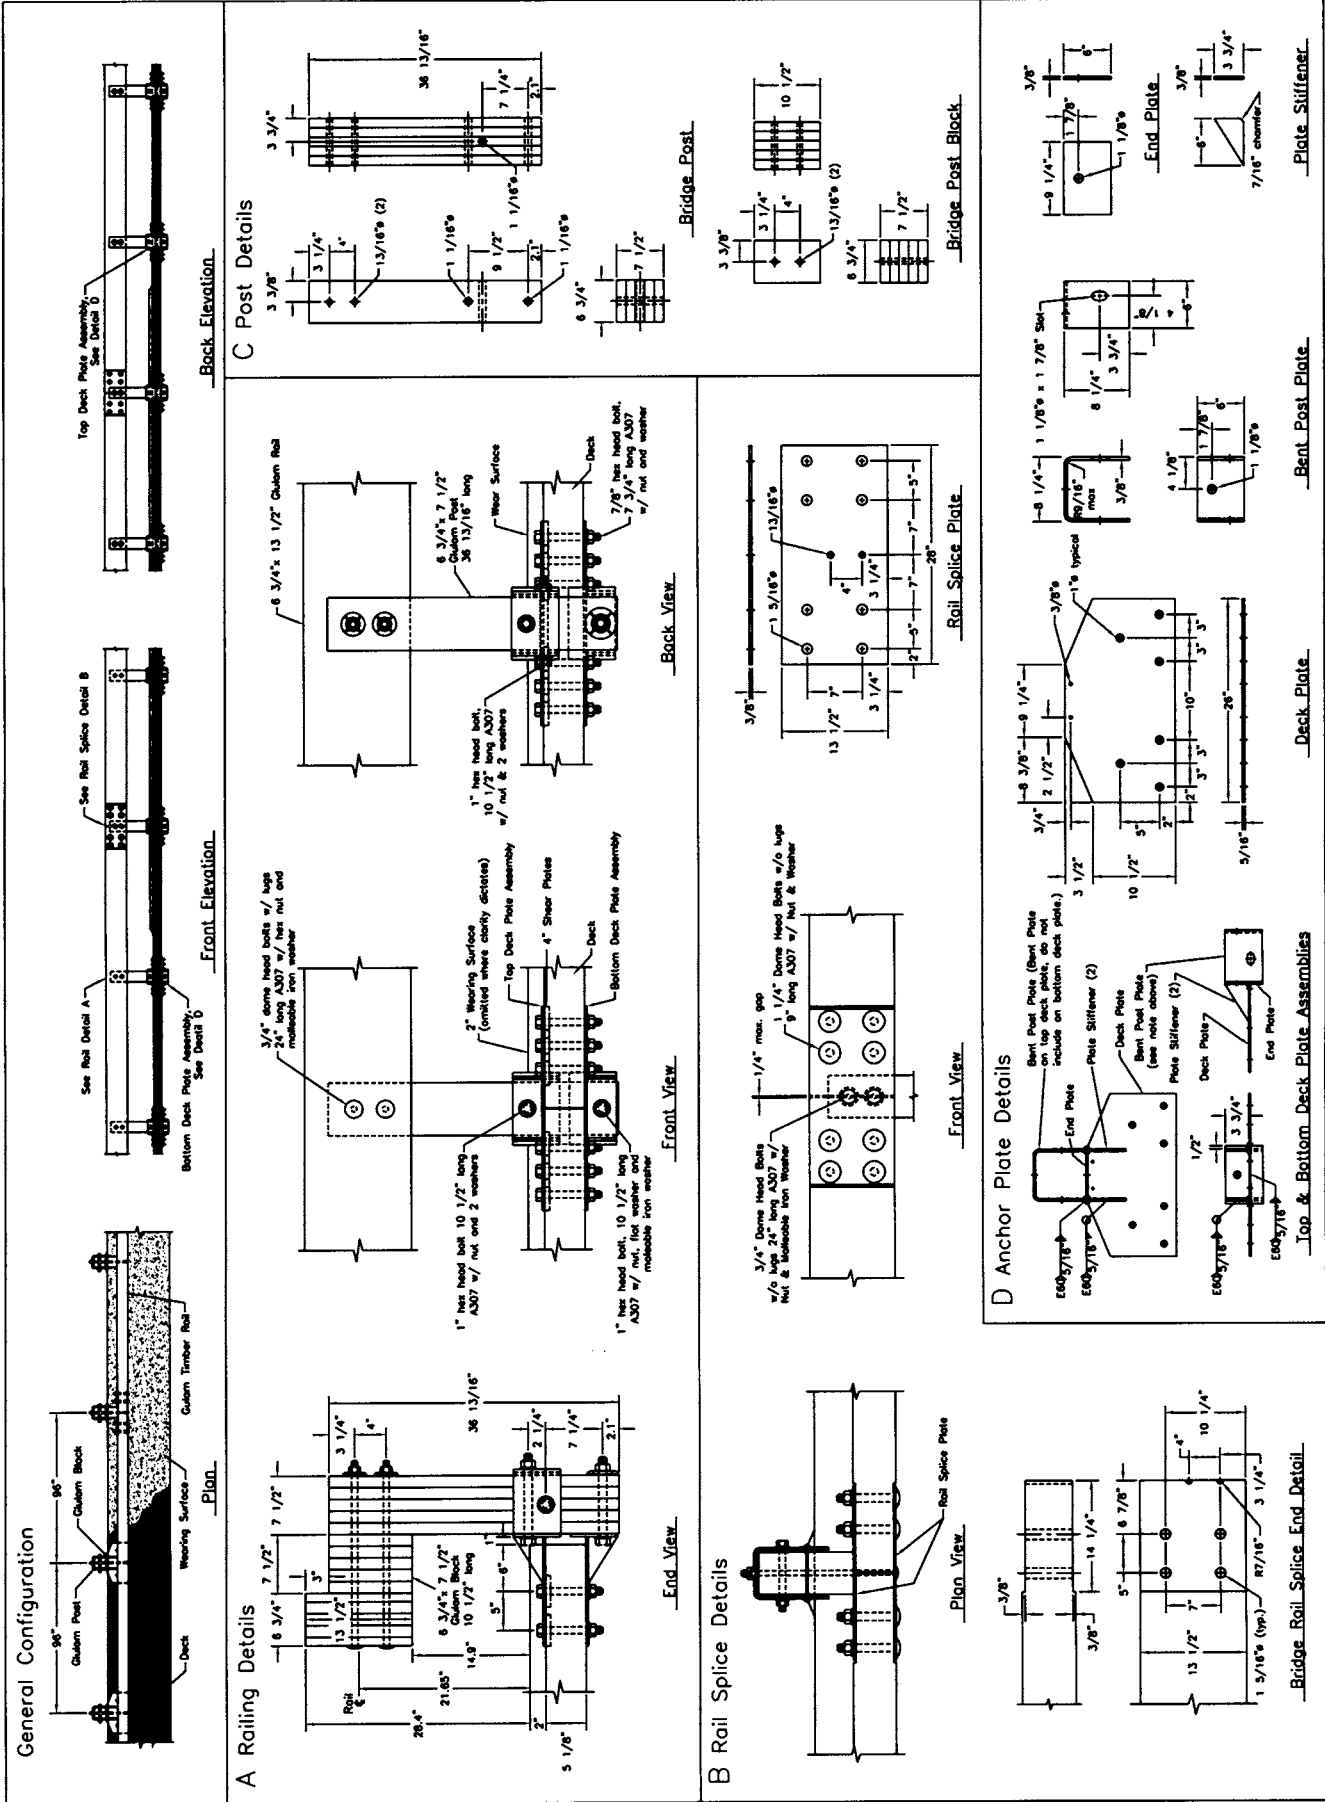
FIGURE 8 Wood bridge railing design details, System 2 (1 in. = 25.4 mm).

blockouts, and deck mounting plates. Details of this system are provided in Figure 8. For the wood system, glulam timber for the rail and post members was Combination 48 southern yellow pine, as specified in AASHTO's *LRFD Bridge Design Specifications*, and it was treated with pentachlorophenol in heavy oil to AWP Standard C14 requirements (23). Glulam timber for the spacer blocks was fabricated with Combination 47 southern yellow pine, as specified by AASHTO, and was treated according to AWP Standard C14 (23).

System 2 was configured similarly to the PL-1 glulam timber rail without curb system previously developed for longitudinal decks (10, 13, 14, 16). However, for this system, all wood components were fabricated from glulam timber, whereas the previous system used glulam rail and sawn lumber posts and blocks. From the PL-1 railing system, the steel box that was used to support the posts was replaced with a more-economical steel U-shaped bracket, which attached to the deck surface. In addition, all structural members and the steel hardware were resized to account for the increased post spacing from 1905 to 2438 mm. Again, the new post spacing was selected to optimize the design and improve the constructability of the railing system, which was based on 1219-mm-wide deck panels.

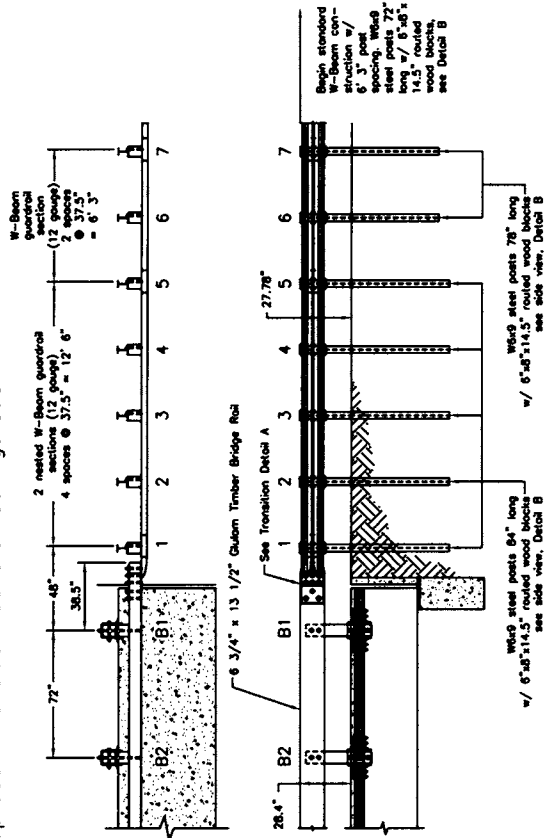
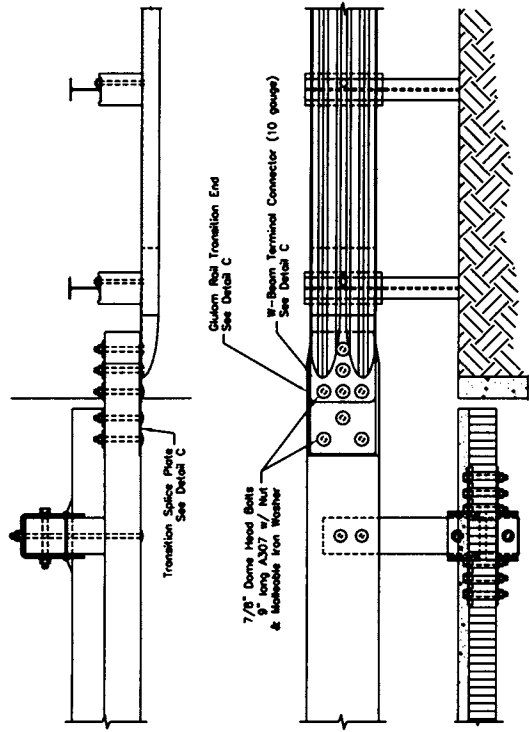
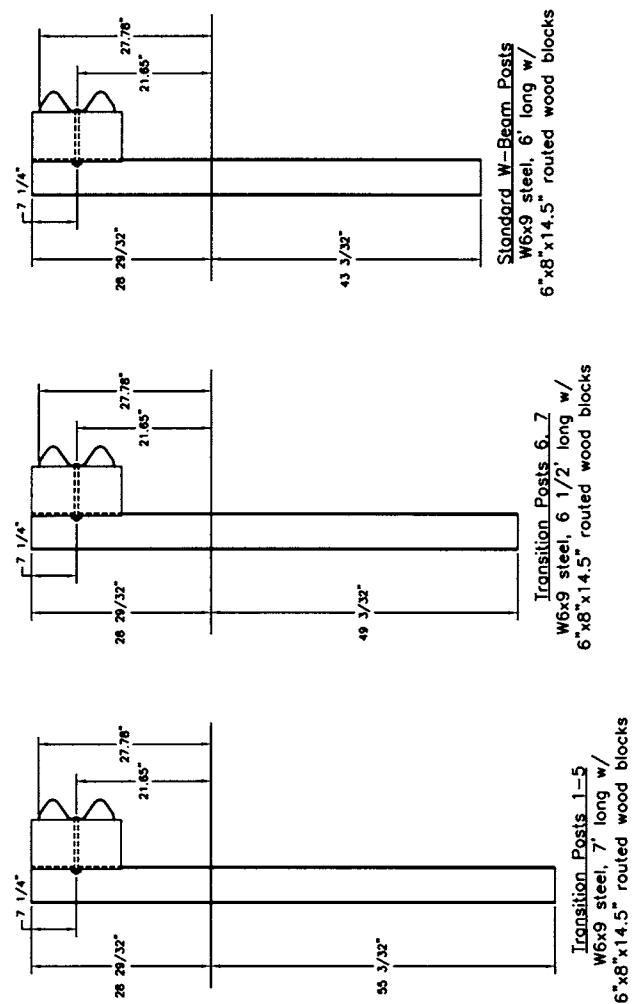
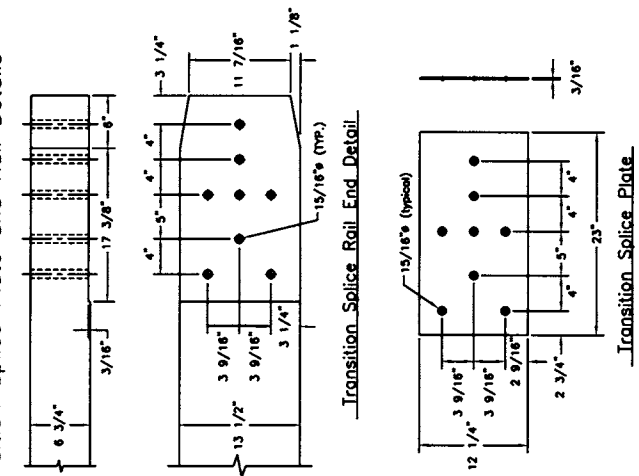
FIGURE 9 Approach guardrail transition design details, System 2 (1 in. = 25.4 mm).

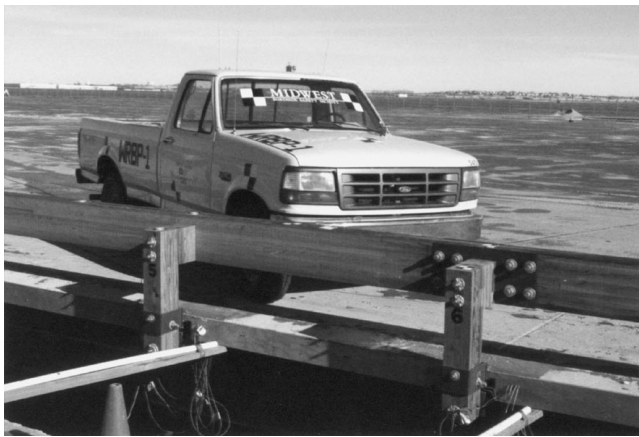
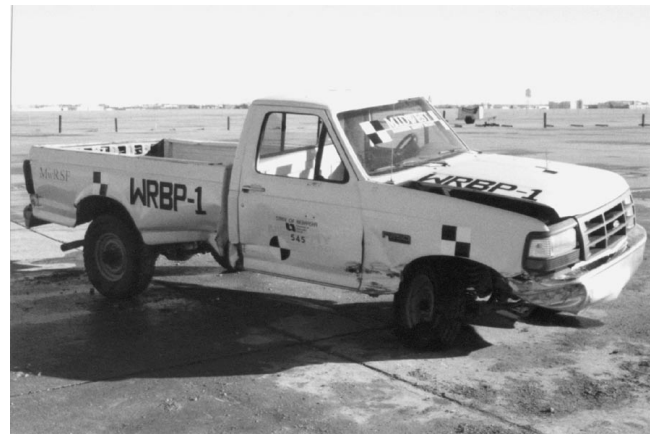
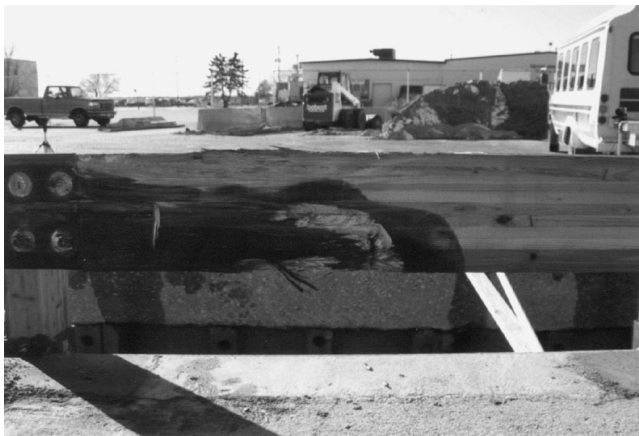
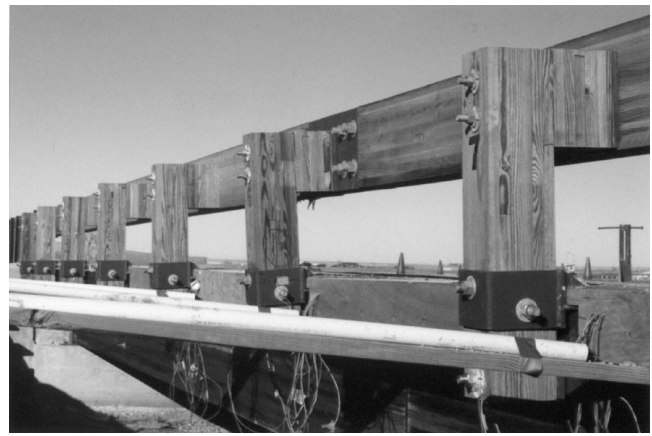
FIGURE 10 Test WRBP-1: (a) impact location, (b) vehicle damage, and (c, d) bridge railing damage.

The first crash test, WRBP-1, was successfully performed with a 1994 Ford F-250 pickup truck with a test inertial mass of 2031 kg and at the impact conditions of 69 km/h and 26.2 degrees. During the impact event, the truck became parallel to the railing at 0.280 s and at a speed of 47.2 km/h. At 0.452 s after impact, the vehicle exited the railing system at a speed of 47.1 km/h and an angle of 5.9 degrees. The maximum lateral permanent set and dynamic rail deflections were observed to be 63 and 189 mm, respectively. The location of the vehicle impact with the bridge railing, vehicle damage, and barrier damage are shown in Figure 10.

Following an analysis of the test results, it was determined that the wood bridge railing system met the TL-2 safety performance criteria provided in NCHRP Report 350. No significant damage to the test bridge was evident from the vehicle impact test. For the bridge railing system, damage consisted primarily of rail gouging and scraping, as well as permanent set deformations of the steel deck mounting plates. The glulam timber railing remained intact and serviceable after the test. Railing replacement would not be considered necessary except to provide improved aesthetics.

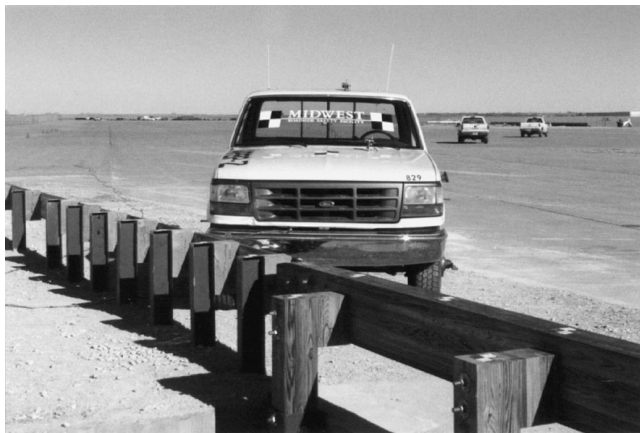
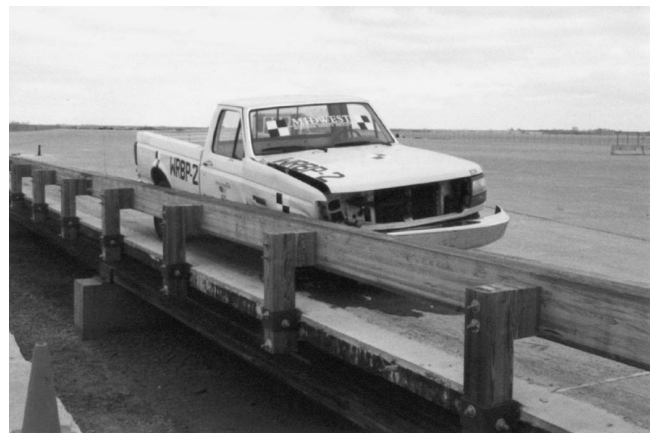
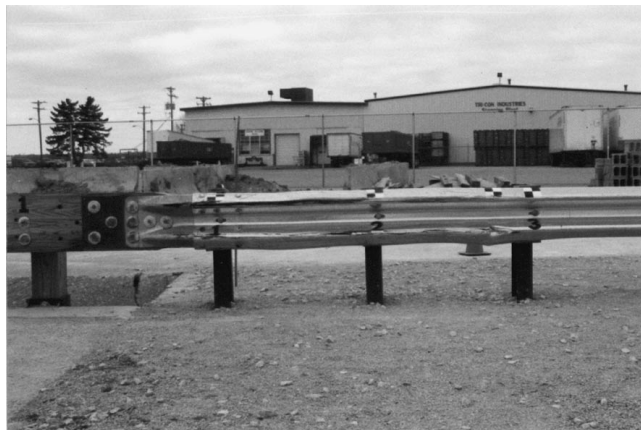
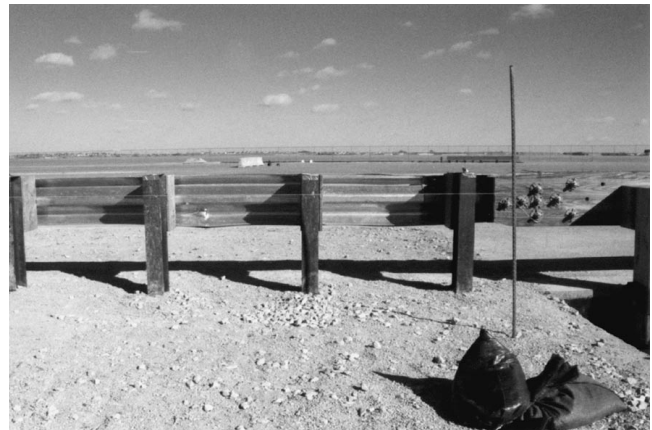
FIGURE 11 Test WRBP-2: (a) impact location, (b) vehicle damage, and (c, d) approach guardrail transition damage.

The first crash test, WRBP-2, was successfully performed with a 1993 Ford F-250 pickup truck with a test inertial mass of 2011 kg and at the impact conditions of 71.6 km/h and 26.3 degrees. During the impact event, the truck became parallel to the railing at 0.261 s and at a speed of 55.9 km/h. At 0.422 s after impact, the vehicle exited the transition system at a speed of 54.6 km/h and an angle of 3.5 degrees. The maximum lateral permanent set and dynamic rail deflections were observed to be 29 and 125 mm, respectively. The location of the vehicle impact with the approach guardrail transition, vehicle damage, and barrier damage are shown in Figure 11.

Following an analysis of the test results, it was determined that the approach guardrail transition for use with the wood bridge railing system met the TL-2 safety performance criteria provided in NCHRP Report 350. No significant damage to the upstream end of the test bridge was evident from the vehicle impact test. For the approach guardrail transition system, damage consisted primarily of deformed W-beam rail and displaced guardrail posts. Although visual permanent set deformations of the W-beam rail were found in the vicinity of the impact, the rail remained intact and serviceable after the test. Thus, replacement of guardrail would be based more on aesthetics than on structural integrity.
