Evaluation of Crash Tests of the MDS-4 and MDS-5 Barriers According to Report 350

Malcolm H. Ray, P.E., Ph.D. (corresponding author)
MDS LLC
186 Staples Hill Road
Canton ME 04221
207-597-2779
mhray@wpi.edu

Submission Date: 23 July 2008
Word Count: 6,620

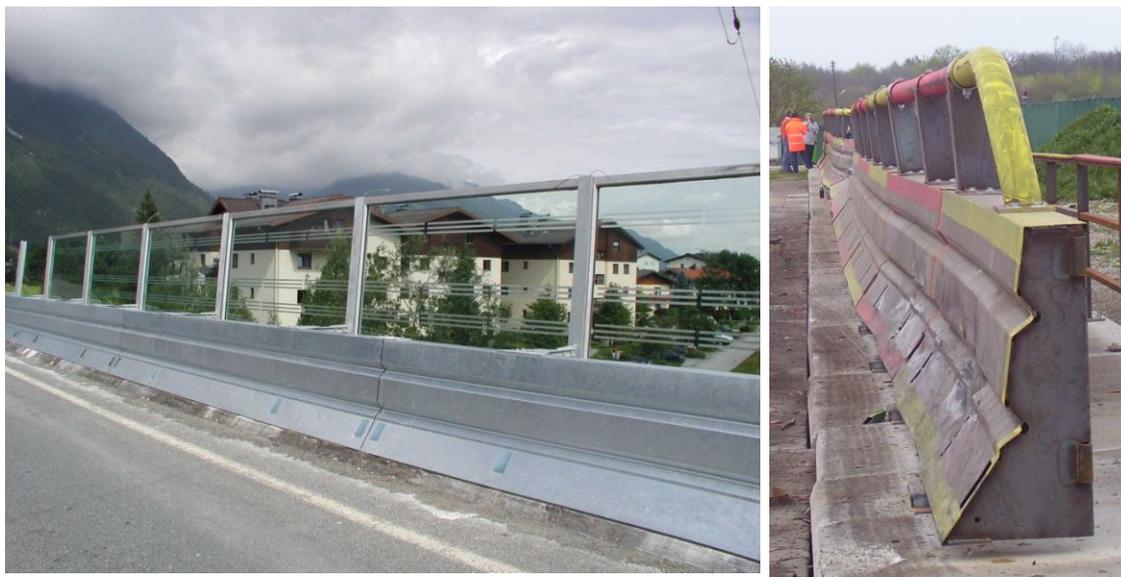
Figure 1. Photographs of the MDS-4 barrier with noise-wall installed (left) and a post-collision photograph of the MDS-5 barrier without the noise wall installed

The integration of both the safety barrier and the noise-protection barrier within a single barrier system provides considerable savings in terms of occupied space, supporting sub-structures and overall cost. The special backward positioning of the noise-protection barrier requires less lateral space on the bridge deck and also makes the disposal of snow easier.

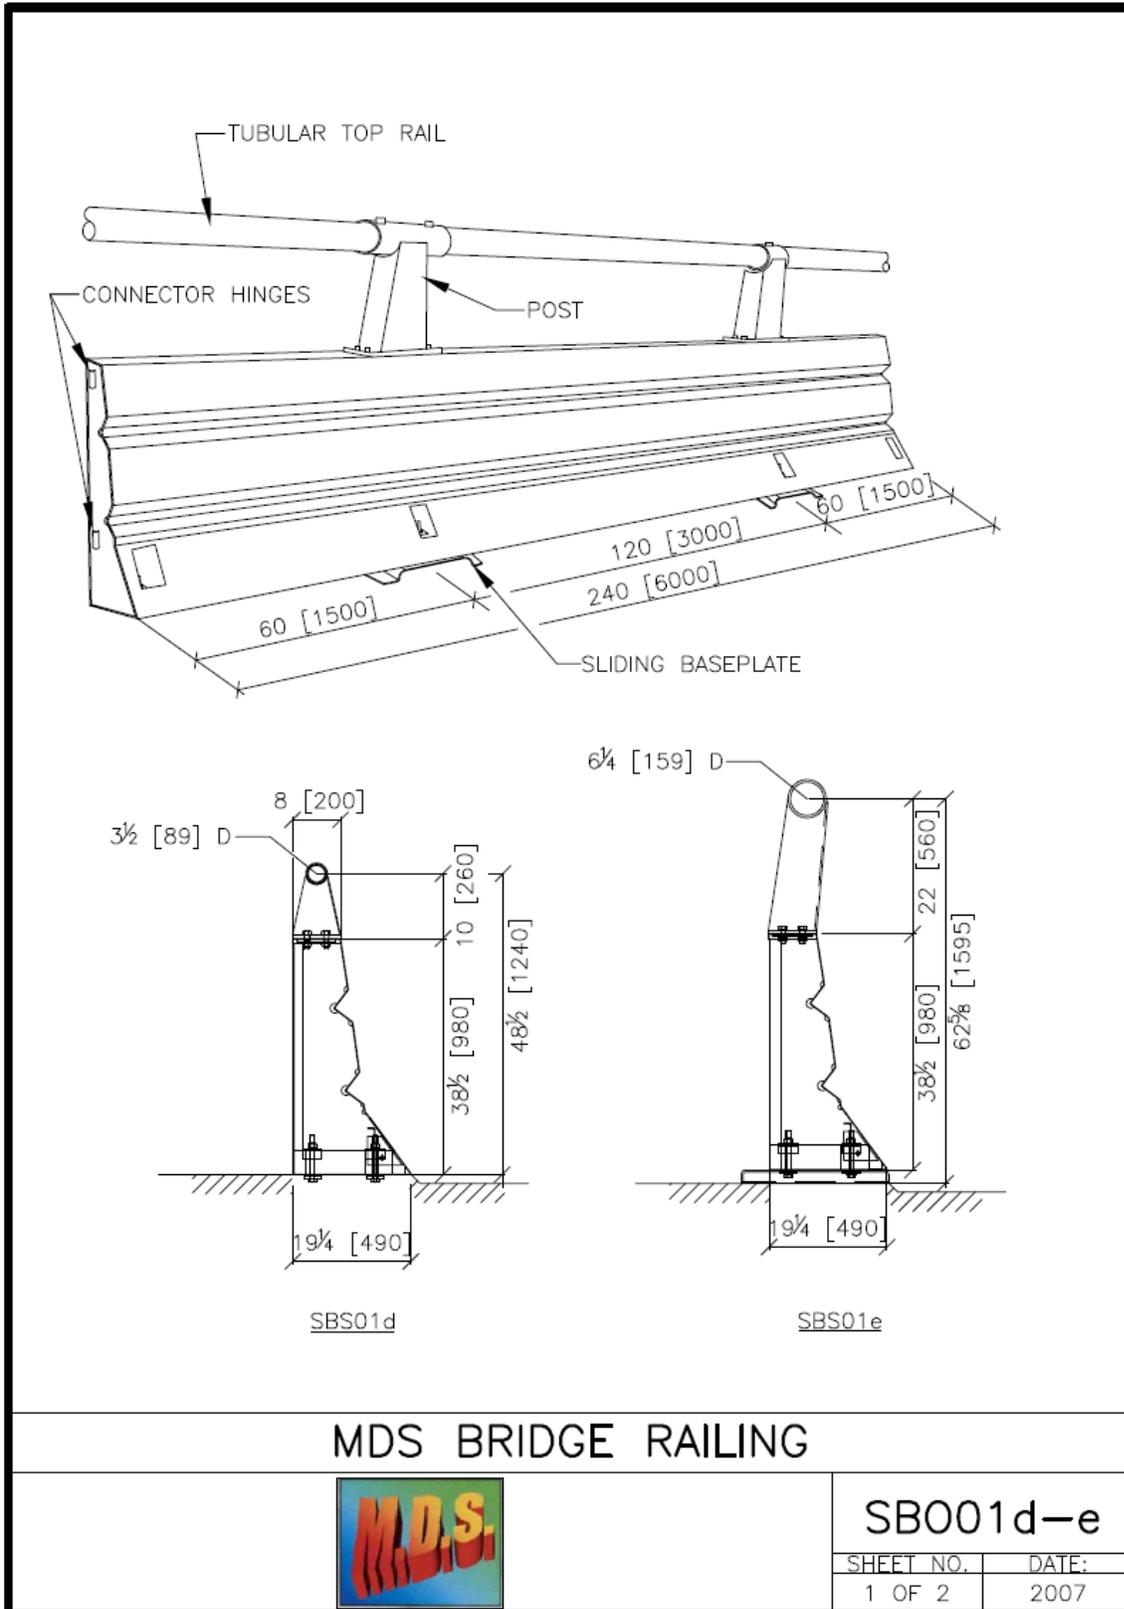
Figure 2. Schematic drawings of the MDS-4 and MDS-5 barriers.

Two new barrier systems have been developed that incorporate both a crash-tested barrier safety system and an optional noise wall that can be used in both permanent and temporary construction. The new MDS barrier systems provide protection against the collision of vehicles as well as noise pollution. A photograph of the 62-5/8 inch (1.595-m) tall version is shown in Figure 1 and a simplified drawing of both systems in the AASHTO-ARTBA-AGC drawing format is shown in Figure 2.

The MDS Barriers are all-steel safety-shape barriers that are bolted directly to the bridge deck. Twenty ft (6 m) long, 38.5 in (980-mm) high safety-shape panels made of 5/32-in (4 mm) steel plate are attached to the bridge deck and a circular steel tube top rail is mounted to the top of the bridge panels. The safety-shape panels have dimensions that place it between the conventional dimensions of the New Jersey shape and the F shape and the traffic face has two corrugations. The barrier is available in two varieties: a 48.5-inch (1.240-m) high system suitable for Report 350/MASH test level four situations, called the MDS-4 in this report, and a 62.625-inch (1.595-m) high system suitable for Report 350/MASH test level five conditions, called the MDS-5 in this report (note: the nominal heights are measured to the center of the top rail). Both versions of the MDS barrier can be used with or without optional noise barriers that are attached to the rear face of the safety barrier. The noise barrier does not contribute to the safety performance of the railing so the drawings in Figure 2 are shown without the optional noise panel.

The barriers take advantage of a unique sliding base attachment. For the MDS-4, two threaded rods are attached to the deck which are then bolted into an inverted hat section in the barrier panels. For the MDS-5, a skid-plate is mounted is bolted to the bridge deck using four deck anchor bolts that may either be drilled through the deck or epoxied into the deck depending on the deck design requirements and the threaded rods are attached to the skid plate at the bottom and the inverted hat section in the barrier panels. The sliding action of the barrier dissipates considerable energy while isolating the deck from high impact forces. The bolt attachment to the deck used in the MDS-5 crash tests were 5/8-inch diameter bolts epoxied five inches (M16 bolt 130 mm into the deck) into the deck. The attachment causes very little disruption of the deck making it ideal for re-decking projects or temporary staged construction. The barrier can be placed in one location on the deck during re-decking and then un-bolted and moved to its final position without any major change to the deck. The 20-ft (6-m) panels are easily moved using a fork lift so repositioning the panels is easily accomplished during a re-decking project.

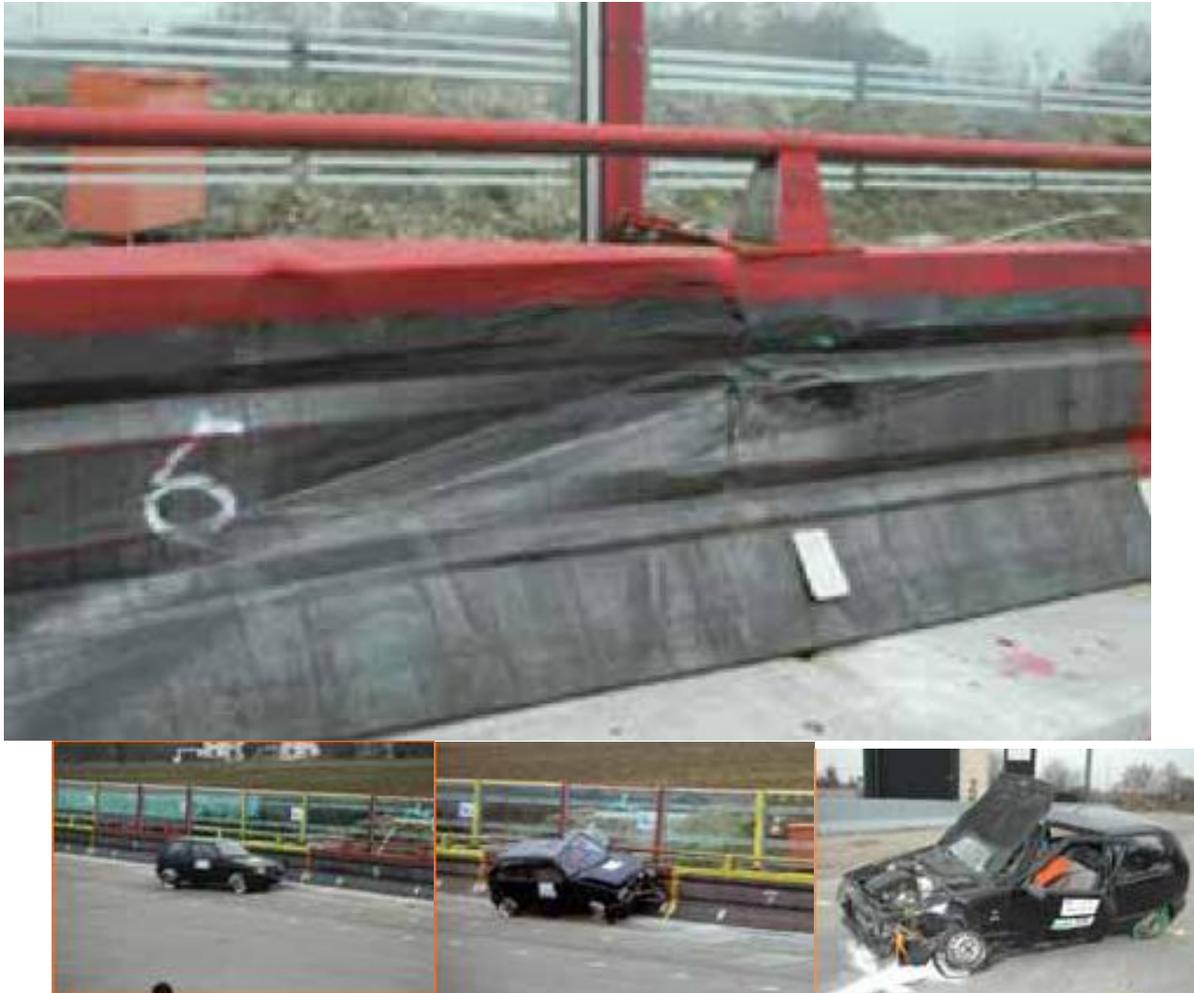
Figure 3. 900-kg 100 km/hr 20 degree small car test of the MDS-4 barrier showing (top) barrier damage, (bottom left and middle) vehicle-barrier interaction and (bottom right) vehicle damage.

As documented in the test report, the small passenger vehicle struck the barrier at a 20 degree angle and a velocity of 102.9 km/hr. After the initial impact, the vehicle was redirected parallel to the barrier. During its interaction with the barrier, the vehicle rode up the barrier as is typical in small car tests of safety shaped barriers and experienced a maximum clockwise roll angle of about 49 degrees. The un-instrumented dummy in the driver seat struck and shattered the driver-side window but the head-form did not contact the barrier itself. The hood-latch released letting the hood open and strike the windshield. Three of the vehicle wheels lifted off the ground for a short time during redirection. The vehicle lost contact with the barrier and all four tires were lifted off the ground for a short period. The passenger-front tire quickly re-contacted the ground with the remaining tires re-contacting the ground shortly thereafter. The vehicle continued downstream where it came to rest near the end of the test installation as shown in the photographs in Annex 3 of the test report.

The 20-ft (6-m) long barrier segment that was the initial point of contact was bent and otherwise deformed but all the damage was limited to this one panel (see Annex 3 of the test report). The anchor bolts under the impacted panel were deformed but the base performed as designed, sliding laterally backwards during the impact. The maximum dynamic deflection of the barrier was 10.25 inches (260 mm) and the maximum permanent lateral deflection was 4.3 inches (110 mm). The damage to the barrier was not extensive and all the damage was contained in the single panel where the initial impact occurred. The barrier successfully contained and redirected the vehicle as designed.

The vehicle was smoothly redirected and the test satisfied all the evaluation criteria of both EN 1317 for TB-11 as certified by the test engineer. The test report and test data were used to re-evaluate the crash test according to Report 350 for test level 4-10 conditions. A summary of the Report 350 evaluation parameters are shown in Table 2 and photographs of the vehicle-barrier interaction, vehicle damage and barrier damage are shown in Figure 3. As demonstrated by the data in Table 2, the small passenger car crash test satisfied all the requirements of Report 350 and the testing conditions, as described earlier, are essentially the same for the European test TB-11 and Report 350 test 4-10. The MASH evaluation criteria are essentially the same as the Report 350 criteria for test 4-10. The exceptions are that more detail is provided for measuring occupant compartment intrusion (i.e., criterion D), the allowable roll and pitch are limited to 75 degrees in MASH (i.e., criterion F) and Report 350 criteria K and M are eliminated. As detailed in the test report, there was some minor damage to the floor pan but it was not extensive so the revised criterion D is not affected. The maximum roll and pitch angles were approximately 40 and 36 degrees respectively so the new criterion F was likewise not affected. The evaluation of

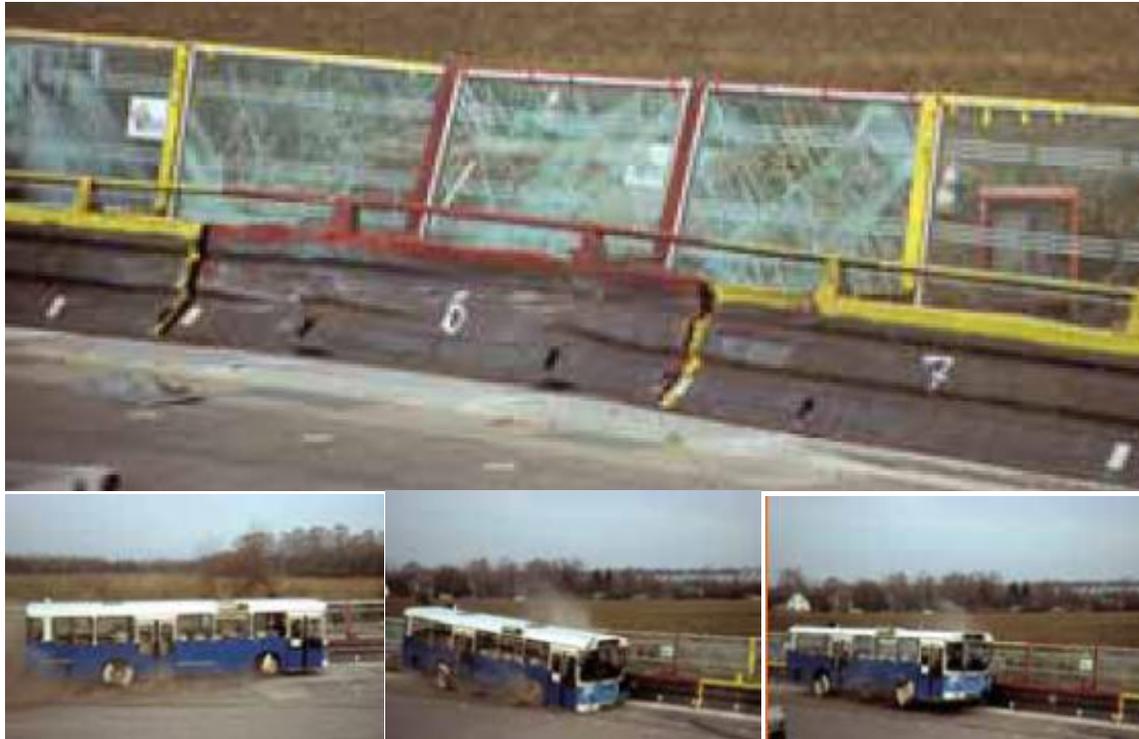
Figure 4. 13,000-kg 70 km/hr 20 degree intercity bus test of the MDS-4 barrier showing (top) barrier damage and (bottom) the vehicle-barrier interaction.

The front-left side of the 13,000-kg bus struck the barrier at 71.6 km/hr and 20 degrees. Upon impact, the vehicle began to push the steel-plate section rearward and the bus began to be redirected, rolling slightly clockwise away from the barrier as it rode up onto the safety-shaped face of the steel panel. The windshield detached during the initial impact and was propelled forward of the vehicle. After the front of the bus pitched upward, the bus was redirected parallel to the barrier. Upon contact with the rear axle the rear pitched upwards as the bus was redirected away from the barrier at a seven degree angle. The pitching of the vehicle caused the front bumper to contact the ground and subsequently regain its stability. The bus then steered back toward the barrier, re-contacting it approximately 132 ft (40 m) downstream of its initial impact point. The vehicle again is redirected parallel to the barrier and along the barrier where it comes to rest.

Most of the damage to the barrier was contained in the panel that was initially contacted. The steel safety shape section was deformed and pushed back but retained its structural integrity and functioned as intended by the designers. The safety shape panel where the second impact occurred was also slightly bowed and deformed but to a lesser extent than the initial impact location. The maximum lateral dynamic deflection was 32.5 inches (800 mm) and the maximum lateral permanent deflection was 25.5 inches (650 mm).

The vehicle was smoothly redirected and the test satisfied all the evaluation criteria of both EN 1317 for TB-51 as certified by the test engineer. Photographs of the impact event, barrier damage and vehicle damage are shown in Figure 4. The test report and test data were used to re-evaluate the crash test according to Report 350 for test 4-12 conditions. As demonstrated by the data in Table 3, the bus crash test satisfied all the requirements of Report 350 and the testing conditions, as described earlier, are more severe than the usual Report 350 test 4-12 involving the single-unit truck. The windshield did become detached and was propelled forward but it is believed this does not constitute an undue hazard under Report 350 criterion D. In any case, the wind shield detachment is more a feature of this particular vehicle design than the barrier. The MDS-4 barrier, therefore, meets all the requirements for Report 350 and MASH test 4-12.

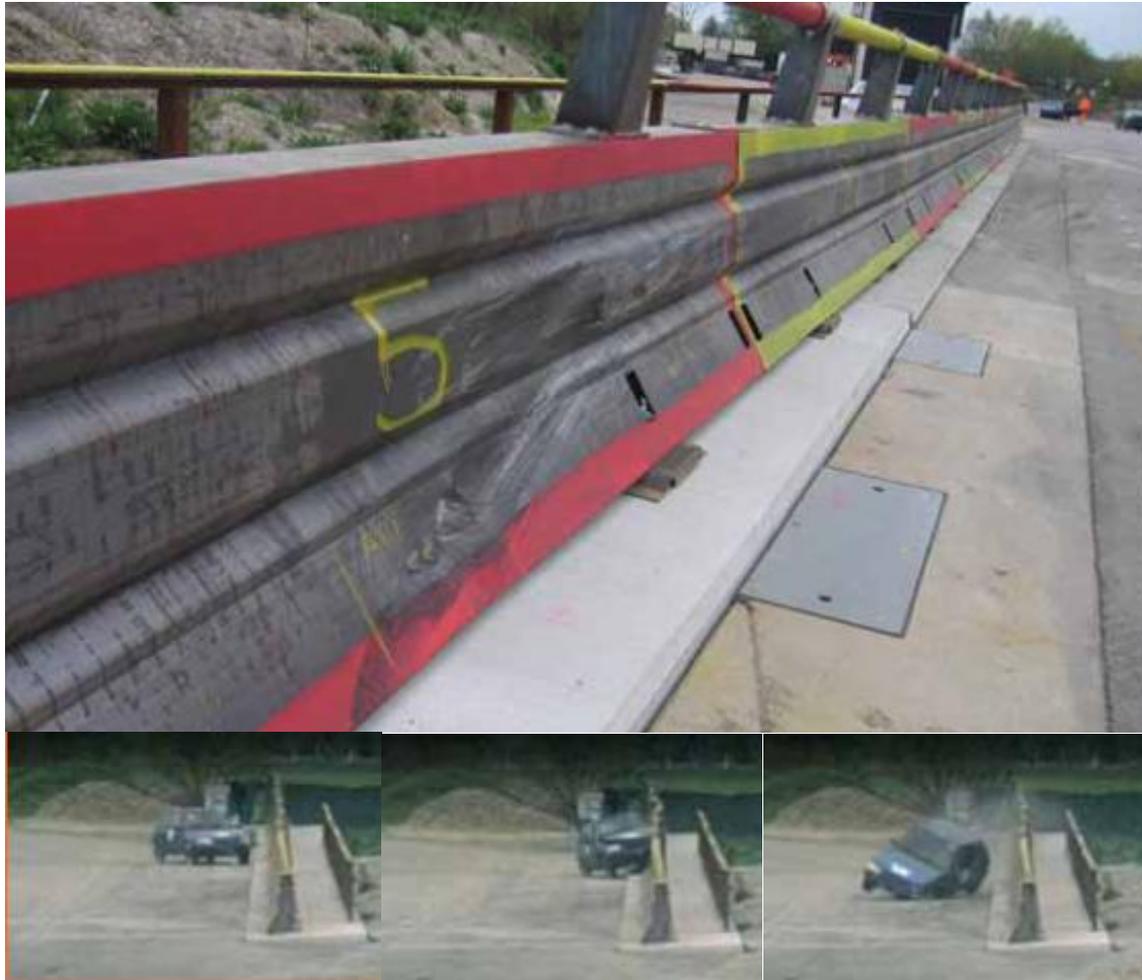
Figure 5. 900-kg 100 km/hr 20 degree small car test of the MDS-5 barrier showing (top) barrier damage and (bottom) the vehicle-barrier interaction.

The small passenger vehicle struck the barrier at 102.4 km/hr at an angle of 20 degrees. After the initial impact, the vehicle was redirected parallel with the barrier. During its interaction with the barrier, the vehicle rode up the barrier and rolled in a clockwise direction as is typical in small car tests of safety shaped barriers. The maximum roll during the interaction with the barrier was approximately 45 degrees and the maximum pitch was approximately 17 degrees. The un-instrumented dummy in the driver seat shattered the driver-side window but the head-form did not contact the barrier itself. The vehicle was lifted off the ground for a short time during redirection losing contact with the barrier and landing first with the right front wheel followed by the left front wheel and rear wheels. The vehicle continued downstream where it experienced a secondary minor impact with another barrier before coming to rest. Not surprisingly, the performance of the vehicle in this test was nearly identical to the results of the small car test with the MDS-4 barrier.

The vehicle was smoothly redirected and the test satisfied all the evaluation criteria of both EN 1317 for TB-11 as certified by the test engineer. The test report and test data were used to re-evaluate the crash test according to Report 350 for test 5-10 conditions. A summary of the Report 350 evaluation parameters are shown in Table 4 and photographs of the impact event, barrier damage and vehicle damage are shown in Figure 5. As demonstrated by the data in Table 4, the small passenger car crash test satisfied all the requirements of Report 350 and the testing conditions, as described earlier, are essentially the same for the European test TB-11 and Report 350 test 5-10. The MASH evaluation criteria are essentially the same as the original Report 350 criteria for test 5-10. The exceptions are that more detail is provided for measuring occupant compartment intrusion (i.e., criterion D), the allowable roll and pitch are limited to 75 degrees in the update (i.e., criterion F) and Report 350 criteria K and M are eliminated. As detailed in the test report, there was no occupant compartment intrusion so the revised criterion D is not affected. The maximum roll and pitch angles were approximately 45 and 17 degrees respectively so the new criterion F was likewise not affected. The evaluation of this small car test indicates, therefore, that the MDS-5 barrier satisfies the requirements for test 5-10 for both Report 350 and MASH.

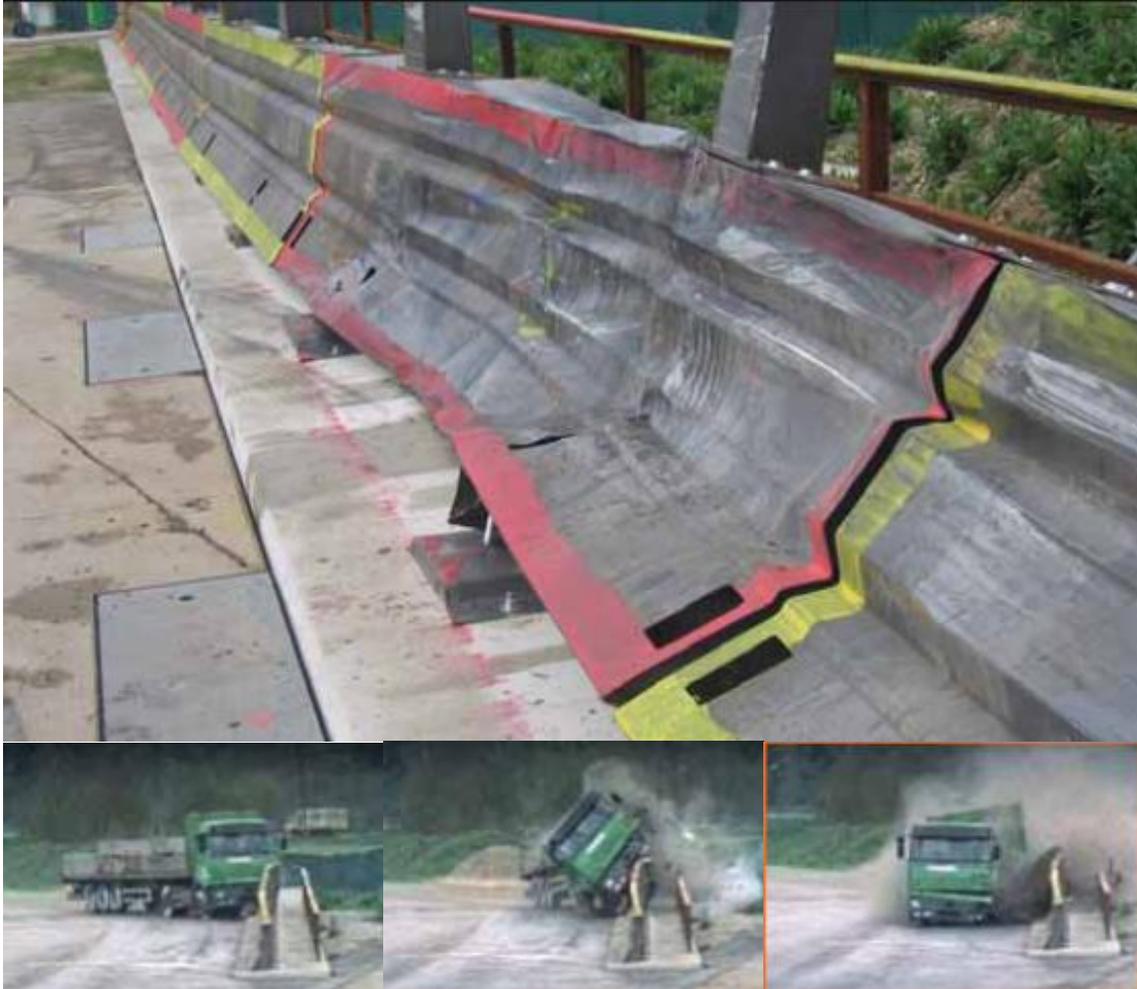
Figure 6. 38,000-kg 65-km/hr 20-degree tractor trailer truck test of the MDS-5 barrier showing (top) barrier damage and (bottom) the vehicle-barrier interaction.

The tractor-trailer truck struck the barrier at 67.6 km/hr at a 20 degree impact angle. The tractor climbed the safety-shaped face of the barrier pushing the impacted panels rearward as designed. During its climb, the tractor began to be redirected rolling away from the barrier with the tractor wheels leaving the pavement. The trailer subsequently struck the barrier and was redirected with the right trailer wheels leaving the ground for a short time. The tractor and trailer both remained upright throughout the entire collision event, losing contact with the barrier and regaining a stable position. The vehicle lost contact with the barrier at essentially a zero degree angle, traveling parallel with the barrier after losing contact. The tractor and trailer steered back into the barrier at a very shallow angle and scraped along parallel to the barrier until the end of the installation was reached.

The damage to the barrier was contained in four of the 20-ft long (6-m) panels from the initial impact point downstream. The first panel was most seriously damaged with decreasing damage to downstream panels. The panels were bent and the sliding bases were moved back as designed and the system maintained its structural integrity throughout the impact event. A panel 130-ft (40-m) downstream of the initial impact was also somewhat damaged as a result of the second collision with the truck. The maximum lateral dynamic deflection of the barrier was 25 inches (640 mm) and the maximum lateral permanent deflection was 19 inches (480 mm).
