Report No. CDOT-DTD-R-2003-10

Final Report

MAILBOXES AND MOUNTING SYSTEMS

**COLORADO DEPARTMENT OF TRANSPORTATION
RESEARCH BRANCH**

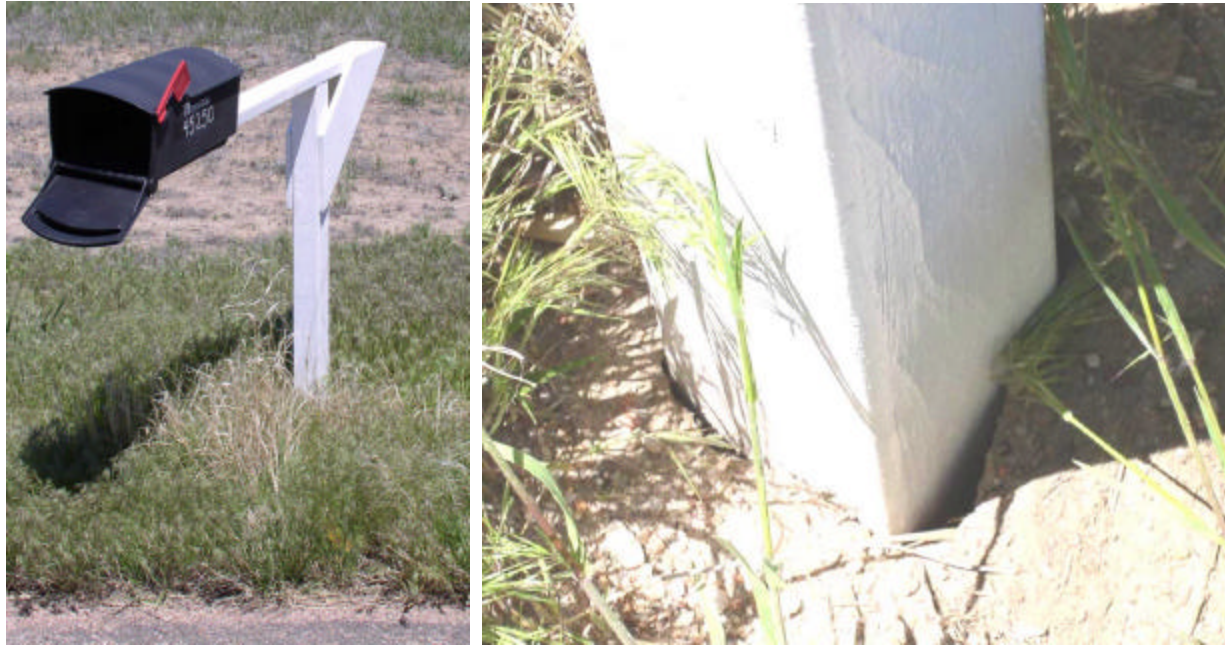
Wooden Mailbox Support system – An all-wood mount design with a 4” x 4” post and a cantilevered wood arm sets the post 4’ back from the front of the box. This is an inexpensive, easily constructed mailbox mount. However, it is a rigid system; it doesn’t absorb any of the energy from the plow blast. While there is no evidence of damage to the plastic box in **Figure 5**, the photo at the right shows that the force of the plow blasts over the winter has twisted the post in its hole, causing the mailbox to be turned slightly away from the highway.

Figure 5. The plastic box is good condition, but the twisted post shows the effects of being hit by the snow thrown by passing plows.

Plastic boxes, like the one in **Figure 5**, seem to be a better choice for rigid mounting systems. The box appears to be better able to withstand the pounding from the snowplow blasts. The fact that the plastic boxes are wider than the metal ones and have a slightly lower profile may help them resist the force of the blast better.
