A LS-DYNA Crash Simulation of the Annisquam River Bridge for Report 350 Test level three Conditions

August 27, 2007

The Massachusetts Highway Department (MHD) is re-designing the bridge railing for the Annisquam River Bridge in Gloucester, Massachusetts (i.e., Bridge No. G-05-017). MHD would like to use a version of the Minnesota Type Three Combination Bridge Railing which was successfully tested by the University of Nebraska for NCHRP Report 350 Test Level 4 conditions in 1996.^{1,2} This system is included in a list of FHWA accepted bridge railings in a memorandum dated May 30, 1997.³

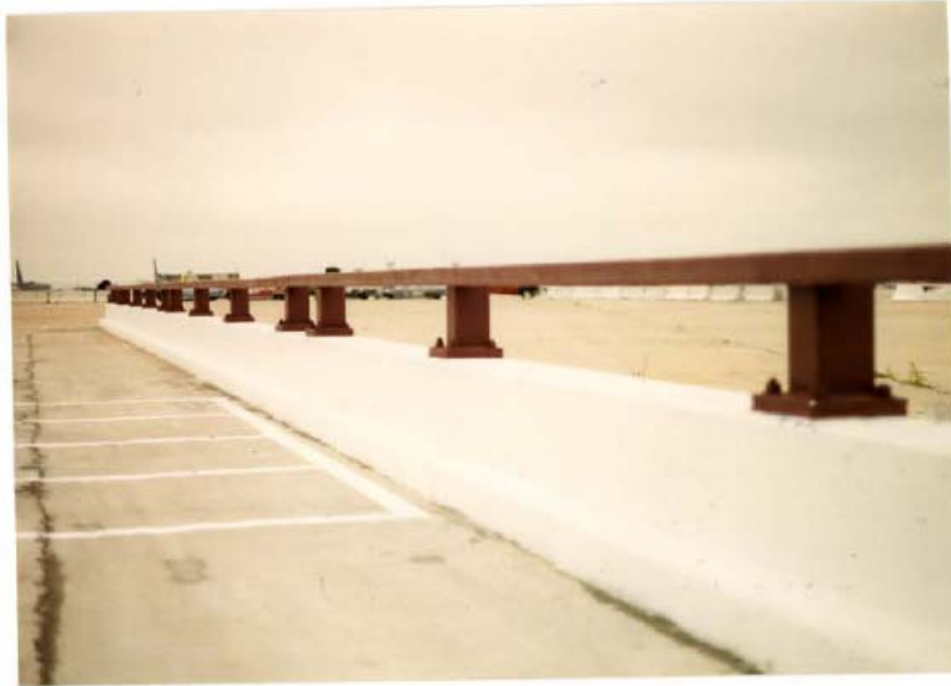
Figure 2 shows the actual bridge railing built for the crash test at MwRSF.

Figure 2. MwRSF test installation of the Minnesota Type Three Combination Bridge Railing.²

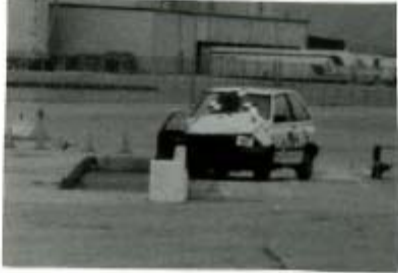
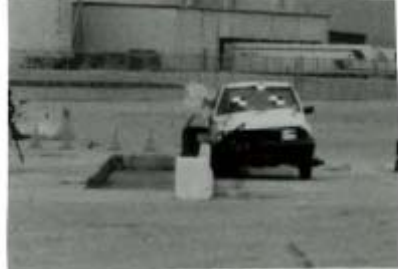
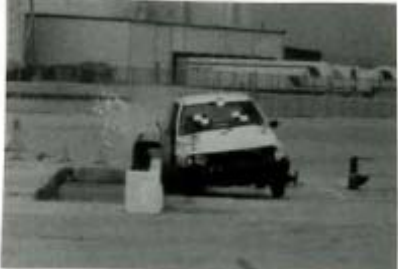
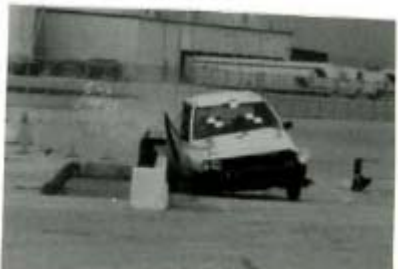
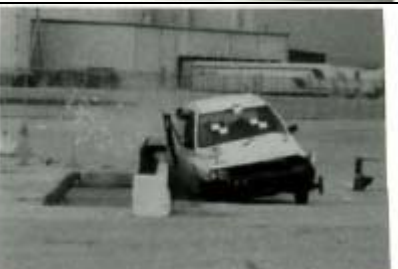
Figure 7. Downstream impact sequence of Report 350 test 4-10 for the original Configuration - full-scale test (left) and finite element simulation (right).

Upon the impact with the concrete parapet, the vehicle right-front corner crushed inward and the vehicle began to be redirected. The vehicle became parallel to the railing and was eventually redirected with an exit angle of 4.7 degrees compared to 7.5 degrees in the physical crash test. The overall behavior of both the crash test and the simulation are very similar as demonstrated by Figures 7 and 8. The only noticeable difference between the numerical simulation and the full-scale test is that the impact front tire in the test was ruptured causing the impact-side front corner to drop down somewhat whereas the tire did not rupture in the finite element simulation.

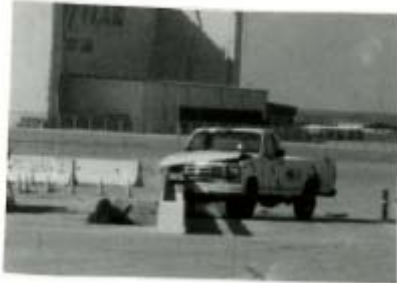
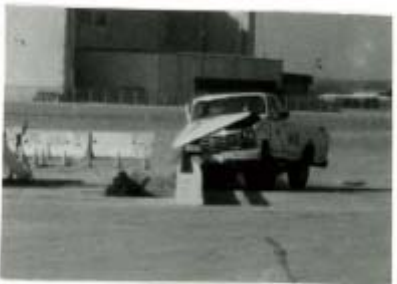
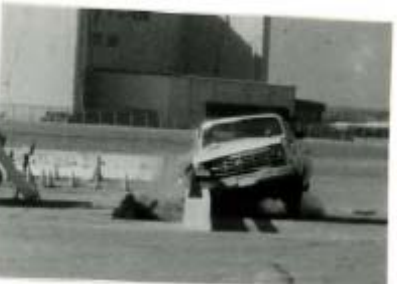
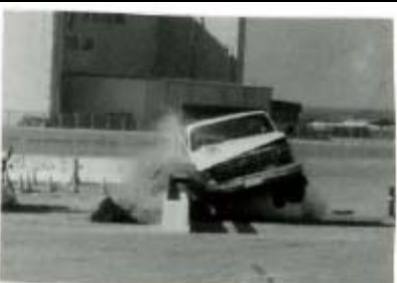
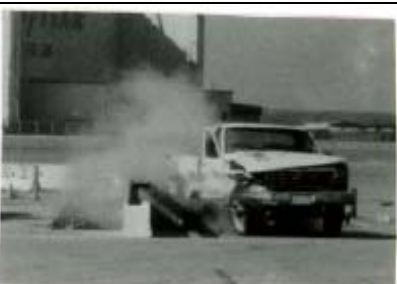
Figure 10. Downstream impact sequence of Report 350 test 4-11 of the original configuration - full-scale test (left) and finite element simulation (right).

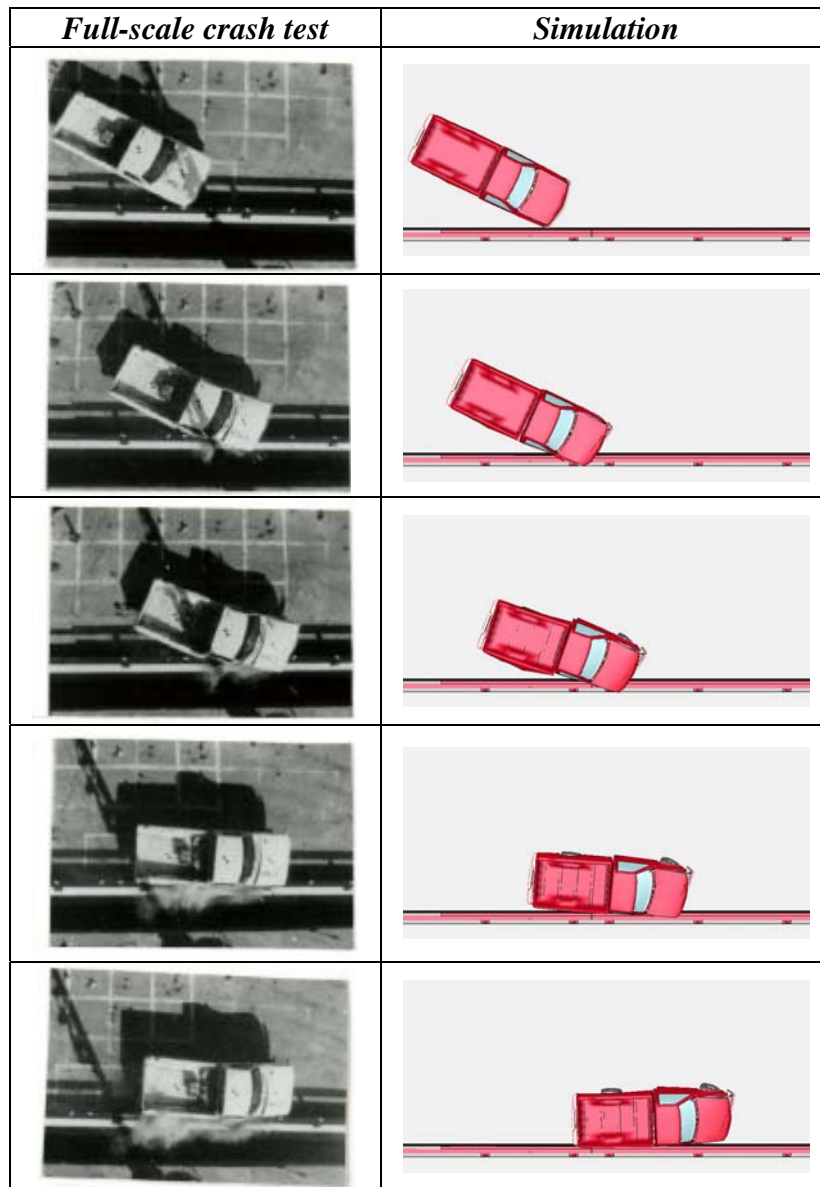
Figure 11. Overhead impact sequence of Report 350 test 4-11 of the original configuration - full-scale test (left) and finite element simulation (right).

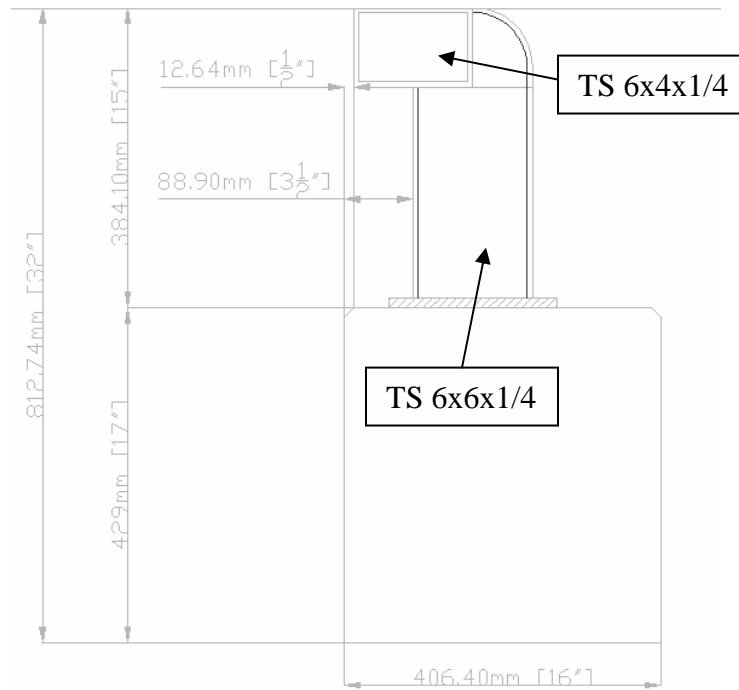
The modifications MHD would like to make to adapt the original Minnesota Type Three Combination Bridge Railing to the Annisquam River Bridge include lowering the rail height to 32 inches, making the traffic face of the railing vertical, changing the curb from 20 inches to 17 inches and eliminating the grout pad for the steel post base plate. Figure 13 shows the cross section of the modified bridge railing considering all these modifications.

Figure 13. Proposed Annisquam River Bridge railing (cross section).
