U.S. Department
of Transportation
**Federal Highway
Administration**

In your February 17 letter to Mr. Henry Rentz, you requested Federal Highway Administration's acceptance of the California Department of Transportation Type 70 Bridge Rail at the National Cooperative Highway Research Program (NCHRP) Report 350 test level 4 (TL-4). To support this request, you sent us a copy of your report: "Vehicle Crash Tests of the Type 70 Bridge Rail," dated January 1998, and a copy of a video tape documenting the certification tests that were conducted.

Our review of this material indicated that the Type 70 Bridge Rail is an 810-mm tall concrete barrier with its traffic face sloped at a constant 9.1 degrees away from traffic. This face geometry is identical to your Type 60 roadside/median barrier that was accepted for use on the National Highway System (NHS) at TL-3 in my February 4 letter to you. However, the Type 70 Bridge Rail has a vertical back face with some architectural treatment and is more heavily reinforced than the Type 60. Design details are shown in Enclosure 1.

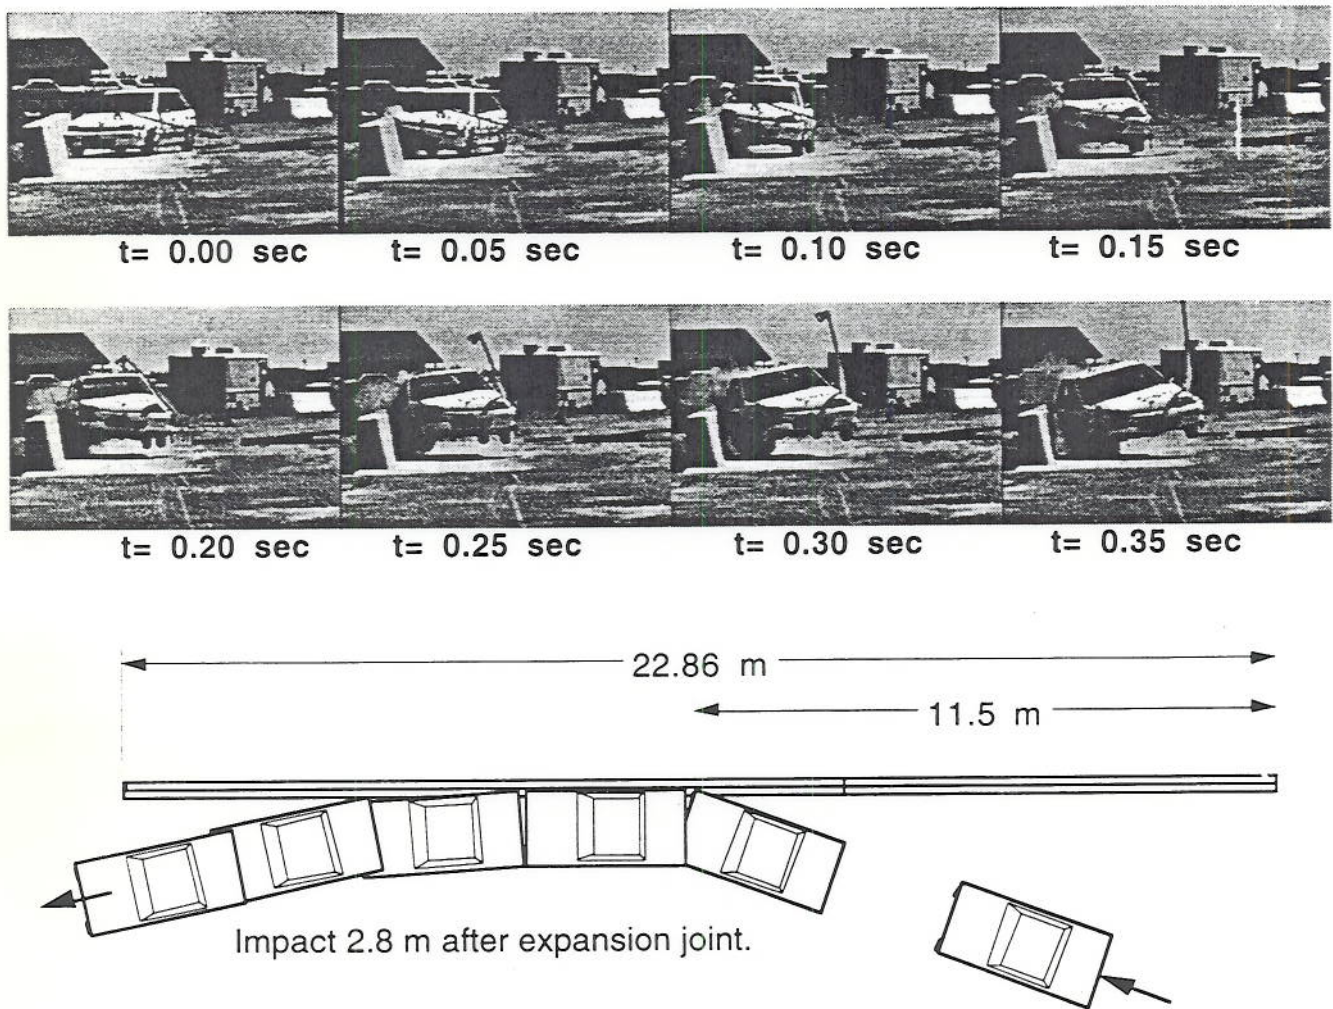
Figure 2.13 - Test 511 Data Summary Sheet

Test Barrier	
Type:	Type 70 Bridge Rail
Length:	22.9 m
Test Date:	May 6, 1997
Test Vehicle:	
Model:	1992 Geo Metro
Inertial Mass:	843 kg
Impact / Exit Velocity:	104.1 km/h / 92 km/h
Impact / Exit Angle:	20.0 / 12.1°
Test Dummy:	
Type:	Hybrid III
Weight / Restraint:	74.8 kg / lap and shoulder
Position:	Front Right
Test Data:	
Occ. Impact Velocity (Long / Lat):	4.51 m/s / 7.22 m/s
Ridedown Acceleration (Long / Lat):	-2.9g / -16.0g
Max. 50 ms Avg. Accel (Long / Lat):	-7.0g / -13.4g
Exterior: VDS ⁽⁷⁾ /CDC ⁽⁸⁾	FR-5, RD-4 / 12RFEW3
Interior: OCDI ⁽¹⁾	RF0000110
Barrier Damage:	Only superficial scuffing

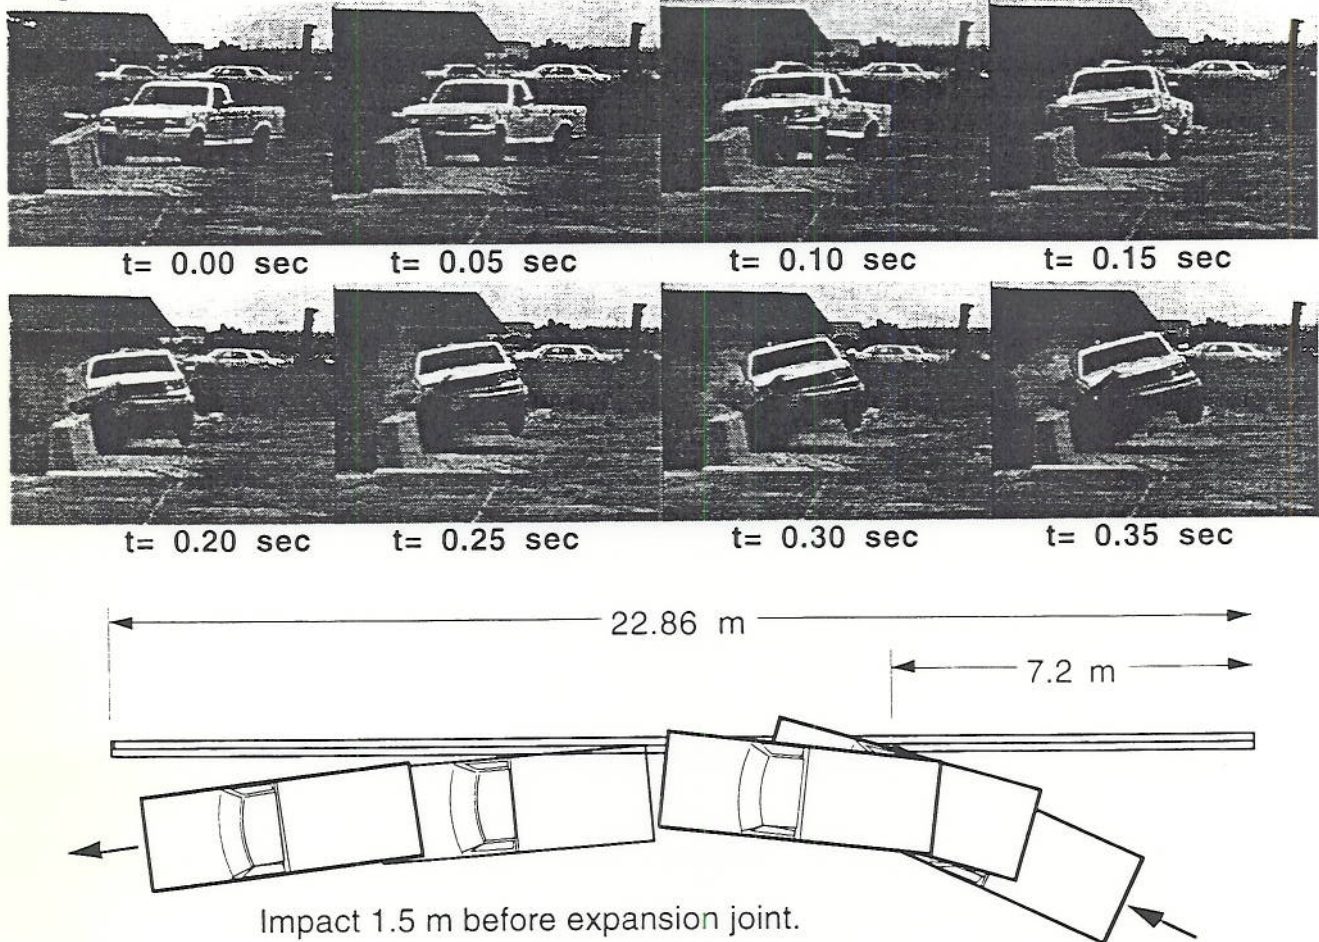
Figure 2.44 - Test 515 Data Summary Sheet

Type: Type 70 Bridge Rail
 Length: 22.9 m

Test Date: July 23, 1997

Model: 1991 Ford F250
 Inertial Mass: 2009
 Impact / Exit Velocity: 100.4 km/h / 54 km/h
 Impact / Exit Angle: 24.2° / 8°

Occ. Impact Velocity (Long / Lat): 5.46 m/s / 6.16 m/s
 Ridedown Acceleration (Long / Lat): -8.2g / -14.1g
 Max. 50 ms Avg. Accel (Long / Lat): -5.7g / -11.9g
 Exterior: VDS⁽²⁾/CDC⁽²⁾ FR-5, RD-5 / 01RFEW3
 Interior: OCDI⁽¹⁾ RF0001000

Damage consisted of only moderate scraping and tire scuffing over a length of four meters
