U.S. Department
of Transportation
**Federal Highway
Administration**

In your February 17 letter to Mr. Henry Rentz, you requested Federal Highway Administration's acceptance of the California Department of Transportation Type 70 Bridge Rail at the National Cooperative Highway Research Program (NCHRP) Report 350 test level 4 (TL-4). To support this request, you sent us a copy of your report: "Vehicle Crash Tests of the Type 70 Bridge Rail," dated January 1998, and a copy of a video tape documenting the certification tests that were conducted.

BRIDGE BARRIER TESTS A & B TYPE 732 CONCRETE BARRIER DETAILS

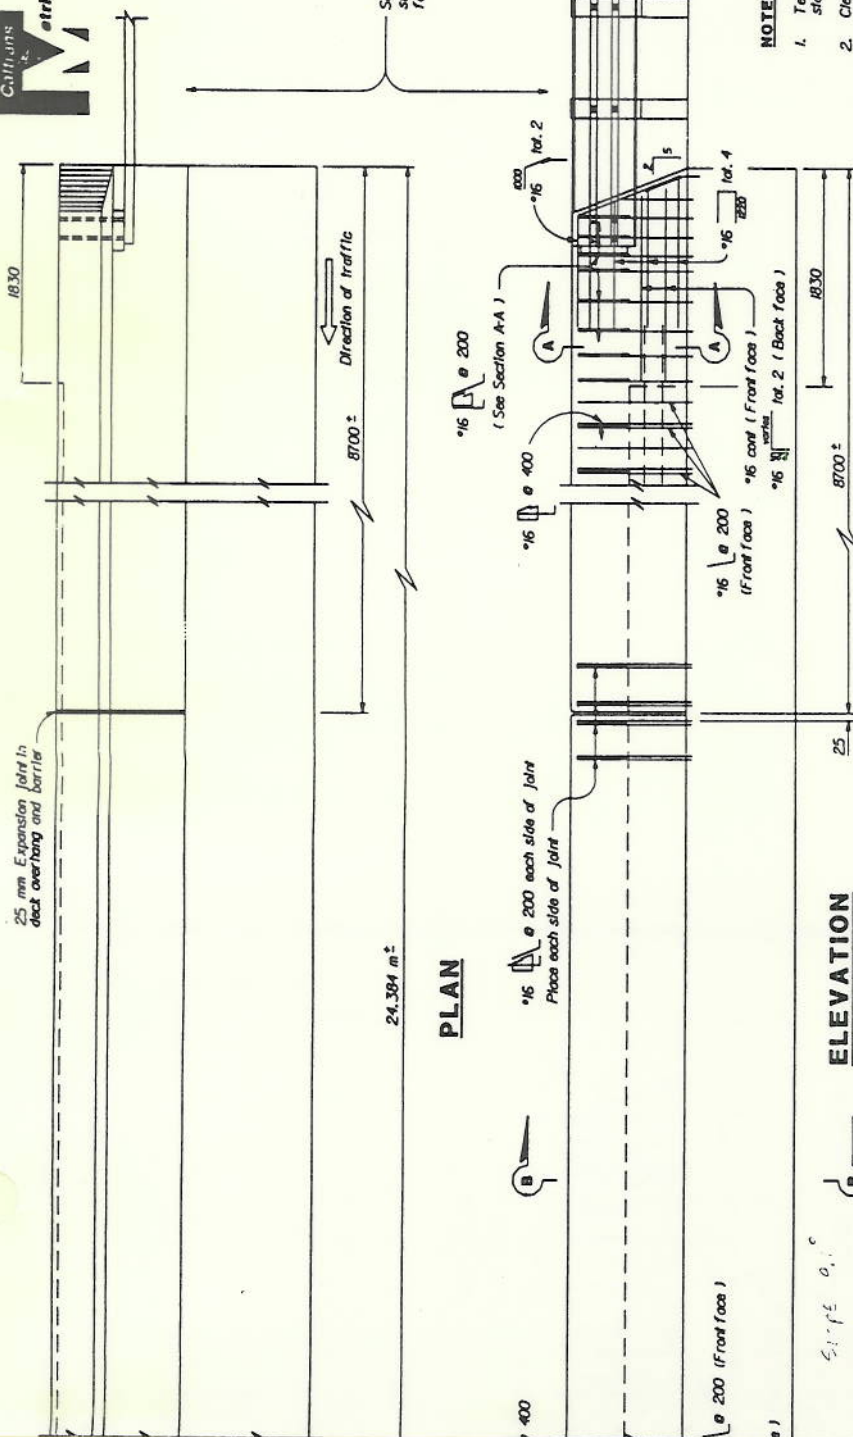
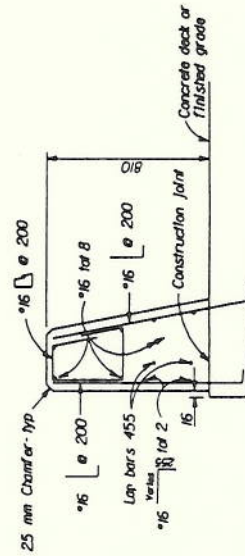
LOAD FACTOR DESIGN

Reinforced concrete $f_y = 413.68 \text{ MPa}$
 $f'_c = 22.408 \text{ MPa}$

1. *Terminate all longitudinal rail and deck reinforcement in standard 90° hooks.*
2. *Clearance to reinforcing steel in barrier shall be 25 mm and in deck shall be 51 mm.*

Our review of this material indicated that the Type 70 Bridge Rail is an 810-mm tall concrete barrier with its traffic face sloped at a constant 9.1 degrees away from traffic. This face geometry is identical to your Type 60 roadside/median barrier that was accepted for use on the National Highway System (NHS) at TL-3 in my February 4 letter to you. However, the Type 70 Bridge Rail has a vertical back face with some architectural treatment and is more heavily reinforced than the Type 60. Design details are shown in Enclosure 1.
