U.S. Department
of Transportation
**Federal Highway
Administration**

In your February 17 letter to Mr. Henry Rentz, you requested Federal Highway Administration's acceptance of the California Department of Transportation Type 70 Bridge Rail at the National Cooperative Highway Research Program (NCHRP) Report 350 test level 4 (TL-4). To support this request, you sent us a copy of your report: "Vehicle Crash Tests of the Type 70 Bridge Rail," dated January 1998, and a copy of a video tape documenting the certification tests that were conducted.

Our review of this material indicated that the Type 70 Bridge Rail is an 810-mm tall concrete barrier with its traffic face sloped at a constant 9.1 degrees away from traffic. This face geometry is identical to your Type 60 roadside/median barrier that was accepted for use on the National Highway System (NHS) at TL-3 in my February 4 letter to you. However, the Type 70 Bridge Rail has a vertical back face with some architectural treatment and is more heavily reinforced than the Type 60. Design details are shown in Enclosure 1.

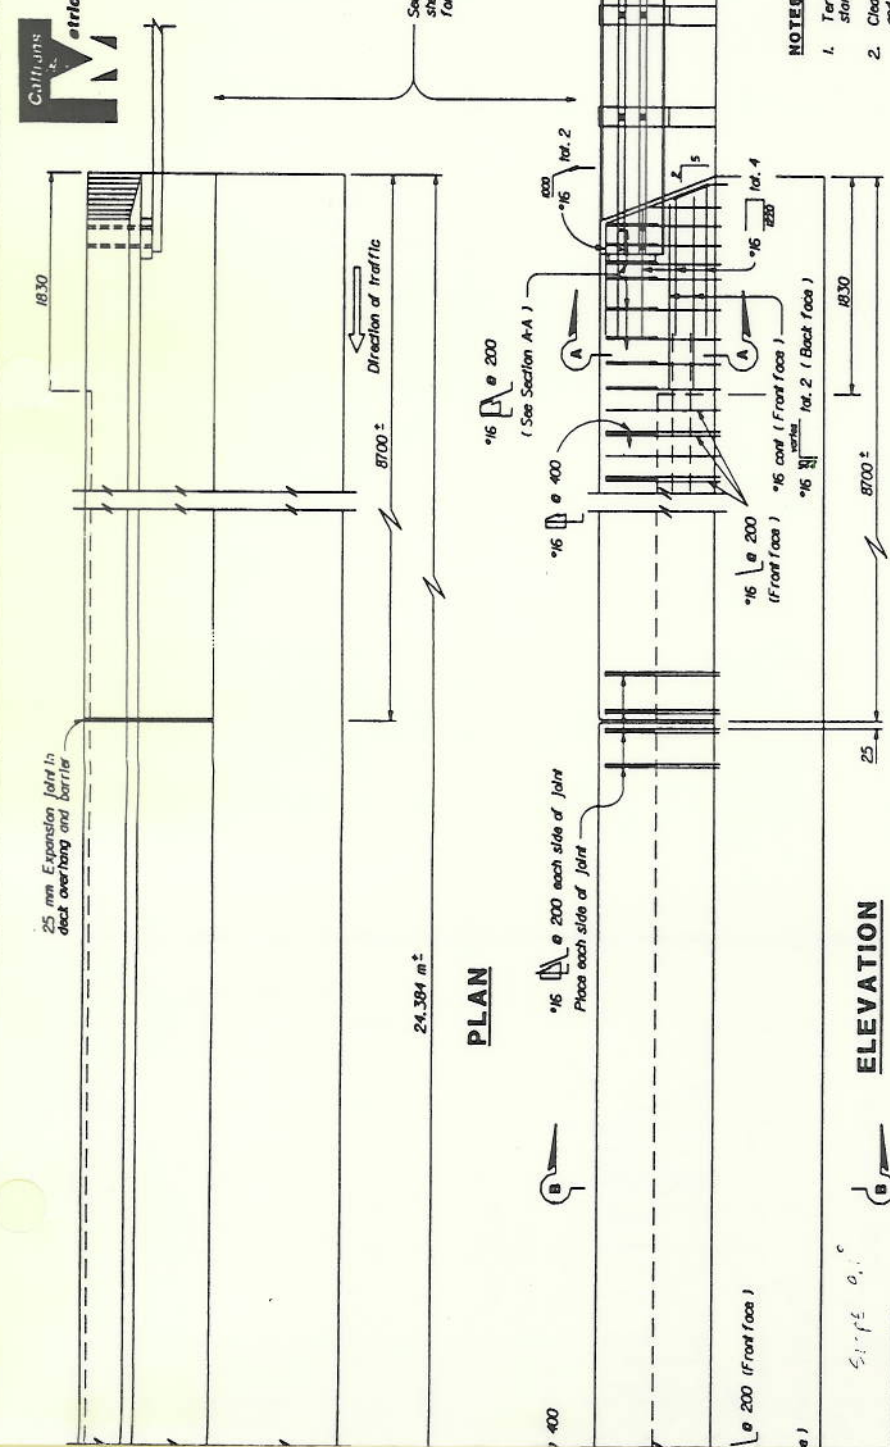
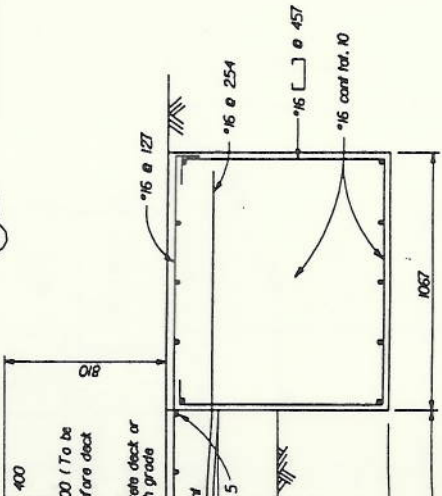
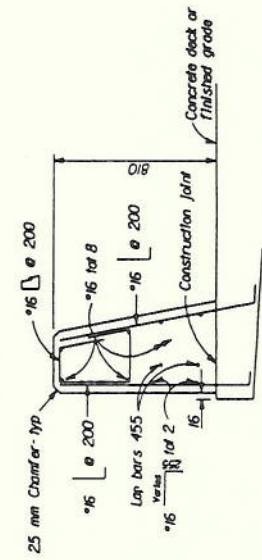
TYPICAL SECTION

Reinforced concrete $f_y = 413.69 \text{ MPa}$
 $f_c = 22.408 \text{ MPa}$

1. Terminate all longitudinal rail and deck reinforcement in standard 90° hooks.
2. Clearance to reinforcing steel in barrier shall be 25 mm and in deck shall be 51 mm.

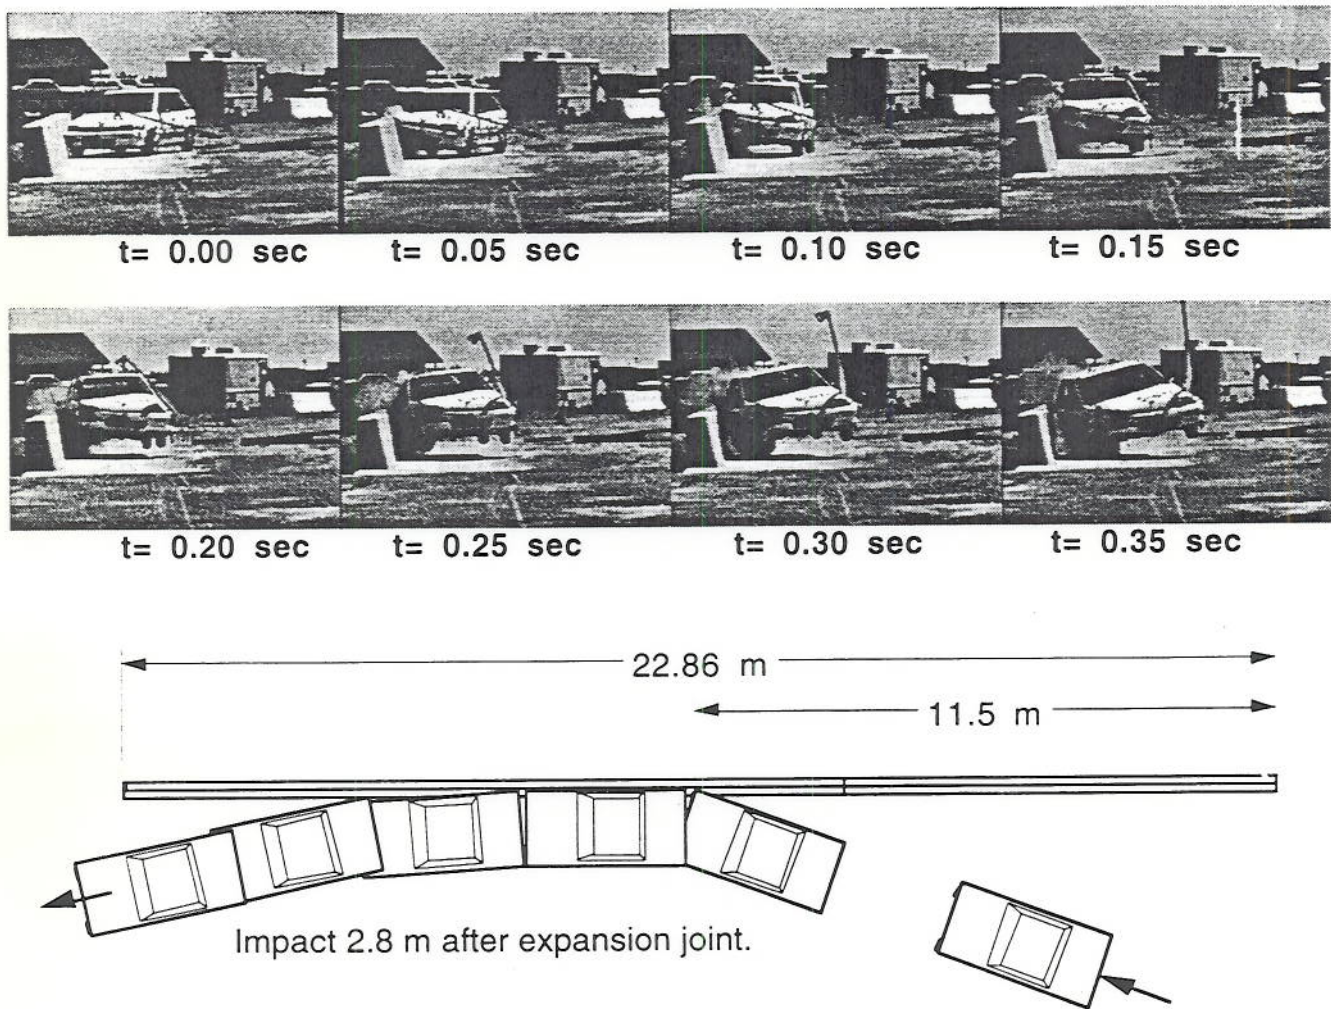
Figure 2.13 - Test 511 Data Summary Sheet

Test Barrier	
Type:	Type 70 Bridge Rail
Length:	22.9 m
Test Date:	May 6, 1997
Test Vehicle:	
Model:	1992 Geo Metro
Inertial Mass:	843 kg
Impact / Exit Velocity:	104.1 km/h / 92 km/h
Impact / Exit Angle:	20.0 / 12.1°
Test Dummy:	
Type:	Hybrid III
Weight / Restraint:	74.8 kg / lap and shoulder
Position:	Front Right
Test Data:	
Occ. Impact Velocity (Long / Lat):	4.51 m/s / 7.22 m/s
Ridedown Acceleration (Long / Lat):	-2.9g / -16.0g
Max. 50 ms Avg. Accel (Long / Lat):	-7.0g / -13.4g
Exterior: VDS ⁽⁷⁾ /CDC ⁽⁸⁾	FR-5, RD-4 / 12RFEW3
Interior: OCDI ⁽¹⁾	RF0000110
Barrier Damage:	Only superficial scuffing

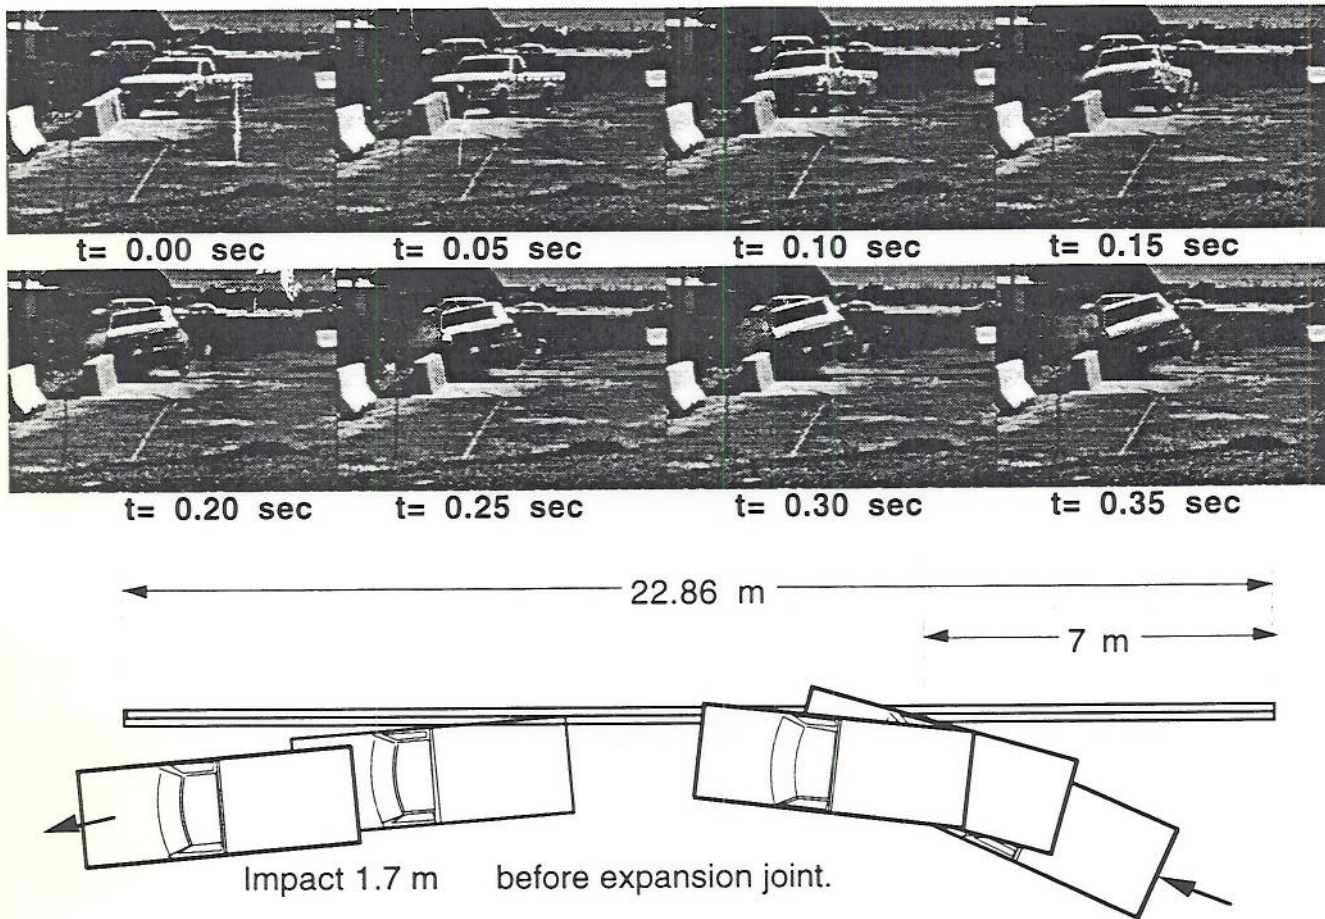
Figure 2.22 - Test 512 Data Summary Sheet

Type: Type 70 Bridge Rail
Length: 22.9 m

Test Date: June 11, 1997

Model: 1991 Ford F250
Inertial Mass: 2018 kg
Impact / Exit Velocity: 97.0 km/h / 65 km/h
Impact / Exit Angle: 25.1° / 5°

Occ. Impact Velocity (Long / Lat): 6.07 m/s / 8.2 m/s
Ridedown Acceleration (Long / Lat): -6.9g / -6.7g
Max. 50 ms Avg. Accel (Long / Lat): -7.1g / -14.6g
Exterior: VDS⁽²⁾/CDC⁽⁸⁾ FR-5, RD-5/ 01RFEW3
Interior: OCD⁽¹⁾ RF0150013

The barrier sustained a 200 mm long gouge just upstream from the impact area. The gouge was 20 to 100 mm wide and 0 to 20 mm deep.

We noted that three tests were reported, including test 4-12 with an 8000 kg single-unit truck impacting the barrier at an angle of 15 degrees and a speed of 80 km/h. Each of these tests met appropriate NCHRP Report 350 evaluation criteria. The individual test results are summarized in Enclosure 2. We noted also that test 4-11 was re-run after a first unsuccessful attempt in which the pickup truck rolled over after impact. You theorized that the non-standard floating rear hub of the test vehicle caused the drive shaft to pull out of the transmission housing on impact and that the shaft then dug into the test track and precipitated the rollover. This test was then re-run with a pickup truck with a standard wheel hub. Considering the successful retest and the earlier pickup truck tests with your Type 60 constant slope barrier as well as successful pickup tests with the New Jersey, F-profile, and the Texas Department of Transportation constant slope barrier, we are willing to consider test 512 (NCHRP Report 350 test 4-11) as an anomaly.

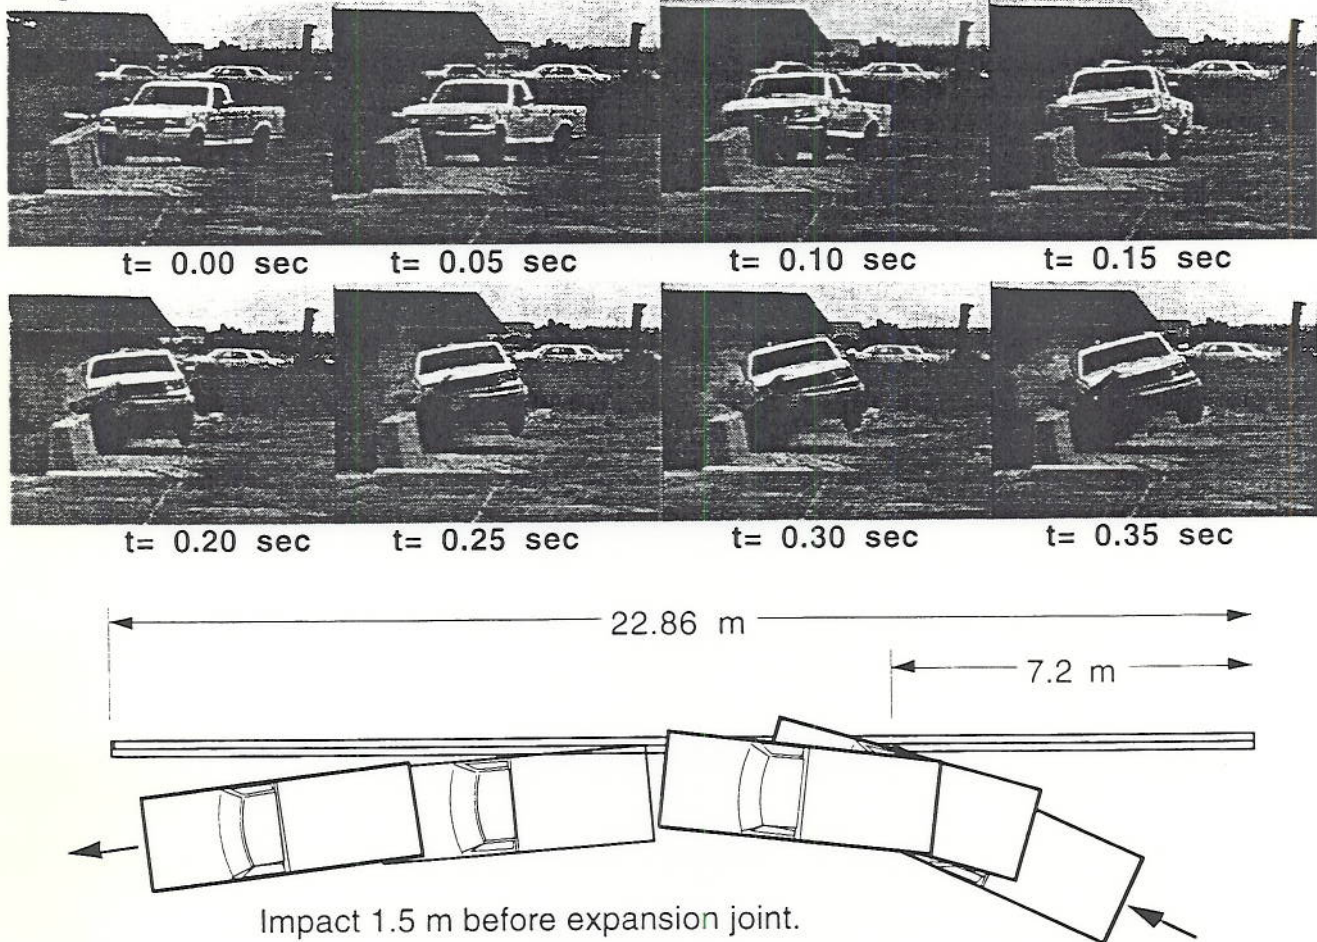
Figure 2.44 - Test 515 Data Summary Sheet

Type: Type 70 Bridge Rail
Length: 22.9 m

Test Date: July 23, 1997

Model: 1991 Ford F250
Inertial Mass: 2009
Impact / Exit Velocity: 100.4 km/h / 54 km/h
Impact / Exit Angle: 24.2° / 8°

Occ. Impact Velocity (Long / Lat): 5.46 m/s / 6.16 m/s
Ridedown Acceleration (Long / Lat): -8.2g / -14.1g
Max. 50 ms Avg. Accel (Long / Lat): -5.7g / -11.9g
Exterior: VDS⁽²⁾/CDC⁽⁸⁾ FR-5, RD-5 / 01RFEW3
Interior: OCDI⁽¹⁾ RF0001000

Damage consisted of only moderate scraping and tire scuffing over a length of four meters

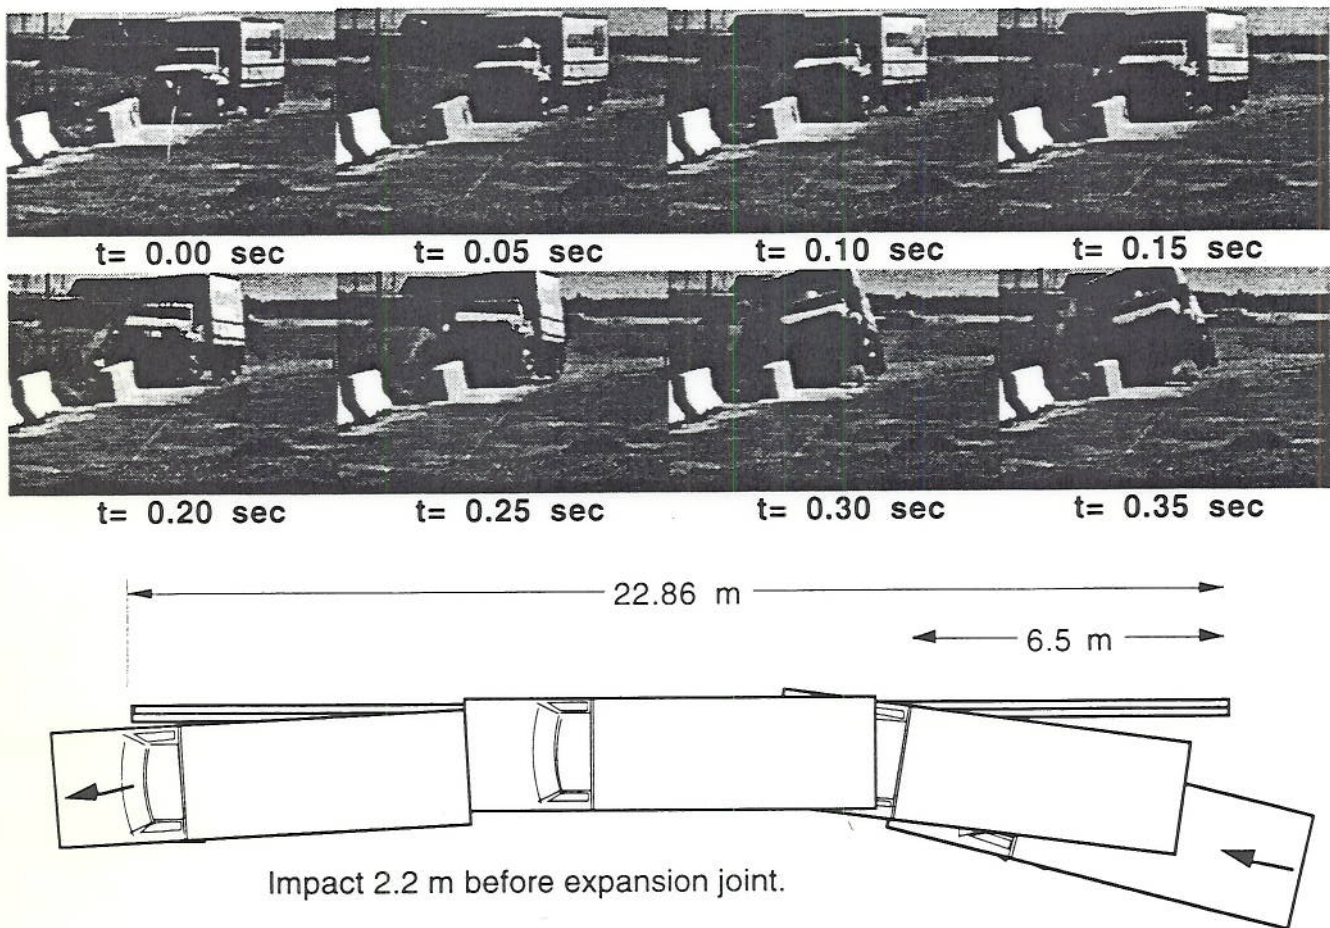
Figure 2.34 - Test 513 Data Summary Sheet

Type: Type 70 Bridge Rail
Length: 22.9 m

Test Date: September 3, 1997

Model: 1992 GMC Topkick
Inertial Mass: 8010 kg
Impact / Exit Velocity: 83.5 km/h / 71 km/h
Impact / Exit Angle: 15.0 / 4°

Occ. Impact Velocity (Long / Lat): not measured
Ridedown Acceleration (Long / Lat): not measured
Max. 50 ms Avg. Accel (Long / Lat): not measured
Interior: OCDI⁽¹⁾ RF0000000

The barrier was scraped during the time of vehicle contact. Damage was mainly limited to minor spalling.
