**DEVELOPMENT AND CRASH TESTING OF AN AESTHETIC,
SEE-THROUGH BRIDGE RAIL, TYPE 90**

DEPARTMENT OF TRANSPORTATION
DIVISION OF RESEARCH AND INNOVATION
OFFICE OF SAFETY INNOVATION AND COOPERATIVE RESEARCH

November, 2008

1. REPORT NO. FHWA/CA08-0766	2. GOVERNMENT ACCESSION NO.	3. RECIPIENT'S CATALOG NO.	
4. TITLE AND SUBTITLE DEVELOPMENT AND CRASH TESTING OF AN AESTHETIC, SEE-THROUGH BRIDGE RAIL, TYPE 90		5. REPORT DATE November 2008

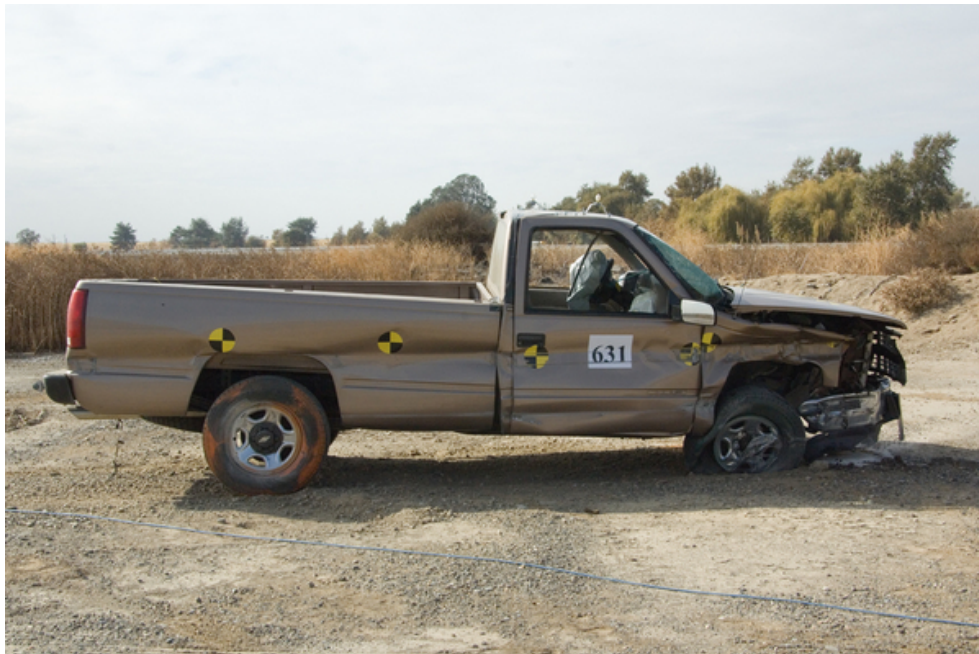
Figure 2-7 – Test vehicle after Test 631

The right front corner of the vehicle was moderately damaged in the initial impact with the barrier. The right front fender, hood, bumper, headlamp area, grille, and suspension components were all affected. The passenger side doorframe was deformed outward but the door remained latched. The right front tire was also ruptured. The steel rail caused denting along the entire length of the passenger side as the vehicle continued to contact the barrier after the initial impact. The right front tire was pushed rearward and slightly into the passenger side foot well area. The maximum amount of passenger compartment deformation was 124 mm¹, which occurred in the floorboard². The entire windshield spider-cracked but did not separate or enter the occupant compartment. However, this cracking was not caused entirely by the test. The windshield was inadvertently damaged (see Figure 2-10) on the impact side shortly before the test was run and it was decided that the damage was not significant enough to warrant postponing the test. Post-crash photos show the initial crack to be the weak point and the source of future cracking.

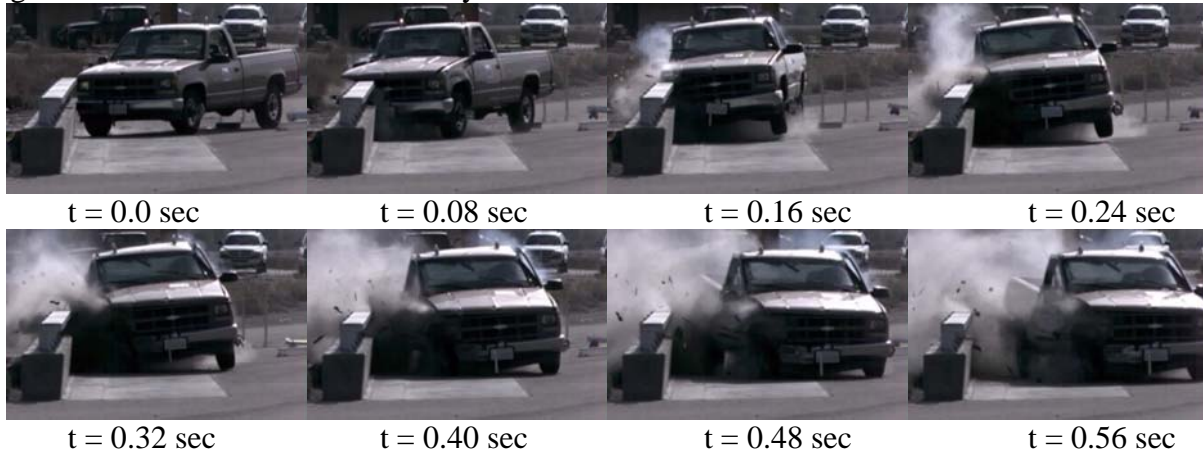
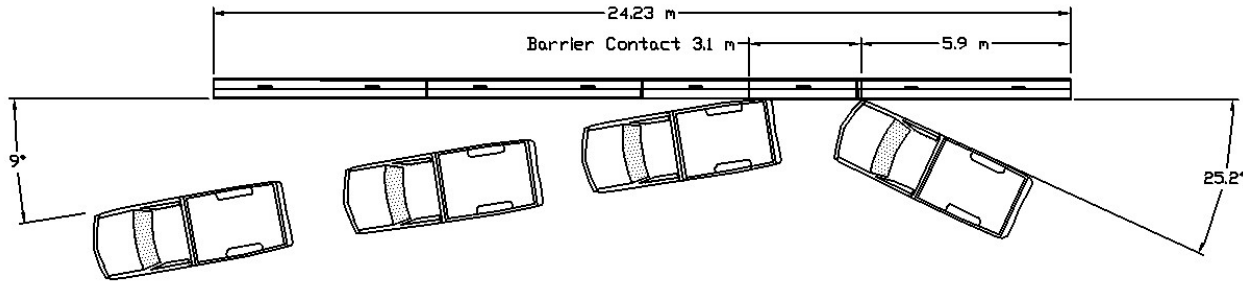
Figure 2-14 – Test 631 Data Summary Sheet

Barrier Damage: Maximum dynamic deflection in steel rail of 38 mm, superficial concrete spalling, and no permanent lateral deflection.

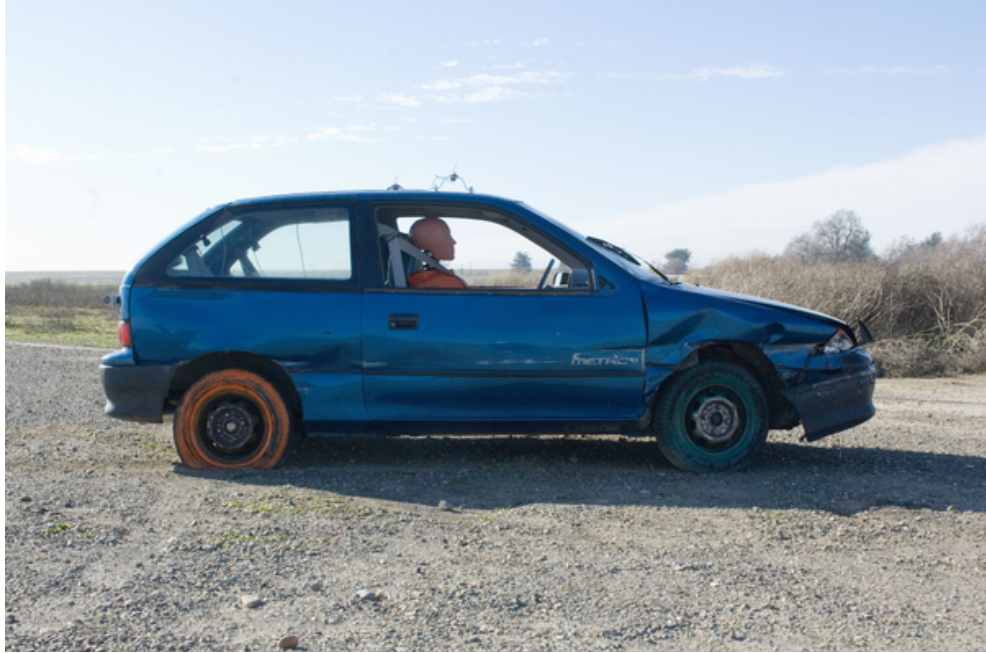
Figure 2-19 – Right side of test vehicle after Test 632

The right front corner of the vehicle was moderately damaged. The right front bumper and right fender were pushed rearward. The right front tire and wheel assembly were pushed rearward about 146 mm into wheel well, deforming it. The entire right side of the vehicle was moderately damaged. There was no significant passenger compartment or floorboard deformation. The passenger-side mirror was broken off.

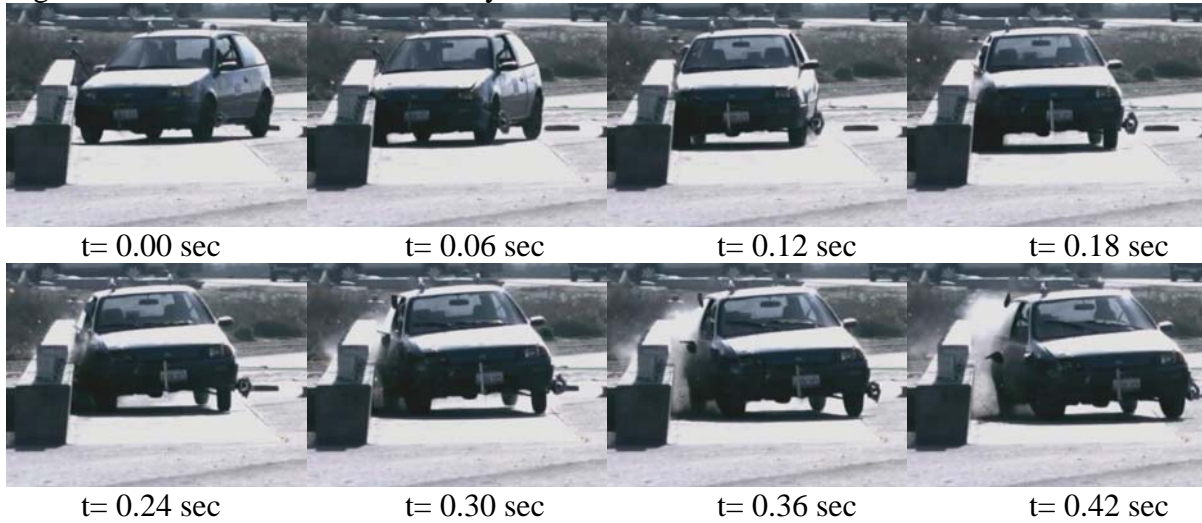
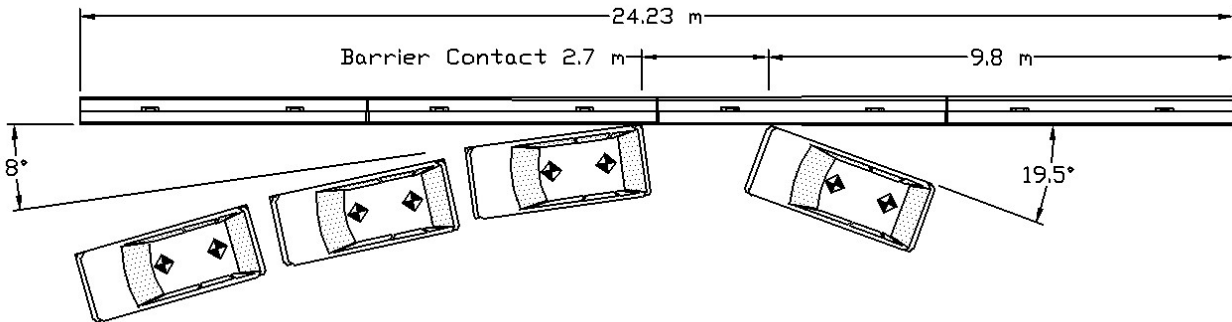
Figure 2-22 – Test 632 Data Summary Sheet

Barrier Damage: No dynamic deflection in steel rail, minor superficial concrete spalling.

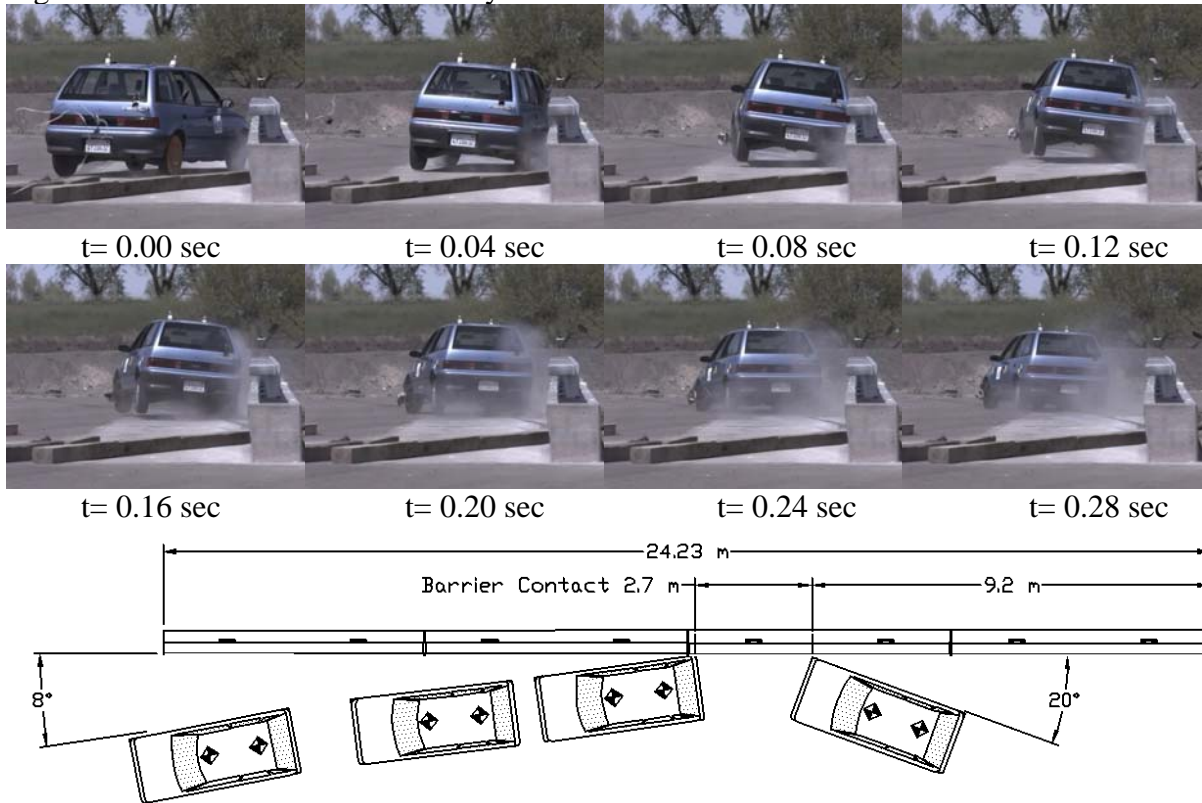
Figure 2-30 – Test 633 Data Summary Sheet

Barrier Damage: No dynamic deflection in steel rail, minor superficial concrete spalling.

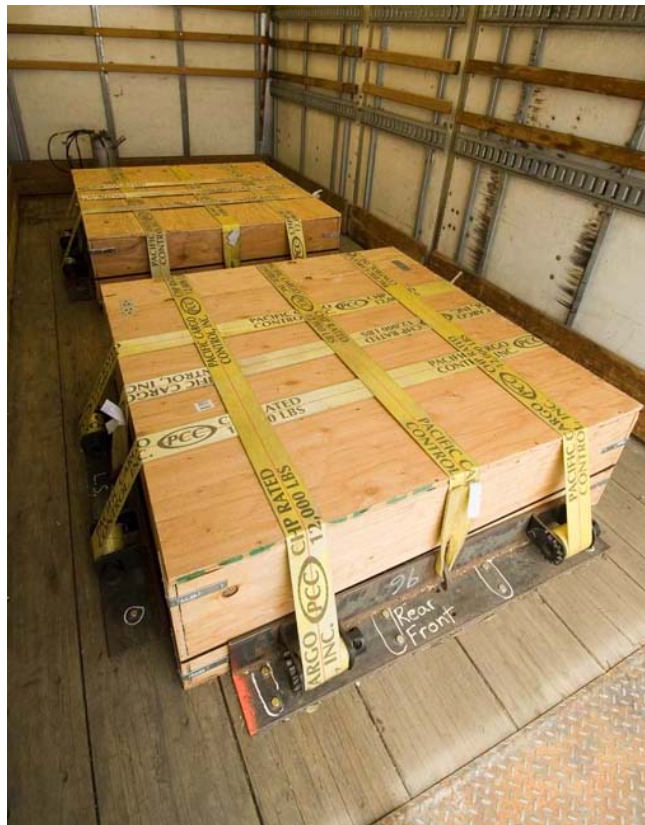
Figure 2-38 – Ballast strapped down in cargo bed of test vehicle after Test 634

The 2041 kg of ballast was comprised of two separate plywood boxes and the associated mounting hardware all bolted and strapped down to the cargo floor. The boxes were constrained by 150-mm angle iron. The sandbags were held down by 100-mm nylon straps as shown in Figure 2-38. The sandbags shifted slightly, but did not brake lose during the test.
