Subject: INFORMATION: In-service Performance Evaluation and Continuous  
Monitoring of Roadside Safety Features

## SCI GM ATTENUATOR IN-SERVICE EVALUATION REPORT

## SCI\_GM ATTENUATOR IMPACT HISTORY

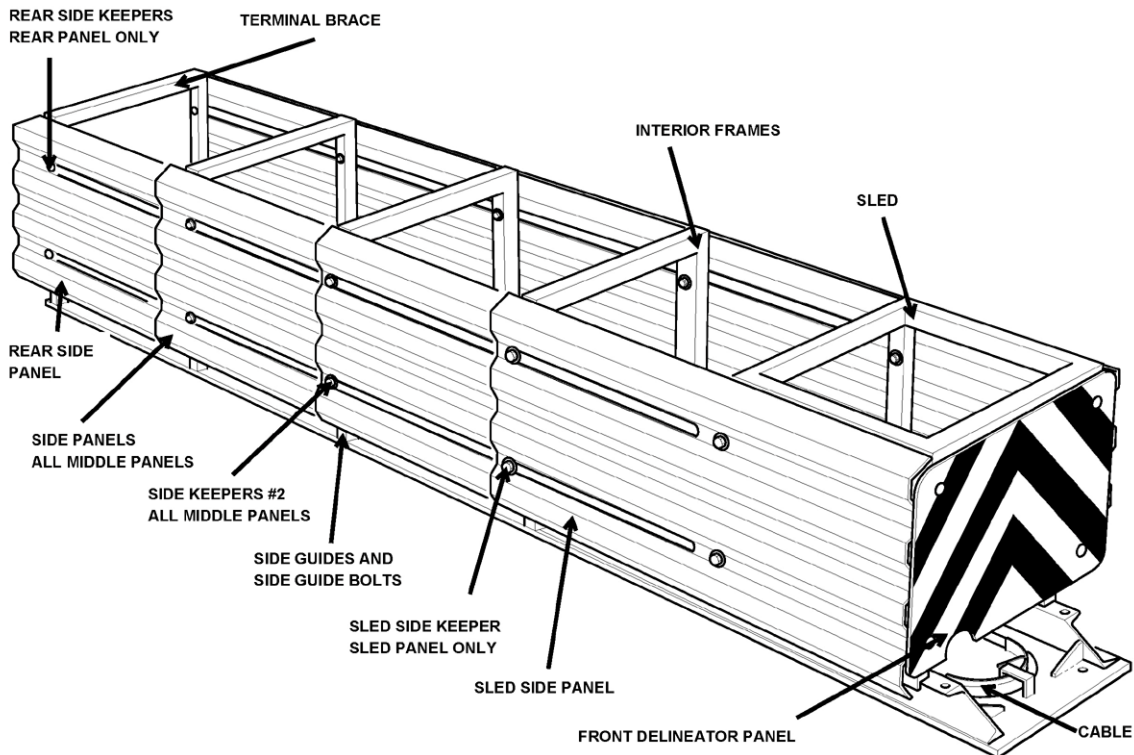
To describe our unit, we would like to start by explaining how the SCI\_GM functions. We have included an isometric layout above. Our stopping forces are a combination of three different mechanical forces. The first force is the transferal of the energy needed to accelerate our parts. The sled, side panels, etc. have to be brought up to speed with the vehicle and this causes a reduction in speed of the vehicle. This represents around

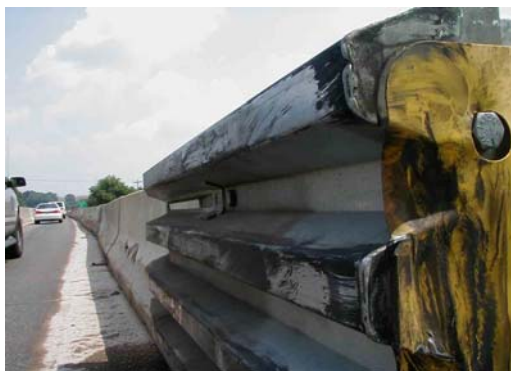
**Repairs on side impacts** are rare as we are not getting reports of side impacts unless they are very extreme, even though we know they occur often. The SCI\_GM panel's

profile pushes on our support frames in a straight line and the steel is rated at 60,000 psi. Our panel and transition fabrication costs are a little higher due to the difficulty in working with this hard material, but the results are worth it. Service crews are seeing tire marks on the side of the attenuators but our side panel's profile and our support structures are so strong that side impacts go unreported. We have had a couple of units' side panels ripped open by Tractor/trailers but they had wide loads and actually were raking
