**VEHICLE CRASH TESTS OF THE
AESTHETIC, SEE-THROUGH CONCRETE
BRIDGE RAIL WITH SIDEWALK, TYPE 80SW**

STATE OF CALIFORNIA
DEPARTMENT OF TRANSPORTATION
ENGINEERING SERVICE CENTER,
OFFICE OF MATERIALS ENGINEERING AND TESTING SERVICES

1. REPORT NO.	2. GOVERNMENT ACCESSION NO.	3. RECIPIENT'S CATALOG NO.	
4. TITLE AND SUBTITLE VEHICLE CRASH TESTS OF THE AESTHETIC, SEE-THROUGH CONCRETE BRIDGE RAIL WITH SIDEWALK, TYPE 80 SW		5. REPORT DATE August 1998, revised 8/99

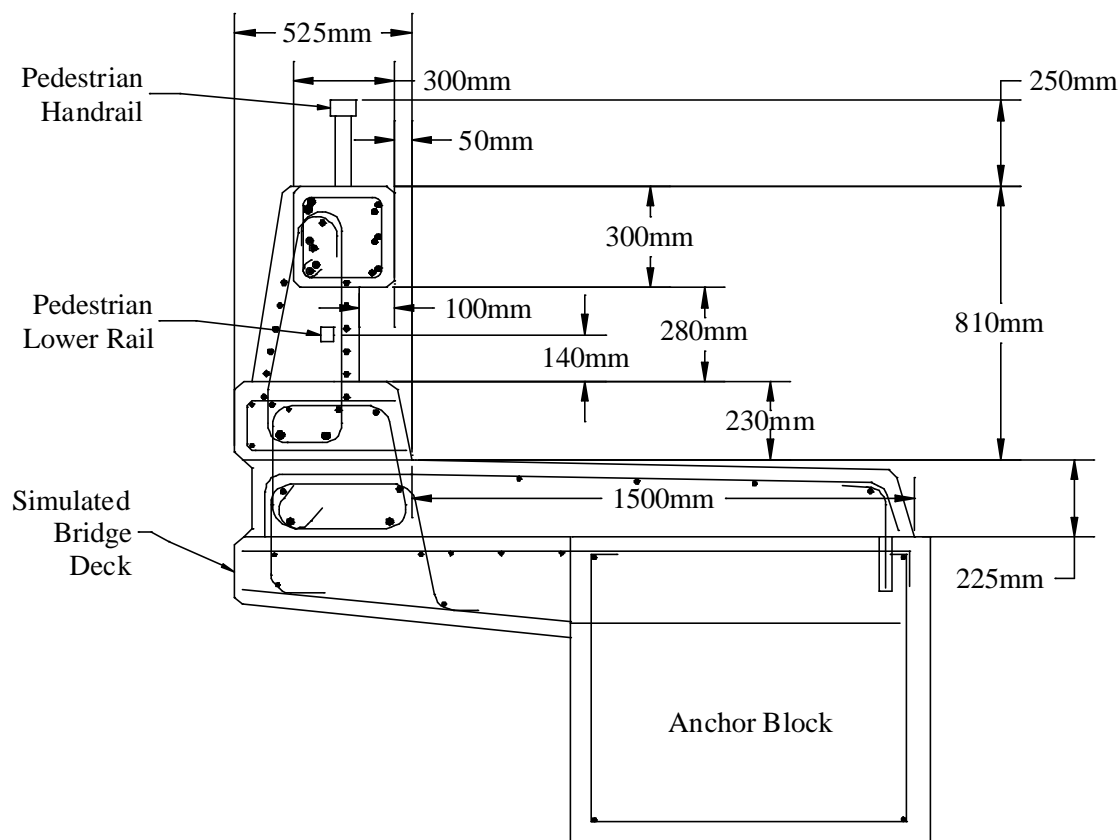
Figure 2-1 - Type 80SW

The design configuration for the Type 80SW includes viewing spaces 310 mm high by 1620 mm long, chosen to meet structural and safety requirements. A structural cross-section is shown in Figure 2-1. The space height was later reduced to 280 mm due to evidence of potential wheel snagging from Test 541. The reinforcing steel is covered with a minimum of 25 mm of concrete and all longitudinal reinforcing is terminated in 90 degree hooks. The 810 mm-high design was used in the tests as the shortest configuration to be placed in service. This provided a more conservative test configuration for the evaluation. Additional as-built drawings for the Type 80SW can be found in Appendix 7.5. Caltrans, Office of Structures Design should be contacted to obtain the most current and complete plans for future construction projects.

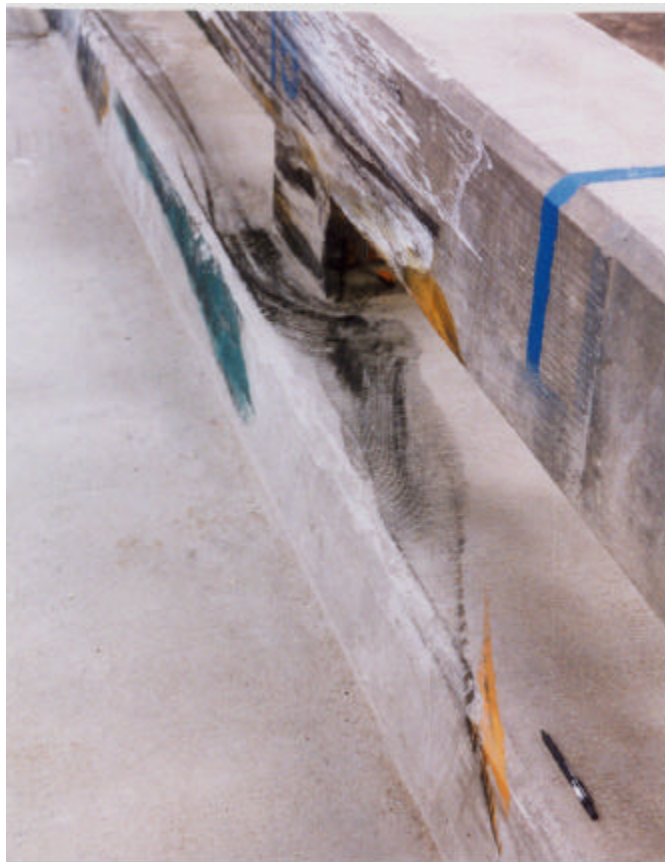
Figure 2-27 - Test 541 Data Summary Sheet

The right front section of the vehicle sustained crushing of the bumper and minor unibody frame deformation, damage to the suspension and a flat tire. Initial right front wheel damage occurred on impact with the sidewalk 0.38 m from the beginning of the bridge rail installation. The sidewalk contact caused deformation of the wheel and tire deflation. Other tires experienced minor deformation on impact with the sidewalk but remained inflated. After contacting the bridge rail the right front wheel was pushed back, forcing the wheel well area to deform (Figure 2-21).

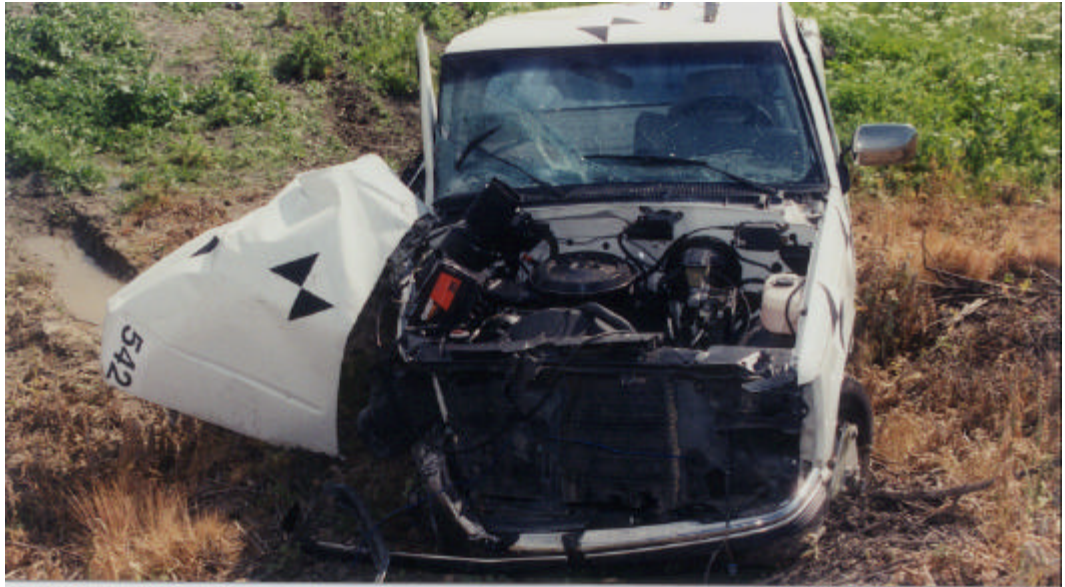
Figure 2-34 -
Final Position
Of Test
Vehicle 542

The vehicle stayed in contact with the rail for approximately 6.5 m. The exit angle and speed were 7° and 77 km/h respectively. The vehicle remained upright throughout and after the collision. Brakes were applied 0.75 s after initial contact with the rail and the stopping point for the vehicle was approximately 34 m from the point of last contact with the barrier. Figure 2-34 shows the vehicle in its final resting position.

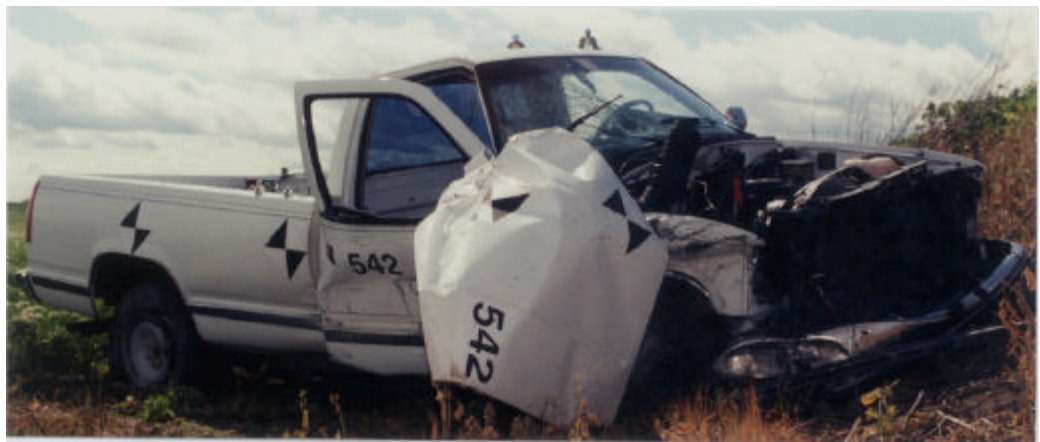
Figure 2-36 -
Close-up of
Impacting
Corner Of
Tested
Vehicle 542

The extra speed of the vehicle, 10.2 km/h over target, undoubtedly contributed to higher deformation of the impacting right corner of the vehicle than would have otherwise occurred. Figure 2-36 shows the right front wheel pushed back into the wheel well, caused by impact with the rail curb and beam face. All of the wheels stayed connected to the vehicle throughout the test. The front right shock absorber, stabilizer bar and upper and lower control arms were bent but still attached. The rear and left front suspension components were intact and appeared undamaged. There was minor deformation of the right front frame.

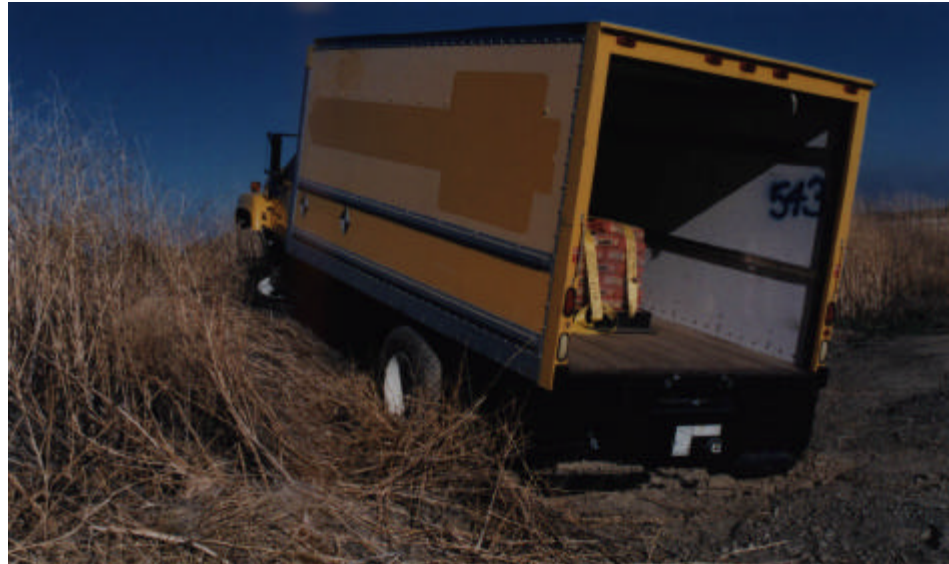
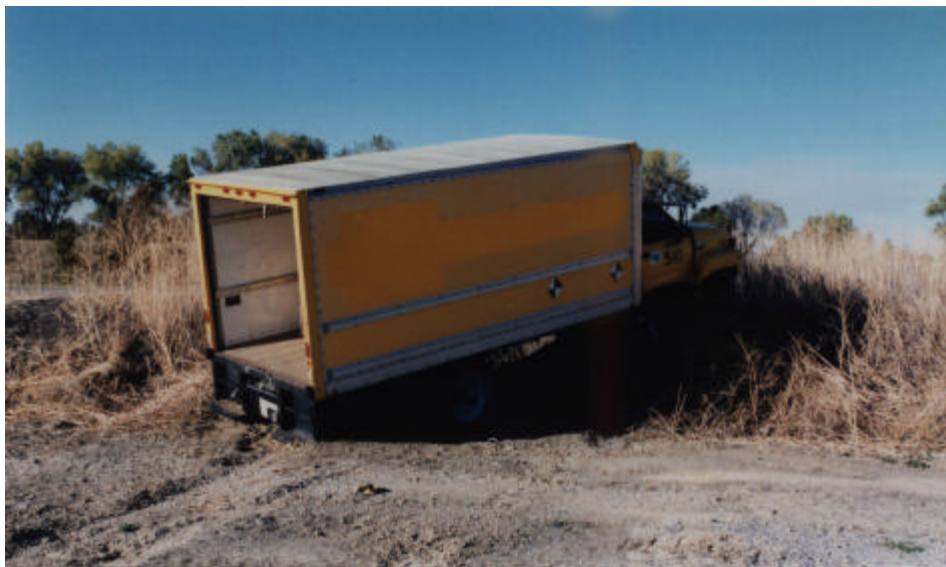
Figure 2-50 -
Vehicle 543
after Impact

Also damaged were the battery box, fuel tank and right front quarter panel. The battery box sustained substantial crushing. The fuel tank was deflected about 0.5m and dented in about 0.15 m, but was not penetrated. Damage to the right front quarter panel occurred on contact with rail face and handrail. There was no visible damage to the cargo box or frame beyond minor scuffing. Both doors, the hood and rear rolling door functioned properly with no visible occupant compartment deformation.

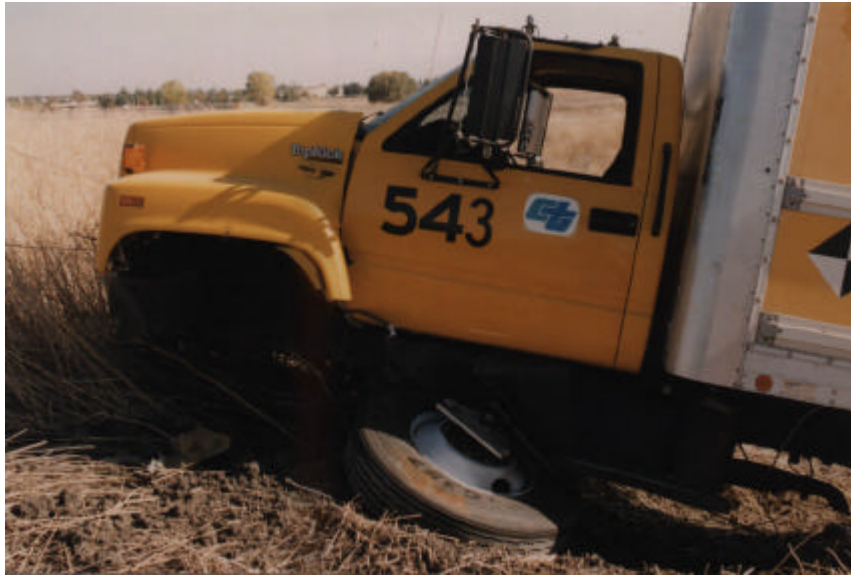
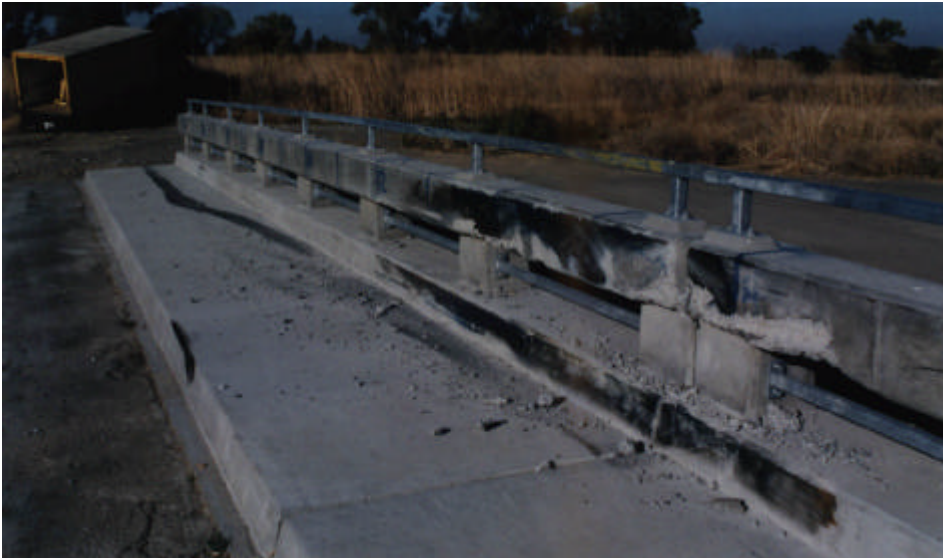
Figure 2-53 -
Bridge Rail and
Vehicle After
Test 543

The barrier was scraped along the face and edges over a 3 m length. There was also spalling on the underside of the beam and at the expansion joint with no structural damage.

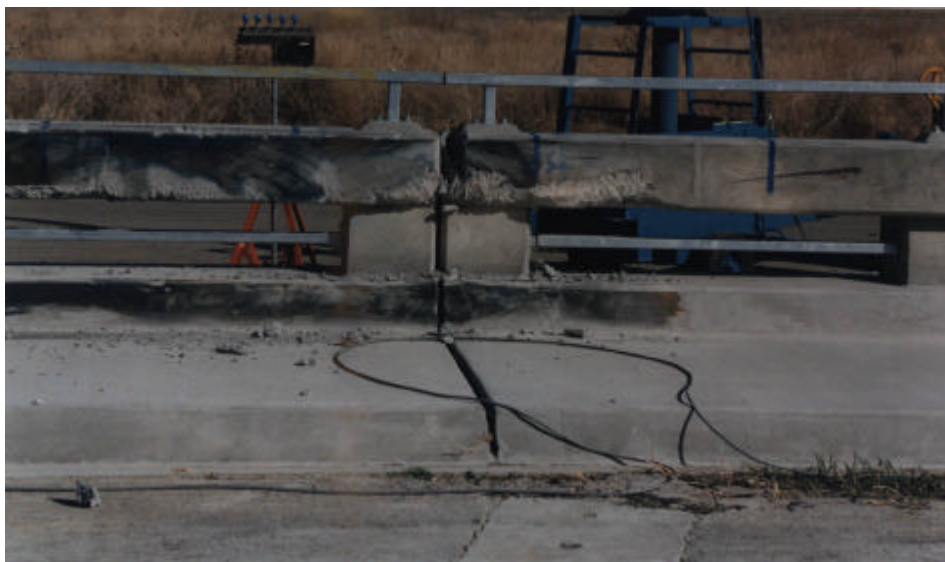
Figure 2-55 -
Close-up of
Impact Area for
Test 543

It appeared that the right front lug nuts scraped along the beam face, causing most of the concrete spalling seen in Figure 2-55. The right wheel well hit the handrail 0.028 s after initial contact with the bridge rail. Beginning 0.177 s after contact with the bridge rail, both the left front and left rear tires rose approximately 1 m off the ground and remained off the ground for 0.480 s and 0.757 s, respectively. The vehicle continued to make contact with the barrier for approximately 4.5 m. A peak roll of the vehicle box section to the right and then left was 17.5° at 0.521 s and 14.5° at 1.099 s, respectively, from the impact with the rail. These peaks were taken before the vehicle exited the end of the test article installation. Higher values may have occurred later after the brakes were applied. The vehicle continued to a point of rest on an earth berm about 43 m from the point of impact. The vehicle remained upright throughout and after the collision.

The barrier was scraped along the face and edges over a 3 m length. There was also spalling on the underside of the beam caused by the downward force of the rotating right front wheel lug nuts. The tire marks along the barrier were only a little longer than the scraping along the face. A concrete spall at the expansion joint was 80 mm to 100 mm deep and extended to the back face of the rail, shown in Figure 2-55 and Figure 2-56. The spall exposed the end of a piece of rebar but no structural damage was evident. The bridge rail withstood the impact from vehicle 543 well with only spall repairs necessary before subsequent tests.

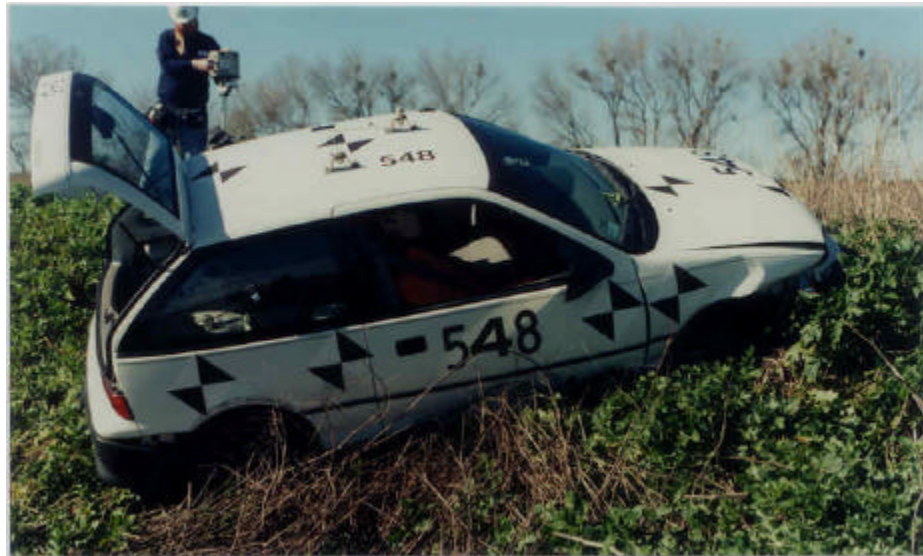
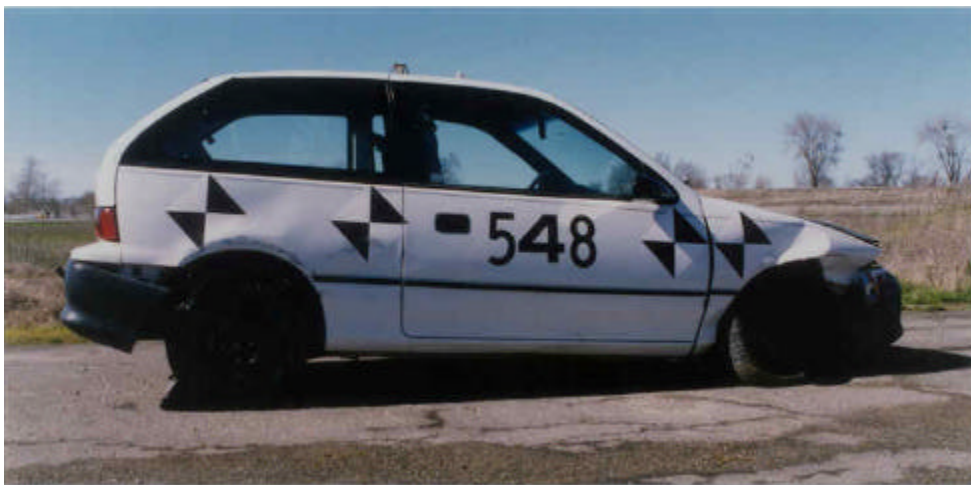
Figure 2-65 -
Right Side of
Vehicle 548
after Impact

The right front section of the vehicle sustained crushing of the bumper and right front quarter panel, damage to the suspension and a flat tire. Initial right front wheel damage occurred on impact with the sidewalk 0.4 m from the beginning of the bridge rail. The sidewalk contact caused deformation of the wheel and tire deflation. Wheel damage is shown in Figure 2-66. Other wheels were slightly deformed upon impact with the sidewalk, but the tires remained inflated. The vehicle first contacted the bridge rail on the curb section below the beam approximately 5.1 m from the beginning of the rail. After contacting the bridge rail, the right front wheel was pushed back, forcing the wheel well area to deform (Figure 2-65). The strut and axle for the right front wheel were bent, but remained attached.

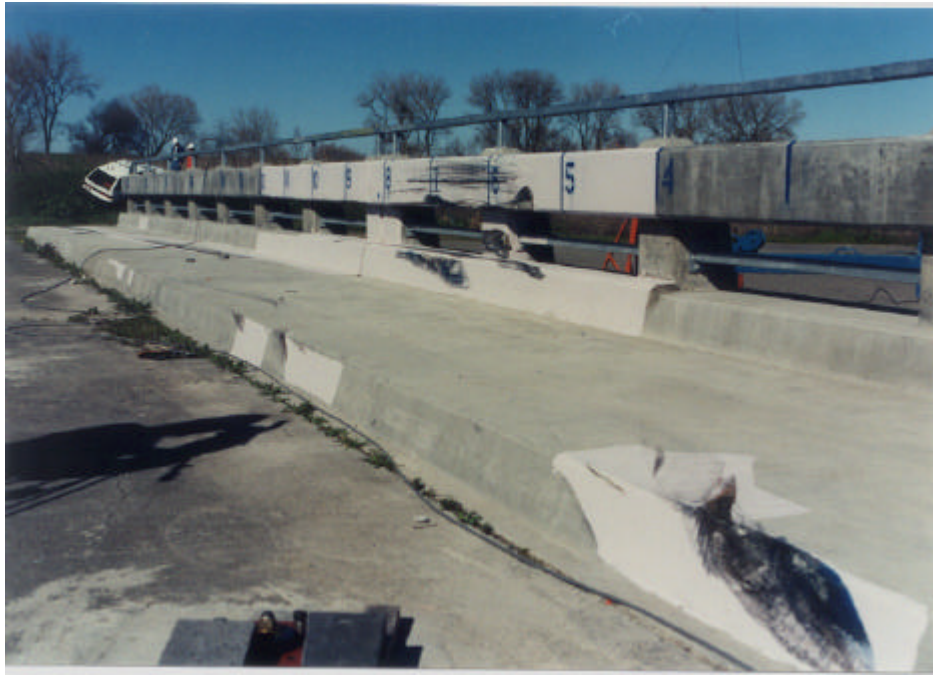
The exit speed and angle were approximately 62 km/h and 4°, respectively. The maximum roll of -14.3° occurred during the initial contact with the bridge rail and a maximum pitch of 5° was obtained as the vehicle's side came into contact with the beam section. The vehicle remained upright throughout and after the collision. Brakes were not applied and the stopping point for the vehicle was approximately 37 m from the point of last contact with the barrier. Figure 2-64 and Figure 2-67 show the vehicle in its resting position.

Figure 2-67 - Downstream View of Bridge Rail and Vehicle after Test 548
