Vehicle Crash Tests of The Type 80 Bridge Rail

March 1999

An aesthetic, see-through concrete bridge rail, Type 80, was built and tested in accordance with NCHRP Report 350. The Type 80 bridge rail is an 810 mm-tall, reinforced concrete barrier. The rail has 280 mm-high by 1620 mm-long gaps, 230 mm above the bridge deck surface. The barrier tested was 23 m-long and was constructed at the Caltrans Dynamic Test Facility in West Sacramento, California.

**VEHICLE CRASH TESTS OF THE  
TYPE 80 BRIDGE RAIL**

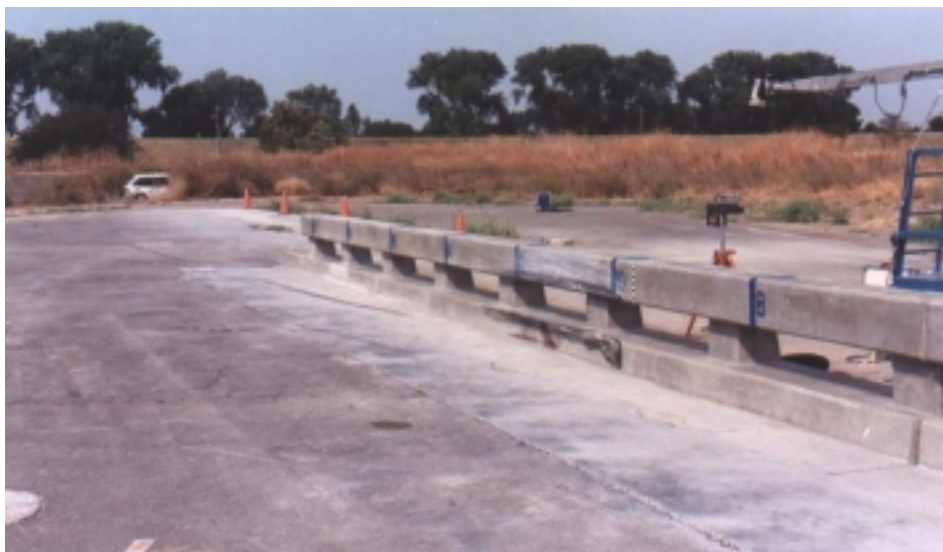
Figure 2-20 Post  
Impact Bridge Rail  
Scuff Marks Test 544

Contact with the bridge rail continued for approximately 2.5 m, determined by visible marks on the rail. The left rear wheel rose off the ground to a maximum of 0.1 to 0.15 m. As shown in Figure 2-19 through Figure 2-21, there were some black tire marks on the face of the barrier posts, but there was no evidence of wheel snagging. At 0.097 s after impact, the dummy's head was out of the right front passenger window. The dummy's head did not come into contact with the barrier or any other items and returned to its original position once the lateral accelerations decreased.

Barrier damage was cosmetic only, consisting of scrapes and tire marks. Both of the right side tires left marks on the curb and beam section of the bridge rail. Small amounts of concrete spalled from the face of the barrier where the vehicle’s sheet metal and wheels made contact.

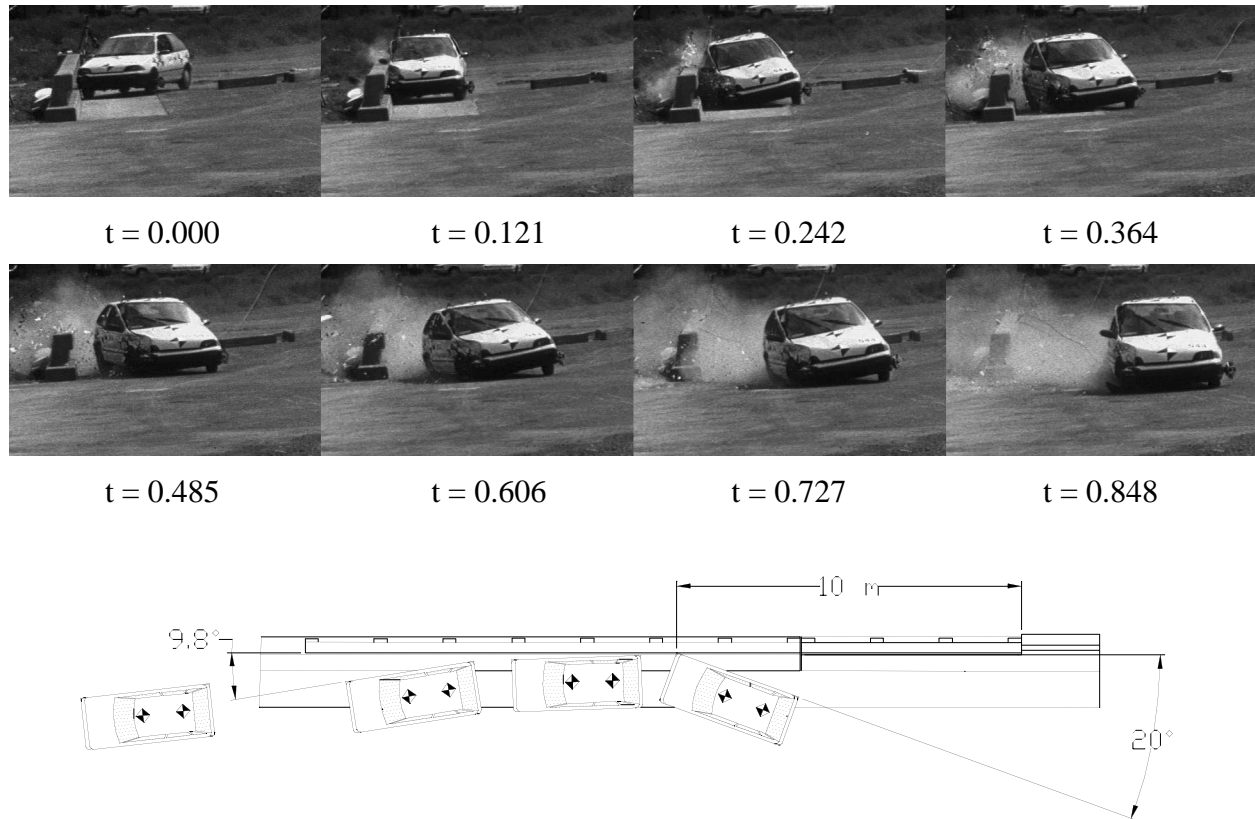
Figure 2-22 Test 544 Data Summary Sheet

Barrier Damage: ..... Superficial scuffing

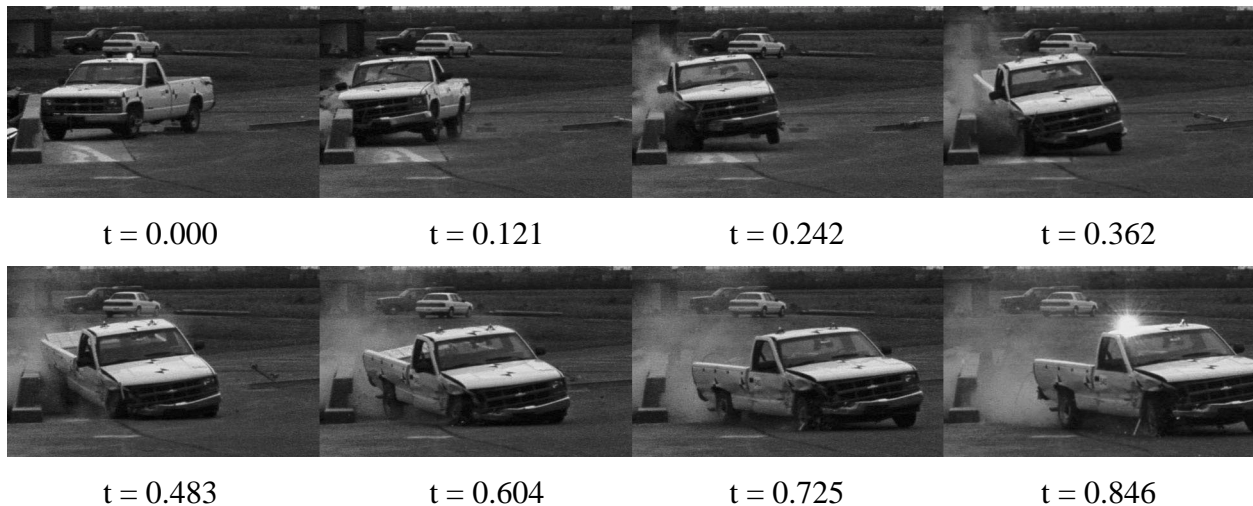
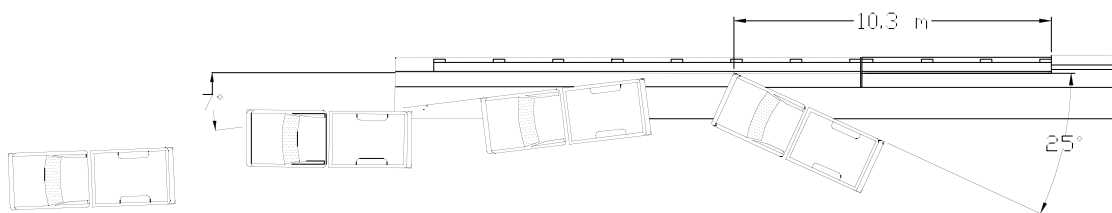
Figure 2-32 Test 545 Data Summary Sheet

Barrier Damage: ..... The barrier sustained minor spalling from the point of impact to 2 m downstream. Other barrier damage was cosmetic, consisting of scrapes and tire marks, with no structural damage.

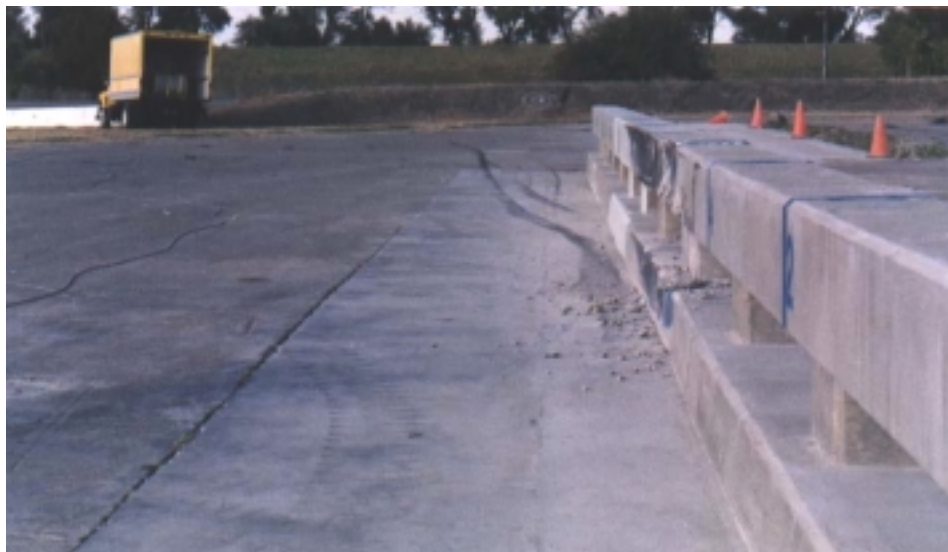
Figure 2-40  
Barrier and Resting  
Point of Vehicle

The 8056 kg van-bodied truck impacted the bridge rail at 80.1 km/h and 15.0 degrees. The impact location was 0.7 m in front of the bridge rail expansion joint, Figure 2-42. At impact the vehicle rolled to the right lifting both left wheels off the ground about 0.8 m. The U-bolt holding the front right leaf springs to the front axle broke, allowing the right front wheel to be pushed back under the cab, Figure 2-39. The vehicle continued to make contact with the barrier for 5 m. The approximate exit angle of the truck after it left contact with the beam face was 8 degrees. The truck then righted itself and continued to move away from the barrier at a shallow angle. The brakes were applied and the truck came to rest about 30 m and 65 m, respectively, from the point of impact, Figure 2-40.

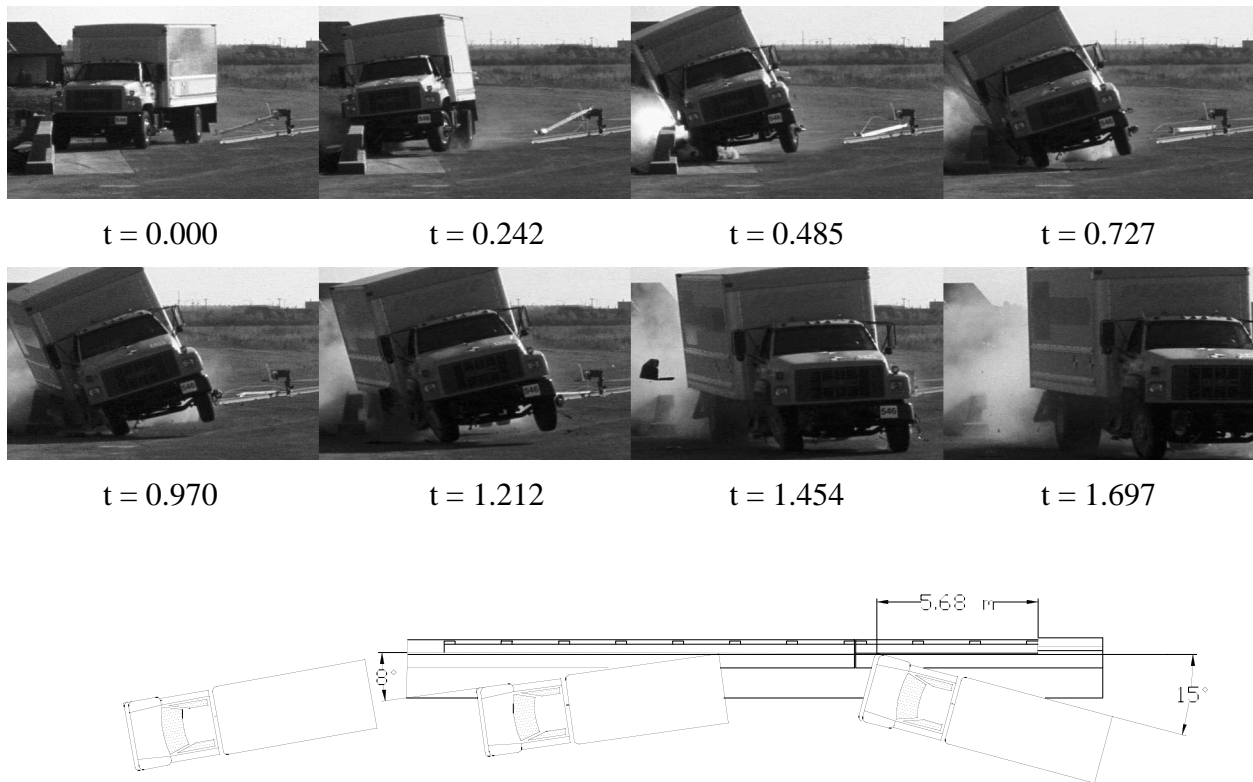
Figure 2-43 Test 546 Data Summary Sheet

Barrier Damage: ..... The barrier sustained minor spalling near the point of impact and at the expansion joint. Other barrier damage was cosmetic, consisting of scrapes and tire marks, with no structural damage.
