1. Report No. TRP-03-212-09	2.	3. Recipient's Accession No.	
4. Title and Subtitle Development of a TL-2 Steel Bridge Railing and Transition for Use on Transverse, Nail-Laminated, Timber Bridges		5. Report Date August 13, 2009

9. Performing Organization Name and Address Midwest Roadside Safety Facility (MwRSF) University of Nebraska-Lincoln 527 Nebraska Hall Lincoln, Nebraska 68588-0529		10. Project/Task/Work Unit No. WV-09-2007-B2

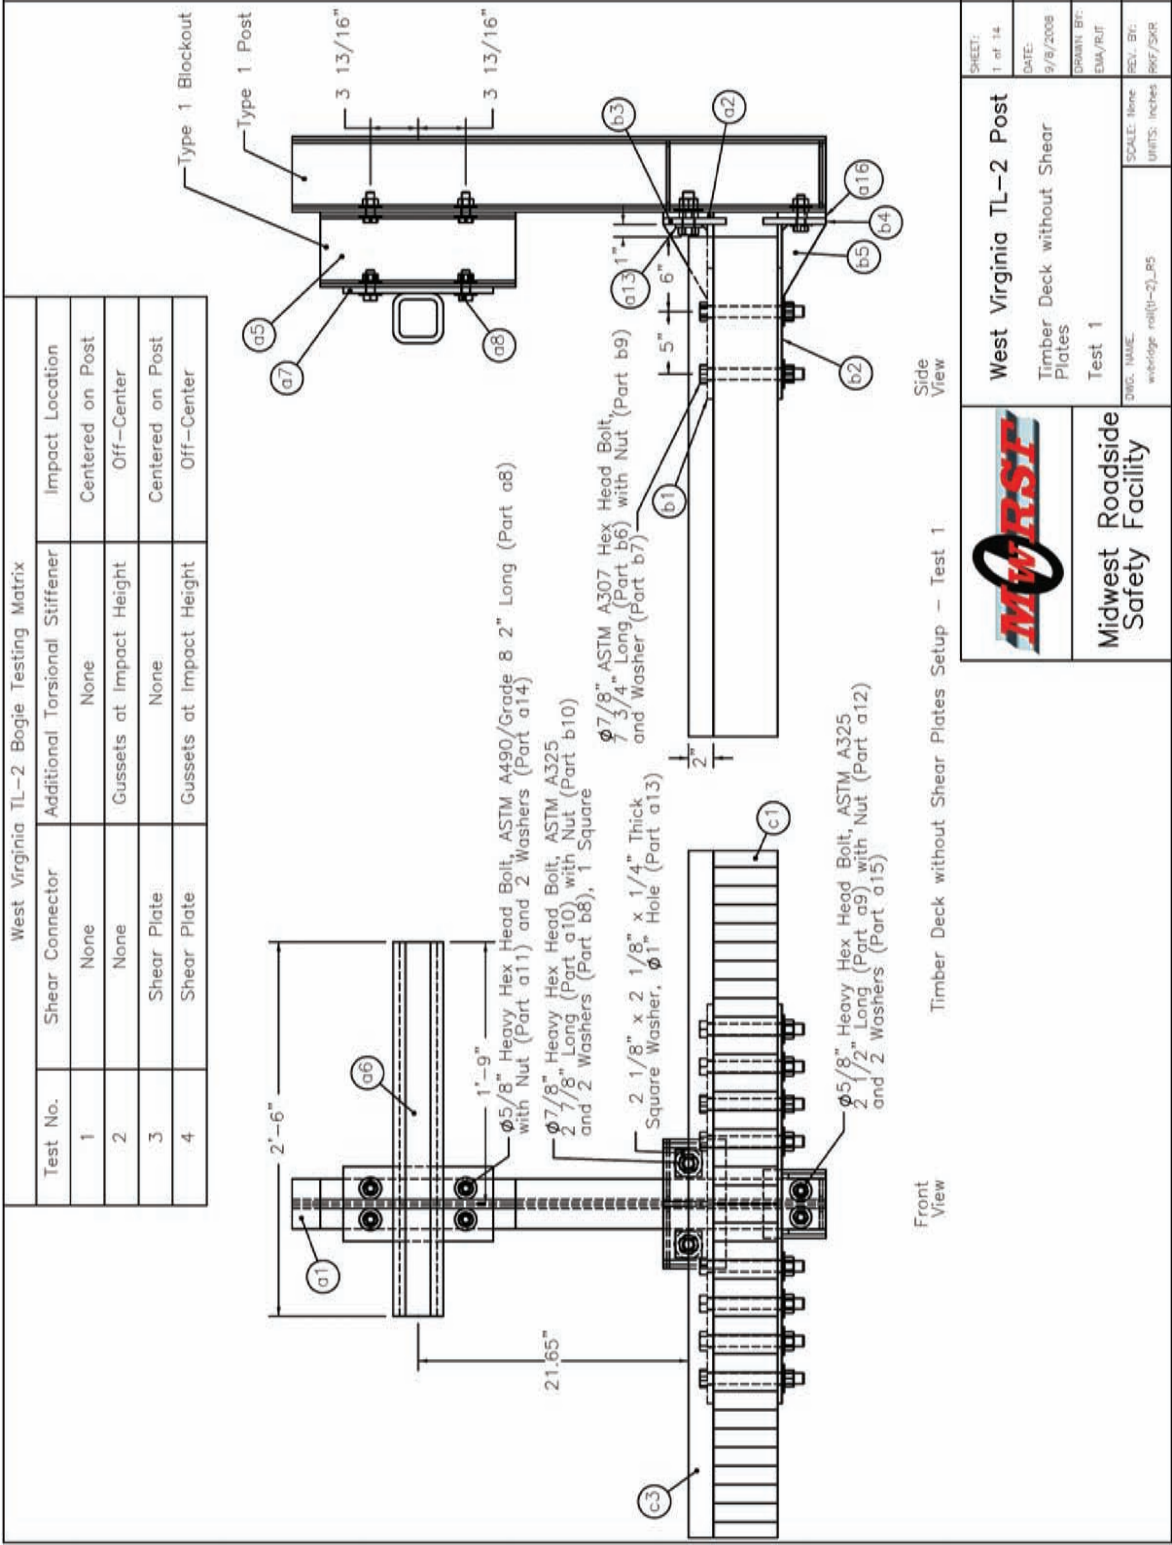
Figure 1. Post Testing Schematic, Test No. WVTL2-1

West Virginia TL-2 Post Timber Deck without Shear Plates Test 1 <small>DWG. NAME: wvbridge_nsl(1-2)_B5 SCALE: None UNITS: inches</small>
Midwest Roadside Safety Facility	SHEET: 1 of 14 DATE: 9/8/2008 DRAWN BY: EMA/RJT REV. BY: BSK/SJR

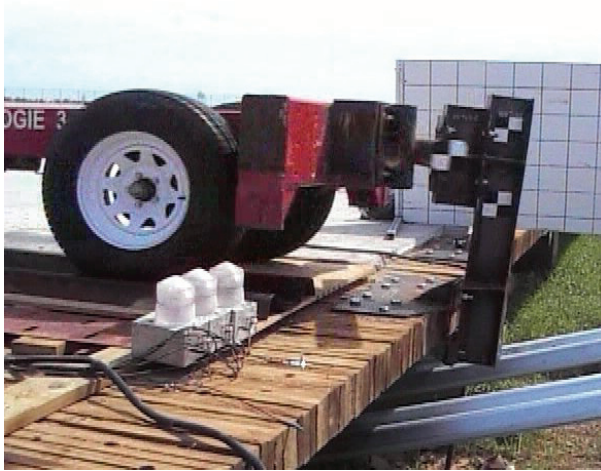
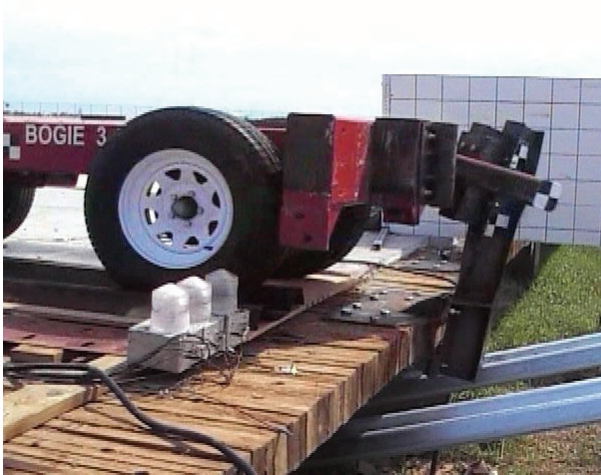
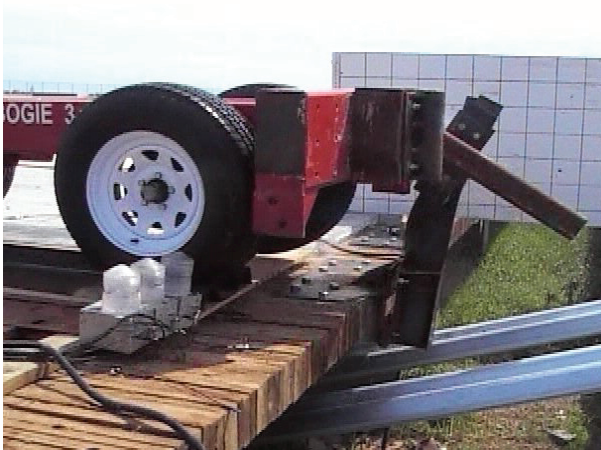
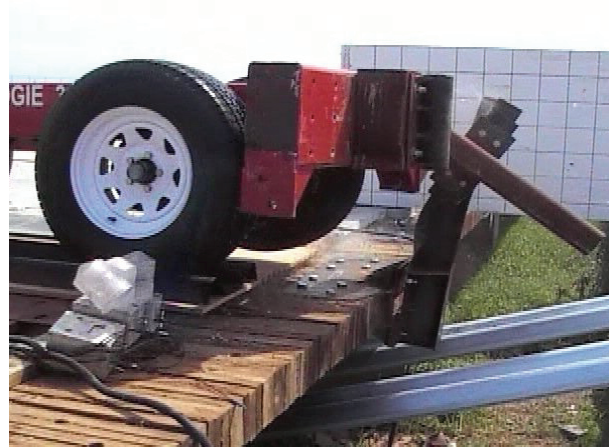
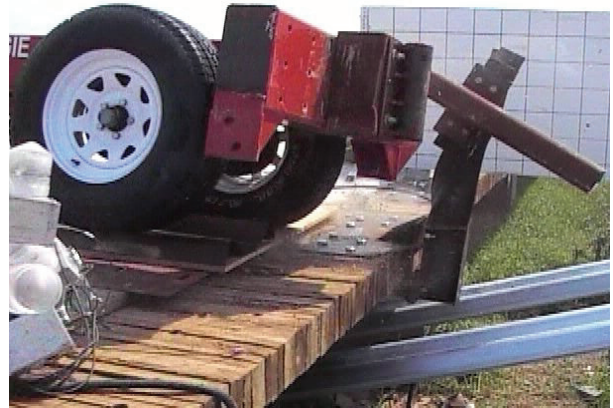
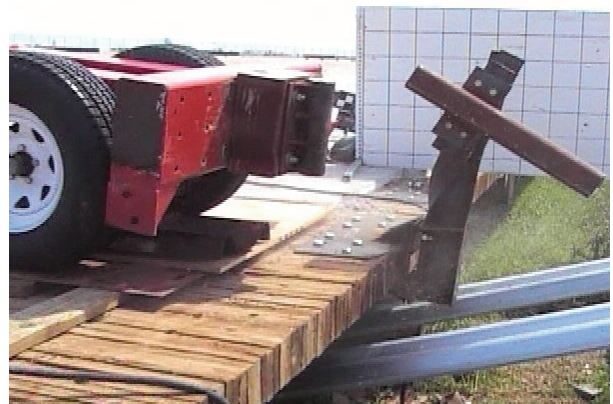
Figure 21. Sequential Photographs, Test No. WVTL2-2

0.000 sec

0.167 sec

0.033 sec

0.267 sec

0.100 sec

0.534 sec

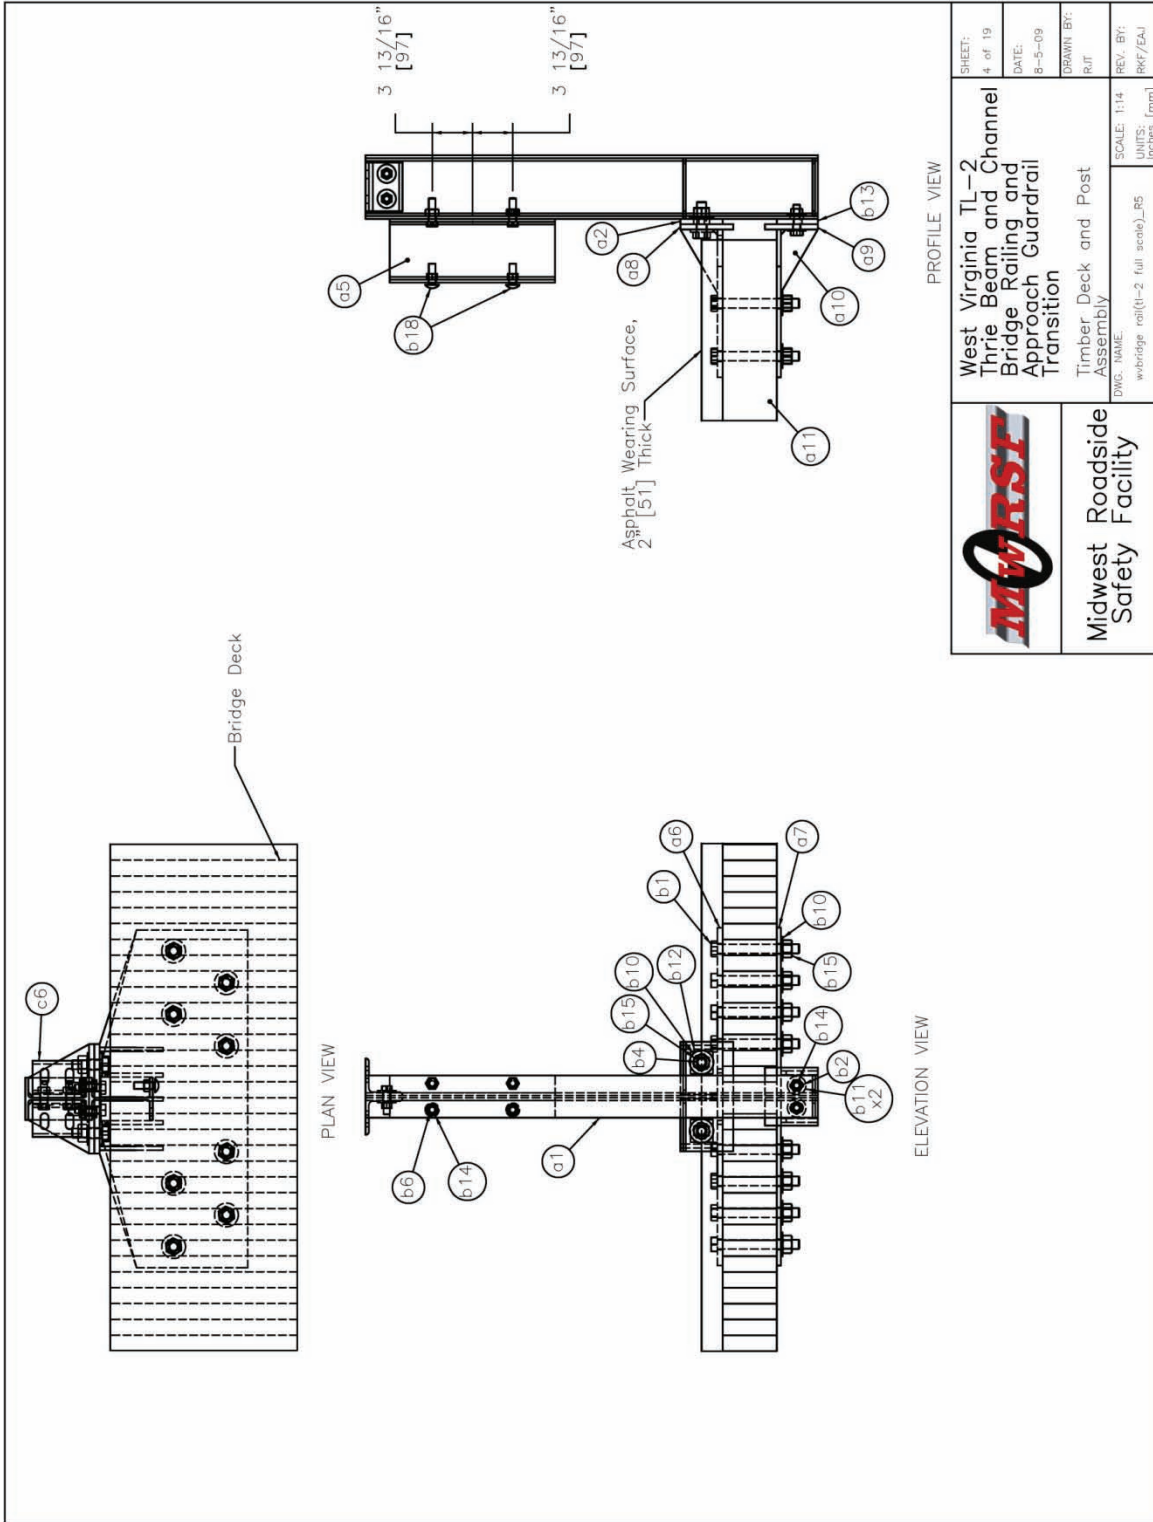
Figure B - 4. Timber Deck and Post Assembly
