HSA-10/B112

In your letter dated October 24, 2002, you requested formal Federal Highway Administration acceptance of a steel strap "tie-down" system designed to limit the deflection of temporary concrete barrier when used on a bridge deck or in other locations where the barrier's normal design deflection would not be tolerable.

Temporary Barrier Tie-Down Strap Concept – ITD-1

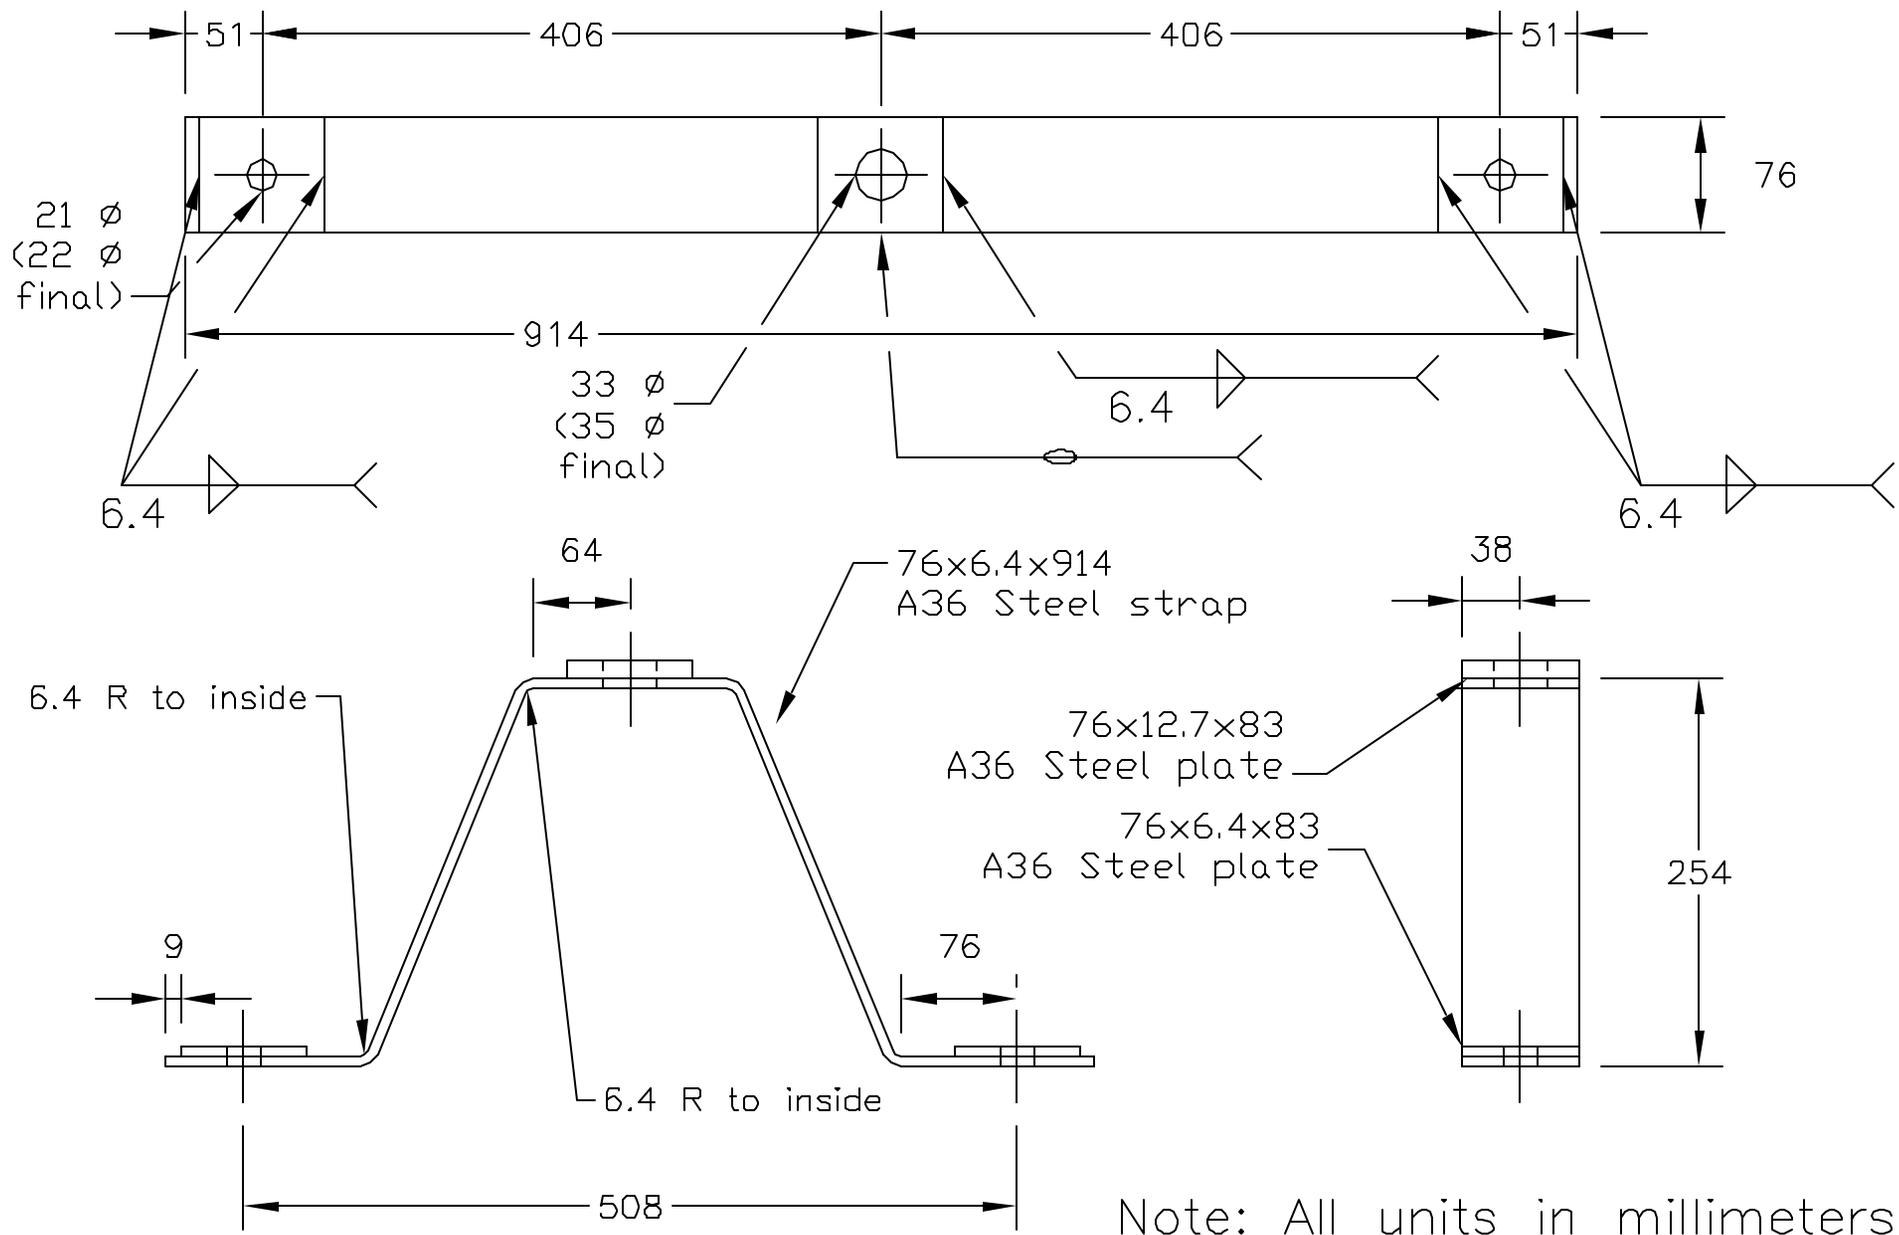
The proposed design was tested using a total of sixteen 3.8-m long sections of the Iowa pin and loop F-shape barrier that was formally accepted as an NCHRP Report 350 barrier at test level 3 (TL-3) in Mr. Dwight A. Horne's October 10, 1997 letter (acceptance letter B-41). These barriers were set 305 mm from the outside edge of the simulated bridge deck. The "tie-down" system consisted of a trapezoidal-shaped 6.4-mm thick A36 steel strap at each barrier joint through which the connecting pin between adjacent barrier segments is inserted. This strap, shown in the enclosure to this letter, was then attached to the concrete bridge deck with two 19-mm diameter x 57-mm long ISO Class 8.8 bolts set into 19-mm diameter Red Head drop-in anchors. These anchors were embedded 81mm into the concrete deck. Eleven tie-down straps were used. The test vehicle impacted the barrier 1.2 upstream of the gap between segments 8 and 9. At that point, there were four strap anchors upstream of the impact point and seven anchors downstream. The first three joints upstream of the impact and the last downstream joint were not anchored. Thus, the impact point was approximately 30 m downstream from the approach end of the test installation and approximately 14 m downstream from the first strap anchor

As noted in your August 16, 2002 report entitled "Development of a Tie-down System for Temporary Concrete Barriers", the design was successfully tested to NCHRP Report 350 TL-3. Dynamic deflection of the barrier was 960 mm, with one segment deflected over the edge of the bridge deck and the two adjacent segments partially deflected over the edge. However, the pin and loop connections and the intact tie-down straps along the rest of the barrier segments held the deflected segments in place on the bridge as desired. Two tie-down straps in the immediate impact area were pulled out of the deck and three adjacent straps showed extensive deformation, as did several of the connecting pins and barrier loops. However, none of the barrier pin and loop connections failed. Impacts closer to the unanchored segments at either end of the bridge can be expected to result in larger lateral barrier deflections.
